**ASBESTOS MANAGEMENT SURVEY WITH REFURBISHMENT
SURVEY TO SPECIFIED AREAS OF
12 CHANDLER CLOSE, SWINDON, SN1 3RT**

**SANCTUARY GROUP (WORCESTER BRANCH)
CHAMBER COURT
CASTLE STREET
WORCESTER**

PROJECT NO: J1011744

DATE: March 2025

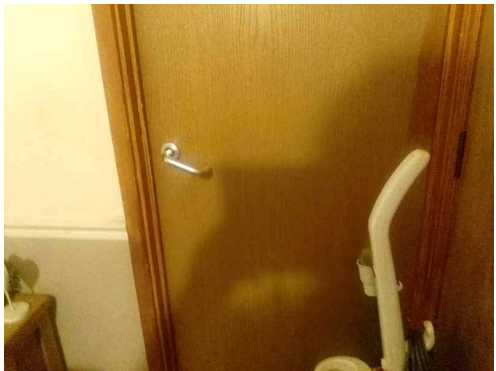
FLOOR/LOCATION:	1st Floor Bedroom 1	
DESCRIPTION:	Inaccessible	
RECOMMENDATIONS:	Conduct further investigation prior to relevant works	
EXTENT:		
SAMPLE REF:	Presumed	
RESULT:	Presumed
