ASBESTOS MANAGEMENT SURVEY WITH REFURBISHMENT  
SURVEY TO ALL CEILINGS OF  
28 AYMER PLACE, SWINDON, SN3 3TR

**PROJECT NO: J1003716**

**DATE: February 2025**

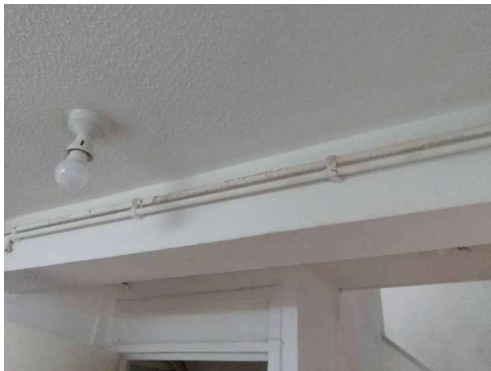
<b>FLOOR/LOCATION:</b>	4th Floor Hall	
<b>DESCRIPTION:</b>	Textured coating to ceiling and beam	
<b>RECOMMENDATIONS:</b>	Remove under controlled conditions	
<b>EXTENT:</b>	<10m² or <10m pipe run	
<b>SAMPLE REF:</b>	CG016072	
<b>RESULT:</b>	Chrysotile

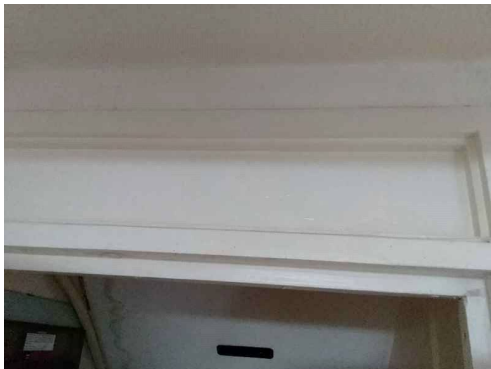
<b>FLOOR/LOCATION:</b>	4th Floor Hall	
<b>DESCRIPTION:</b>	Insulating board header panel to door	
<b>RECOMMENDATIONS:</b>	Manage, monitor and inform maintenance personnel prior to relevant works	
<b>EXTENT:</b>	<10m² or <10m pipe run	
<b>SAMPLE REF:</b>	CG016071	
<b>RESULT:</b>	Amosite

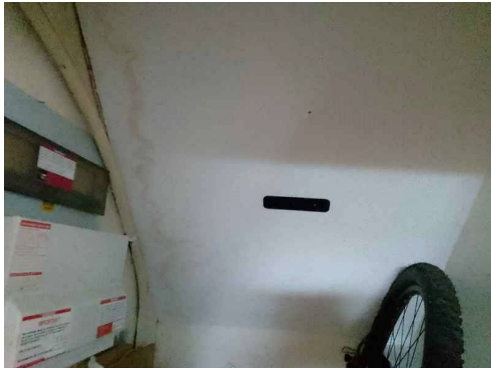
<b>FLOOR/LOCATION:</b>	4th Floor Understairs Cupboard	
<b>DESCRIPTION:</b>	Textured coating to ceiling and beam	
<b>RECOMMENDATIONS:</b>	Remove under controlled conditions	
<b>EXTENT:</b>	<10m² or <10m pipe run	
<b>SAMPLE REF:</b>	SPST CG016072	
<b>RESULT:</b>	Chrysotile

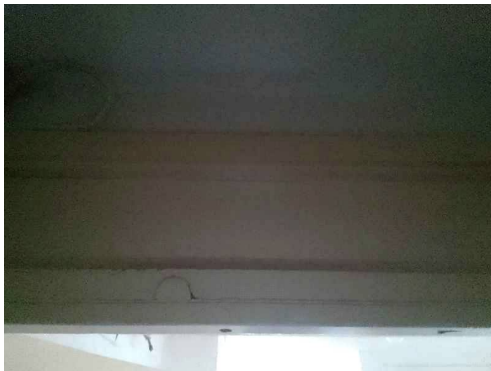
20	4th Floor	Understairs Cupboard	Cement header panel to door	Asbestos Insulating Board	2	1no.	1	Good Condition	0		0	CG016071	SPST	Manage	Amosite	2	4		
21	4th Floor	Understairs Cupboard	All other areas visually no asbestos identified											No action	No Asbestos Detected				
22	4th Floor	Store Room 1	Visually no asbestos identified											No action	No Asbestos Detected			Limited access due to stored items, unable to investigate boxig at rear of cupboard. Plasterboard ceiling, masonry and plasterboard walls, fixed modern vinyl floor covering to floor. Timber door frame and architrave with glass header	
23	4th Floor	Kitchen	Textured coating to the ceiling	Decorative Finishes	1	12m²	1	Good Condition	0		0	CG016073	Sampled	Remove under Controlled Cond	Chrysotile	1	2	Plasterboard ceiling, masonry and plasterboard walls, fixed laminate floor covering to floor. Upvc window frame reveal and tiled sill. Timber door frame and architrave with glass header. Modern sink pad.

<b>FLOOR/LOCATION:</b>	4th Floor Understairs Cupboard	
<b>DESCRIPTION:</b>	Cement header panel to door	
<b>RECOMMENDATIONS:</b>	Manage, monitor and inform maintenance personnel prior to relevant works	
<b>EXTENT:</b>	<10m² or <10m pipe run	
<b>SAMPLE REF:</b>	SPST CG016071	
<b>RESULT:</b>	Amosite

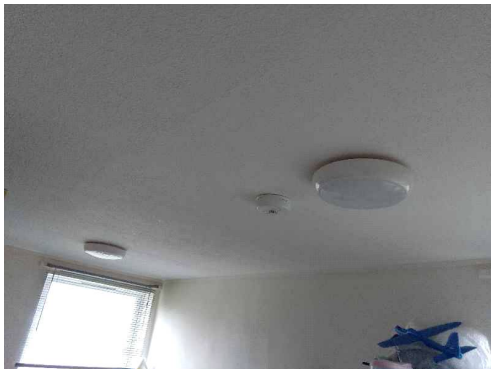
<b>FLOOR/LOCATION:</b>	4th Floor Kitchen	
<b>DESCRIPTION:</b>	Textured coating to the ceiling	
<b>RECOMMENDATIONS:</b>	Remove under controlled conditions	
<b>EXTENT:</b>	<10m² or <10m pipe run	
<b>SAMPLE REF:</b>	CG016073	
<b>RESULT:</b>	Chrysotile

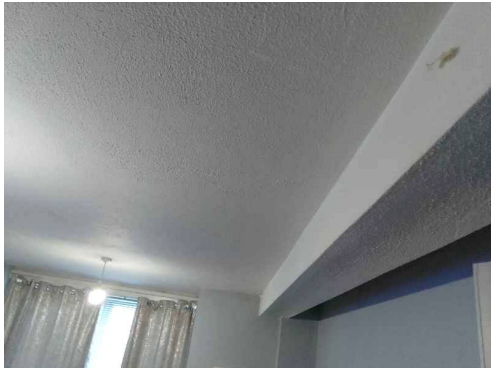
24	4th Floor	Kitchen	All other areas visually no asbestos identified											No action	No Asbestos Detected				
25	4th Floor	Lounge	Textured coating to the ceiling	Decorative Finishes	1	12m²	1	Good Condition	0		0	CG016073	SPST	Remove under Controlled Cond	Chrysotile	1	2	Plasterboard ceiling, masonry and plasterboard walls, fixed laminate floor covering to floor. Upvc window frame reveal and tiled sill. Timber door frame and architrave with glass header. Modern sink pad.	
26	4th Floor	Lounge	All other areas visually no asbestos identified											No action	No Asbestos Detected				
1	5th Floor	Landing	Textured coating to ceiling and beam.	Decorative Finishes	1	7m²	1	Good Condition	0		0	CG016068	Sampled	Remove under Controlled Cond	Chrysotile	1	2	Plasterboard ceiling, masonry and plasterboard walls, fixed carpet to floor, tenant requested no access below carpets, upvc and timer doors frames and architrave with glass and timber header panels.

<b>FLOOR/LOCATION:</b>	4th Floor Lounge	
<b>DESCRIPTION:</b>	Textured coating to the ceiling	
<b>RECOMMENDATIONS:</b>	Remove under controlled conditions	
<b>EXTENT:</b>	<10m² or <10m pipe run	
<b>SAMPLE REF:</b>	SPST CG016073	
<b>RESULT:</b>	Chrysotile

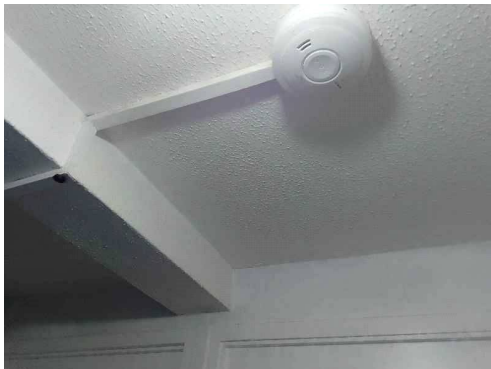
<b>FLOOR/LOCATION:</b>	5th Floor Landing	
<b>DESCRIPTION:</b>	Textured coating to ceiling and beam.	
<b>RECOMMENDATIONS:</b>	Remove under controlled conditions	
<b>EXTENT:</b>	<10m² or <10m pipe run	
<b>SAMPLE REF:</b>	CG016068	
<b>RESULT:</b>	Chrysotile

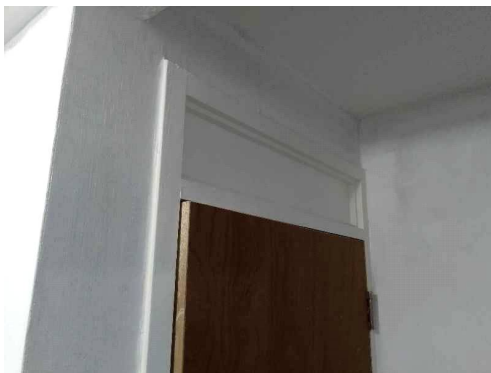
2	5th Floor	Landing	Insulating board panel to header panel above door.	Asbestos Insulating Board	2	1no.	1	Good Condition	0		2	CG016069	Sampled	Manage	Amosite	2	6

<b>FLOOR/LOCATION:</b>	5th Floor Landing	
<b>DESCRIPTION:</b>	Insulating board panel to header panel above door.	
<b>RECOMMENDATIONS:</b>	Manage, monitor and inform maintenance personnel prior to relevant works	
<b>EXTENT:</b>	<10m² or <10m pipe run	
<b>SAMPLE REF:</b>	CG016069	
<b>RESULT:</b>	Amosite

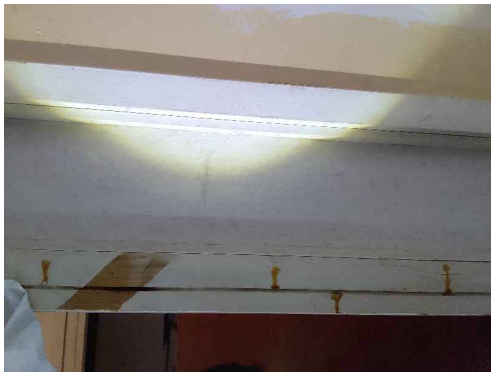
<b>FLOOR/LOCATION:</b>	5th Floor Landing cupboard	
<b>DESCRIPTION:</b>	Insulating board panel to header panel above door.	
<b>RECOMMENDATIONS:</b>	Manage, monitor and inform maintenance personnel prior to relevant works	
<b>EXTENT:</b>	<10m² or <10m pipe run	
<b>SAMPLE REF:</b>	SPST CG016069	
<b>RESULT:</b>	Amosite

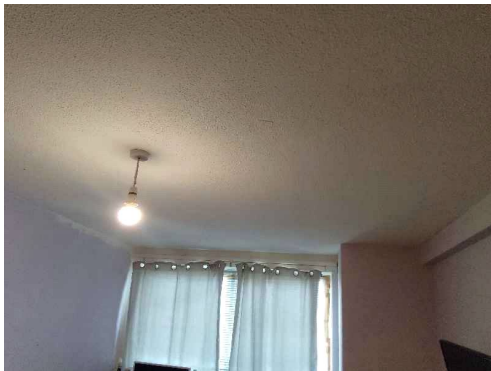
<b>FLOOR/LOCATION:</b>	5th Floor Bedroom 1	
<b>DESCRIPTION:</b>	Textured coating to and high level boxing	
<b>RECOMMENDATIONS:</b>	Remove under controlled conditions	
<b>EXTENT:</b>	<10m² or <10m pipe run	
<b>SAMPLE REF:</b>	SPST CG016068	
<b>RESULT:</b>	Chrysotile

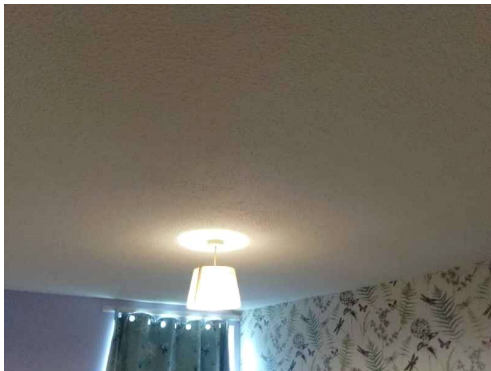
9	5th Floor	Bedroom 1	All other areas visually no asbestos identified									No action	No Asbestos Detected					
10	5th Floor	Bedroom 2	Textured coating to and high level boxing	Decorative Finishes	1	9m²	2	Good Condition	0	0	CG016070	Sampled	Remove under Controlled Cond	Chrysotile	1	2	Plasterboard ceiling, masonry and plasterboard walls, fixed carpet to floor, tenant requested no access below carpets, upvc window frame reveal and timber sill, timber doors frames and architrave with glass header panels. Vertical plaster board boxing.	
11	5th Floor	Bedroom 2	All other areas visually no asbestos identified									No action	No Asbestos Detected					
12	5th Floor	Toilet	Textured coating to the ceiling.	Decorative Finishes	1	2m²	1	A Few Scratches or Surface Marks	1	0	CG016070	SPST	Remove under Controlled Cond	Chrysotile	1	3	Plasterboard ceiling, masonry and plasterboard walls, fixed carpet to floor, tenant requested no access below carpets, upvc window frame reveal and timber sill, timber doors frames and architrave with glass header panels. Vertical plaster board boxing. Ceramic toilet and cistern with plastic collar and waste pipe penetrating plasterboard boxing.

<b>FLOOR/LOCATION:</b>	5th Floor Bedroom 2	
<b>DESCRIPTION:</b>	Textured coating to and high level boxing	
<b>RECOMMENDATIONS:</b>	Remove under controlled conditions	
<b>EXTENT:</b>	10 - 50 m² or 10 - 50m pipe run	
<b>SAMPLE REF:</b>	CG016070	
<b>RESULT:</b>	Chrysotile

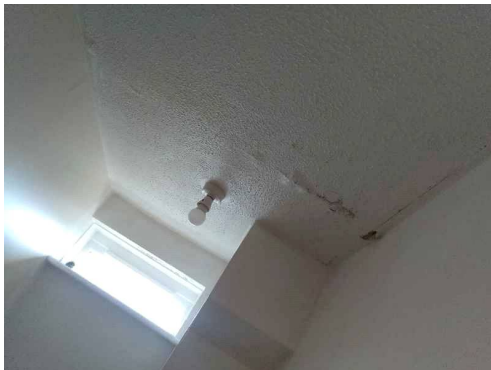
<b>FLOOR/LOCATION:</b>	5th Floor Toilet	
<b>DESCRIPTION:</b>	Textured coating to the ceiling.	
<b>RECOMMENDATIONS:</b>	Remove under controlled conditions	
<b>EXTENT:</b>	<10m² or <10m pipe run	
<b>SAMPLE REF:</b>	SPST CG016070	
<b>RESULT:</b>	Chrysotile

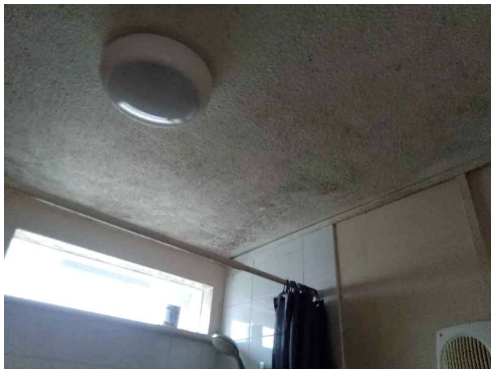
<b>FLOOR/LOCATION:</b>	5th Floor Bathroom	
<b>DESCRIPTION:</b>	Textured coating to the ceiling.	
<b>RECOMMENDATIONS:</b>	Remove under controlled conditions	
<b>EXTENT:</b>	<10m² or <10m pipe run	
<b>SAMPLE REF:</b>	SPST CG016070	
<b>RESULT:</b>	Chrysotile
