**ASBESTOS MANAGEMENT SURVEY WITH REFURBISHMENT
SURVEY TO THE BULGING CEILING (BEDROOM 1) OF
4 DEERSWOOD GARDENS, STREET, SOMERSET, BA16 9PY**

**SANCTUARY GROUP (WORCESTER BRANCH)
CHAMBER COURT
CASTLE STREET
WORCESTER**

PROJECT NO: J1028225

DATE: June 2025

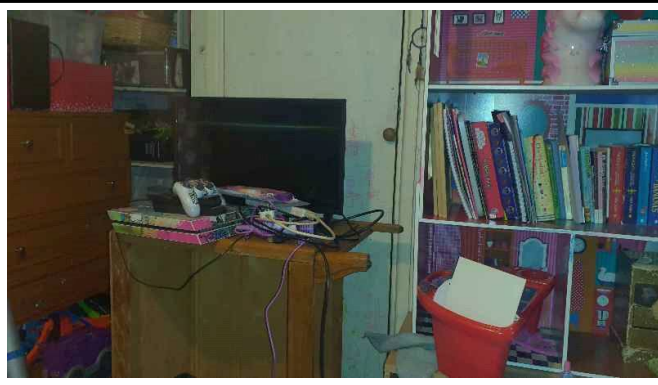
BUILDING NAME:	Main building
FLOOR/LOCATION:	1st Floor Bedroom 2 Cupboard
DESCRIPTION:	Inaccessible
RECOMMENDATIONS:	Conduct further investigation prior to relevant works
EXTENT:	
SAMPLE REF:	Presumed
RESULT:	Presumed
