Asbestos Management Survey with  
refurbishment element to specified  
area(s) only

1 Huntley Court, Erleigh Road, Reading,  
Berkshire RG1 5NW

REPORT DATE – 18 Apr 2025

BATCH REF – J037452

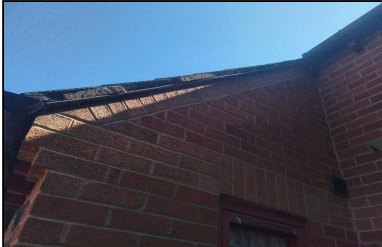
Floor Level	Location Item Position & Description	Survey Date	Item Reference	Material Assessment				Mean Assessment Total	Level of Identification	Asbestos Identification	Extent	Comments	Recommendations	Risk Category	Photograph
				Product Type	Damage Deterioration	Surface Treatment	Asbestos Type								
External	External - Roof area (1) - undercloaking - Cement	07/04/2025	BC001212_1	0	0	0	0	0	Sampled	No Asbestos Detected	12lm	Clay tiles to roof, solid brick walls, concrete slabs to ground, plastic rain water goods.	No Action Required	N/A

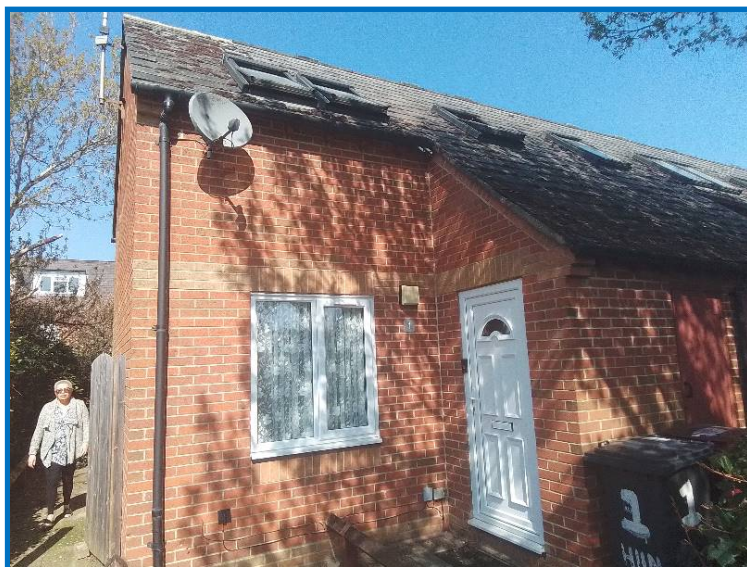
Floor Level	Location	Item, Position & Description	Materials/ Comments	Risk Level Assessment	Sample No	Photo
External	Roof area	undercloaking - Cement	No Asbestos Detected		BC001212_1
