Asbestos Management Survey with  
refurbishment element to specified  
area(s) only

N / A 19 Arbour Close, Reading, Berkshire RG1  
6EW

REPORT DATE – 29 Apr 2025

PROJECT NUMBER – 803161

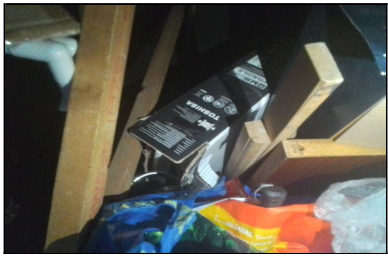
| Floor Level | Location Item Position & Description | Survey Date | Item Reference | Material Assessment | | | | Mean Assessment Total | Level of Identification | Asbestos Identification | Extent | Comments | Recommendations | Risk Category | Photograph |
|---|---|---|---|---|---|---|---|---|---|---|---|---|---|---|---|
| Second Floor | Second Floor - Loft space (1) - Stored items - Loft space - limited access due to no walkways throughout and stored items | 08/04/2025 | 1 | 0 | 0 | 0 | 0 | 0 | Inaccessible (Presumed) | No Access | | Bitumen layers to roof lining, masonry solid walls, fibreglass insulation, metal flue. Limited access | Further Investigation Required Prior to Works | N/A | |

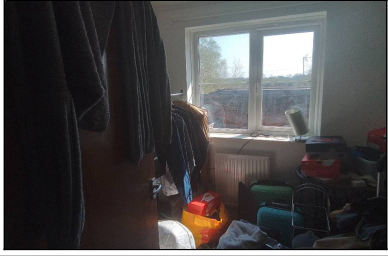
| Floor Level | Location Item Position & Description | Survey Date | Item Reference | Material Assessment | | | | Mean Assessment Total | Level of Identification | Asbestos Identification | Extent | Comments | Recommendations | Risk Category | Photograph |
|---|---|---|---|---|---|---|---|---|---|---|---|---|---|---|---|
| First Floor | First Floor - Bedroom 1 (1) - No suspect materials found | 08/04/2025 | 2 | 0 | 0 | 0 | 0 | 0 | | No Asbestos Detected | | Plasterboard panels to ceiling, solid & plasterboard walls, vinyl to wood flooring, pvc window & frame, modern mastic. | No Action Required | N/A | |

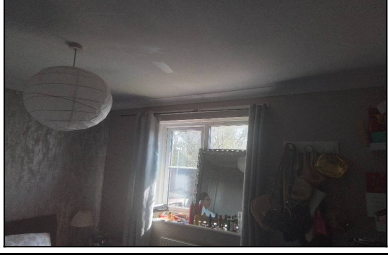
| Floor Level | Location Item Position & Description | Survey Date | Item Reference | Material Assessment | | | | Mean Assessment Total | Level of Identification | Asbestos Identification | Extent | Comments | Recommendations | Risk Category | Photograph |
|---|---|---|---|---|---|---|---|---|---|---|---|---|---|---|---|
| First Floor | First Floor - Bedroom 2 & cupboard 1 (2) - No suspect materials found | 08/04/2025 | 3 | 0 | 0 | 0 | 0 | 0 | | No Asbestos Detected | | Plasterboard panels to ceiling, solid & plasterboard walls, vinyl to wood flooring, pvc window and frame, modern mastic. | No Action Required | N/A | |

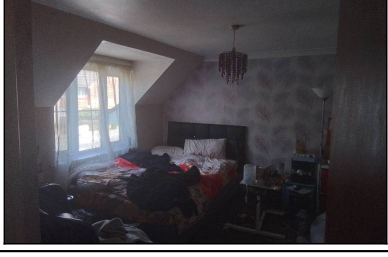
| Floor Level | Location Item Position & Description | Survey Date | Item Reference | Material Assessment | | | | Mean Assessment Total | Level of Identification | Asbestos Identification | Extent | Comments | Recommendations | Risk Category | Photograph |
|---|---|---|---|---|---|---|---|---|---|---|---|---|---|---|---|
| First Floor | First Floor - Bedroom 3 & cupboard 2 (3) - No suspect materials found | 08/04/2025 | 4 | 0 | 0 | 0 | 0 | 0 | | No Asbestos Detected | | Plasterboard panels to ceiling, solid & plasterboard walls, vinyl to wood flooring, plasterboard boxing, pvc window and frame, modern mastic. | No Action Required | N/A | |

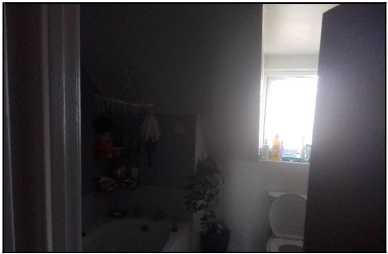
| Floor Level | Location Item Position & Description | Survey Date | Item Reference | Material Assessment | | | | Mean Assessment Total | Level of Identification | Asbestos Identification | Extent | Comments | Recommendations | Risk Category | Photograph |
|---|---|---|---|---|---|---|---|---|---|---|---|---|---|---|---|
| First Floor | First Floor - Bathroom (5) - No suspect materials found | 08/04/2025 | 6 | 0 | 0 | 0 | 0 | 0 | | No Asbestos Detected | | Plasterboard panels to ceiling, solid & plasterboard walls, vinyl to wood flooring, plasterboard boxing, pvc window and frame, modern mastic, plastic bath panel, ceramic toilet cistern, plasterboard boxing. | No Action Required | N/A | |

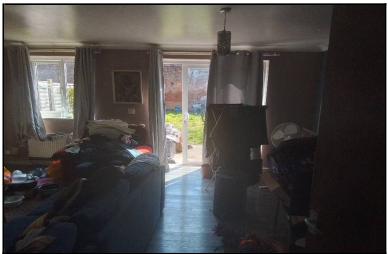
| Floor Level | Location Item Position & Description | Survey Date | Item Reference | Material Assessment | | | | Mean Assessment Total | Level of Identification | Asbestos Identification | Extent | Comments | Recommendations | Risk Category | Photograph |
|---|---|---|---|---|---|---|---|---|---|---|---|---|---|---|---|
| Ground Floor | Ground Floor - Lounge (1) - No suspect materials found | 08/04/2025 | 7 | 0 | 0 | 0 | 0 | 0 | | No Asbestos Detected | | Plasterboard panels to ceiling, solid & plasterboard walls, vinyl to concrete flooring, pvc window/ door & frame, modern mastic. | No Action Required | N/A | |

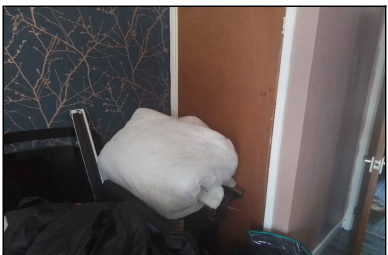
| Floor Level | Location Item Position & Description | Survey Date | Item Reference | Material Assessment | | | | Mean Assessment Total | Level of Identification | Asbestos Identification | Extent | Comments | Recommendations | Risk Category | Photograph |
|---|---|---|---|---|---|---|---|---|---|---|---|---|---|---|---|
| Ground Floor | Ground Floor - Cupboard 5 (2) - Access blocked - Inaccessible | 08/04/2025 | 8 | 0 | 0 | 0 | 0 | 0 | Inaccessible (Presumed) | No Access | | No Access | Further Investigation Required Prior to Works | N/A | |

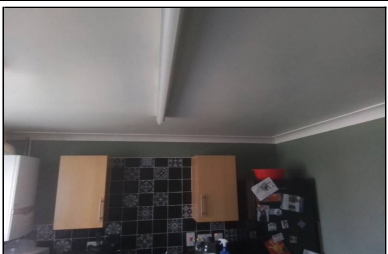
| Floor Level | Location Item Position & Description | Survey Date | Item Reference | Material Assessment | | | | Mean Assessment Total | Level of Identification | Asbestos Identification | Extent | Comments | Recommendations | Risk Category | Photograph |
|---|---|---|---|---|---|---|---|---|---|---|---|---|---|---|---|
| Ground Floor | Ground Floor - Kitchen (3) - No suspect materials found | 08/04/2025 | 9 | 0 | 0 | 0 | 0 | 0 | | No Asbestos Detected | | Plasterboard panels to ceiling, solid & plasterboard walls, vinyl to concrete flooring, pvc window & frame, modern mastic & sink. | No Action Required | N/A | |

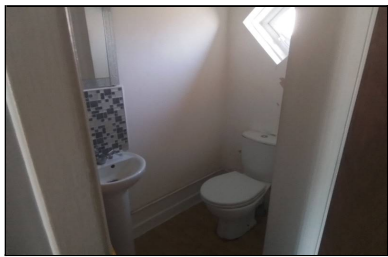
| Floor Level | Location Item Position & Description | Survey Date | Item Reference | Material Assessment | | | | Mean Assessment Total | Level of Identification | Asbestos Identification | Extent | Comments | Recommendations | Risk Category | Photograph |
|---|---|---|---|---|---|---|---|---|---|---|---|---|---|---|---|
| Ground Floor | Ground Floor - W/C (4) - No suspect materials found | 08/04/2025 | 11 | 0 | 0 | 0 | 0 | 0 | | No Asbestos Detected | | Plasterboard panels to ceiling, solid & plasterboard walls, vinyl to concrete flooring, pvc window & frame, modern mastic, ceramic toilet cistern, plasterboard & timber boxing. | No Action Required | N/A | |

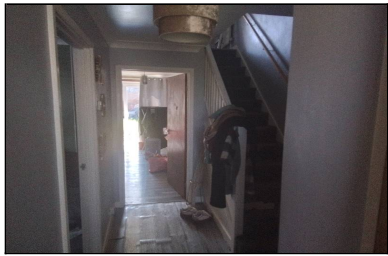
| Floor Level | Location Item Position & Description | Survey Date | Item Reference | Material Assessment | | | | Mean Assessment Total | Level of Identification | Asbestos Identification | Extent | Comments | Recommendations | Risk Category | Photograph |
|---|---|---|---|---|---|---|---|---|---|---|---|---|---|---|---|
| Ground Floor | Ground Floor - Hallway (5) - No suspect materials found | 08/04/2025 | 12 | 0 | 0 | 0 | 0 | 0 | | No Asbestos Detected | | Plasterboard panels to ceiling, solid & plasterboard walls, vinyl to concrete flooring, pvc & wood window/ door & frame, modern mastic. | No Action Required | N/A | |

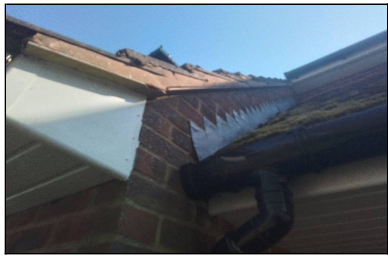
| Floor Level | Location Item Position & Description | Level of Identification | Asbestos Identification | Risk Category | Recommendation |
|---|---|---|---|---|---|
| External | Externals - roof undercloaking - Cement | Sampled | Chrysotile | D | Remove if affected by the works |

| Floor Level | Location Item Position & Description | Survey Date | Item Reference | Material Assessment | | | | Mean Assessment Total | Level of Identification | Asbestos Identification | Extent | Comments | Recommendations | Risk Category | Photograph |
|---|---|---|---|---|---|---|---|---|---|---|---|---|---|---|---|
| External | External - Externals (1) - roof undercloaking - Cement | 08/04/2025 | BC001217_13 | 1 | 0 | 1 | 1 | 3 | Sampled | Chrysotile | 7lm | Concrete roof tiling, solid brick walls, concrete slabs to floor, plastic soffits & front porch ceiling. | Remove if affected by the works | D | |

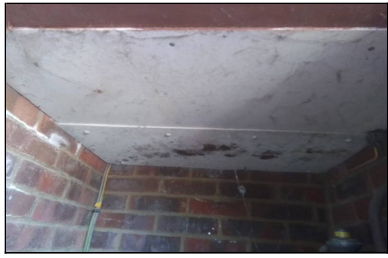
| Floor Level | Location Item Position & Description | Survey Date | Item Reference | Material Assessment | | | | Mean Assessment Total | Level of Identification | Asbestos Identification | Extent | Comments | Recommendations | Risk Category | Photograph |
|---|---|---|---|---|---|---|---|---|---|---|---|---|---|---|---|
| External | External - Cupboard 6 (2) - ceiling panels - Insulating board | 08/04/2025 | BC001218_14 | 0 | 0 | 0 | 0 | 0 | Sampled | No Asbestos Detected | 1m <sup>2</sup> | Solid brick walls, solid concrete floor, modern electrics. | No Action Required | N/A | |
