Asbestos Management Survey with
refurbishment element to specified
area(s) only

N/A 26 Barnard's Hill Drive, Salisbury, Wiltshire
SP2 9RA

REPORT DATE – 7 Jul 2025

BATCH REF – J037763

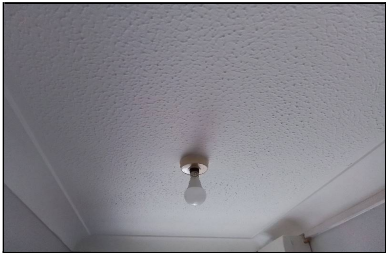
Floor Level	Location Item Position & Description	Survey Date	Item Reference	Material Assessment				Mean Assessment Total	Level of Identification	Asbestos Identification	Extent	Comments	Recommendations	Risk Category	Photograph
				Product Type	Damage Deterioration	Surface Treatment	Asbestos Type								
Ground Floor	Ground Floor - Hall (1) - to the ceiling - Textured coating	21/06/2025	ET000094_1	0	0	0	0	0	Sampled	No Asbestos Detected	1m ²	Sampled textured coating to plasterboard ceiling, plaster skimmed masonry and plasterboard walls, no access beneath laminate flooring, modern electrics.	No Action Required	N/A

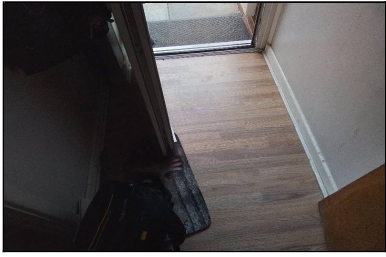
Ground Floor	Ground Floor - Hall (1) - No access - No access beneath laminate flooring	21/06/2025	2	0	0	0	0	0	Inaccessible (Presumed)	No Access		Sampled textured coating to plasterboard ceiling, plaster skimmed masonry and plasterboard walls, no access beneath laminate flooring, modern electrics.	Further Investigation Required Prior to Works	N/A

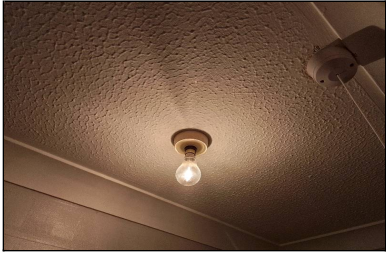
Ground Floor	Ground Floor - Toilet (2) - to the ceiling - Textured coating	21/06/2025	As /ET000094_3	0	0	0	0	0	Not sampled. Refer to other sample	N/A	1m ²	Sampled textured coating to plasterboard ceiling, plaster skimmed masonry and plasterboard walls, no access beneath modern vinyl flooring, timber boxing, ceramic cistern.	No Action Required	N/A

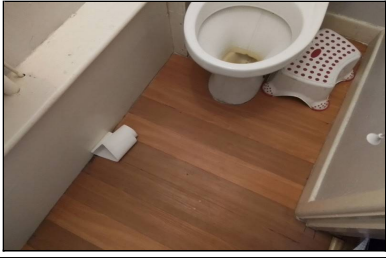
Ground Floor	Ground Floor - Toilet (2) - No access - No access beneath vinyl flooring	21/06/2025	4	0	0	0	0	0	Inaccessible (Presumed)	No Access		Sampled textured coating to plasterboard ceiling, plaster skimmed masonry and plasterboard walls, no access beneath modern vinyl flooring, timber boxing, ceramic cistern.	Further Investigation Required Prior to Works	N/A

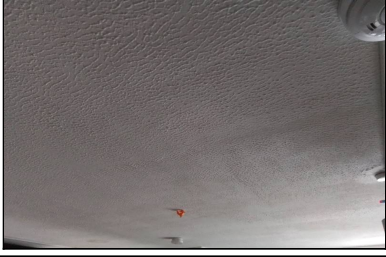
Ground Floor	Ground Floor - Lounge (3) - to the ceiling - Textured coating	21/06/2025	As /ET000094_5	0	0	0	0	0	Not sampled. Refer to other sample	N/A	30m ²	Sampled textured coating to plasterboard ceiling, plaster skimmed masonry and plasterboard walls, no access beneath laminate flooring.	No Action Required	N/A

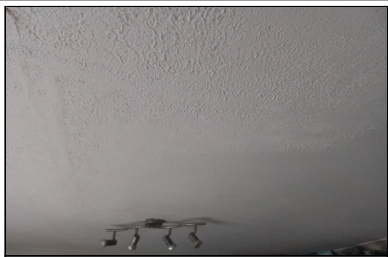
Floor Level	Location Item Position & Description	Survey Date	Item Reference	Material Assessment				Mean Assessment Total	Level of Identification	Asbestos Identification	Extent	Comments	Recommendations	Risk Category	Photograph
				Product Type	Damage Deterioration	Surface Treatment	Asbestos Type								
Ground Floor	Ground Floor - Lounge (3) - No access - No access beneath laminate flooring	21/06/2025	6	0	0	0	0	0	Inaccessible (Presumed)	No Access		Sampled textured coating to plasterboard ceiling, plaster skimmed masonry and plasterboard walls, no access beneath laminate flooring.	Further Investigation Required Prior to Works	N/A	No photographic evidence available
Ground Floor	Ground Floor - Kitchen (4) - to the ceiling - Textured coating	21/06/2025	As /ET000094_7	0	0	0	0	0	Not sampled. Refer to other sample	N/A	12m ²	Sampled textured coating to plasterboard ceiling, plaster skimmed masonry and plasterboard walls, no access beneath modern vinyl flooring, timber boxing, timber units.	No Action Required	N/A

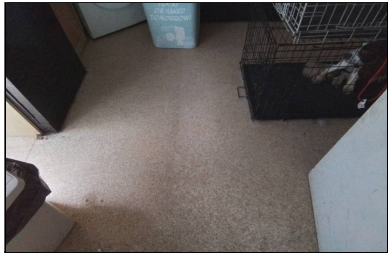
Ground Floor	Ground Floor - Kitchen (4) - No access - No access beneath vinyl flooring	21/06/2025	8	0	0	0	0	0	Inaccessible (Presumed)	No Access		Sampled textured coating to plasterboard ceiling, plaster skimmed masonry and plasterboard walls, no access beneath modern vinyl flooring, timber boxing, timber units.	Further Investigation Required Prior to Works	N/A

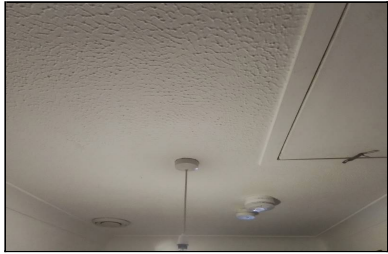
First Floor	First Floor - Landing and cupboards 3 & 4 (1) - to the ceiling - Textured coating	21/06/2025	ET000095_9	0	0	0	0	0	Sampled	No Asbestos Detected	8m ²	Sampled textured coating to plasterboard ceiling, plaster skimmed masonry and plasterboard walls, carpet to timber floor, modern boiler mounted on to sampled insulating board panel within cupboard. Continues in to cupboards	No Action Required	N/A

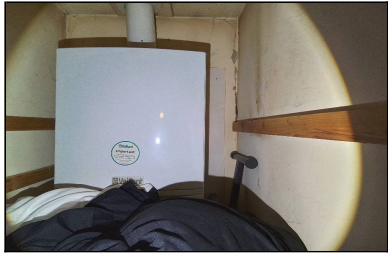
First Floor	First Floor - Landing and cupboards 3 & 4 (1) - behind boiler within cupboard - Insulating board mounting panel	21/06/2025	ET000096_10	0	0	0	0	0	Sampled	No Asbestos Detected	1m ²	Sampled textured coating to plasterboard ceiling, plaster skimmed masonry and plasterboard walls, carpet to timber floor, modern boiler mounted on to sampled insulating board panel within cupboard.	No Action Required	N/A

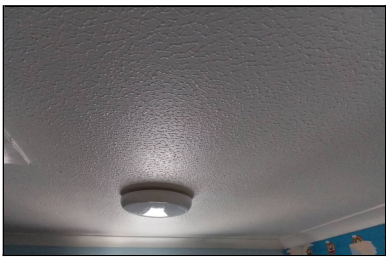
Floor Level	Location Item Position & Description	Survey Date	Item Reference	Material Assessment				Mean Assessment Total	Level of Identification	Asbestos Identification	Extent	Comments	Recommendations	Risk Category	Photograph
				Product Type	Damage Deterioration	Surface Treatment	Asbestos Type								
First Floor	First Floor - Bedroom 3 (2) - to the ceiling - Textured coating	21/06/2025	As /ET000095_11	0	0	0	0	0	Not sampled. Refer to other sample	N/A	10m²	Sampled textured coating to plasterboard ceiling, plaster skimmed masonry and plasterboard walls, carpet to timber floor.	No Action Required	N/A

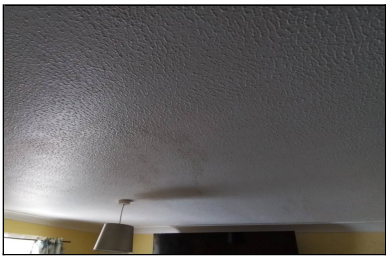
First Floor	First Floor - Bedroom 1 and cupboard 1 (3) - to the ceiling - Textured coating	21/06/2025	As /ET000095_12	0	0	0	0	0	Not sampled. Refer to other sample	N/A	17m²	Sampled textured coating to plasterboard ceiling, plaster skimmed masonry and plasterboard walls, carpet to timber floor. Continues in to cupboard	No Action Required	N/A

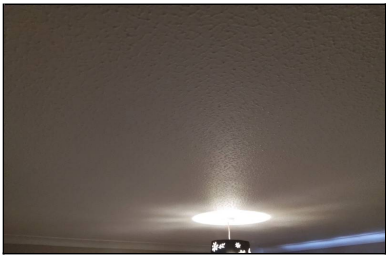
First Floor	First Floor - Bedroom 2 and cupboard 2 (4) - to the ceiling - Textured coating	21/06/2025	As /ET000095_13	0	0	0	0	0	Not sampled. Refer to other sample	N/A	16m²	Sampled textured coating to plasterboard ceiling, plaster skimmed masonry and plasterboard walls, carpet to timber floor. Continues in to cupboard	No Action Required	N/A

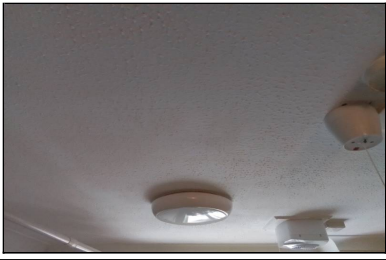
First Floor	First Floor - Bathroom (5) - to the ceiling - Textured coating	21/06/2025	As /ET000095_14	0	0	0	0	0	Not sampled. Refer to other sample	N/A	8m²	Sampled textured coating to plasterboard ceiling, plaster skimmed masonry and plasterboard walls, 2x layers of modern vinyl to timber floor, timber boxing, ceramic cistern.	No Action Required	N/A

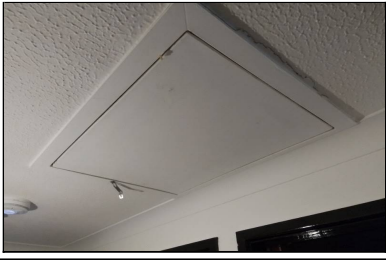
Roof Void	Roof Void - Loft space (1) - Inaccessible	21/06/2025	15	0	0	0	0	0	Inaccessible (Presumed)	No Access		No Access	Further Investigation Required Prior to Works	N/A

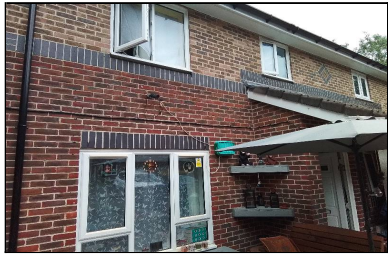
Floor Level	Location Item Position & Description	Survey Date	Item Reference	Material Assessment				Mean Assessment Total	Level of Identification	Asbestos Identification	Extent	Comments	Recommendations	Risk Category	Photograph
				Product Type	Damage Deterioration	Surface Treatment	Asbestos Type								
External	External - External (1) - No suspect materials found	21/06/2025	16	0	0	0	0	0		No Asbestos Detected		Concrete roof tiles, UPVC soffits and fascias, plastic rainwater goods, no visible undercloak, masonry walls with plastic DPC, timber canopy ceiling.	No Action Required	N/A
