Asbestos Management Survey with
refurbishment element to specified
area(s) only

N/A 3 Arbour Close, Reading, Berkshire RG1
6EW

REPORT DATE – 21 Jul 2025

BATCH REF – J037935

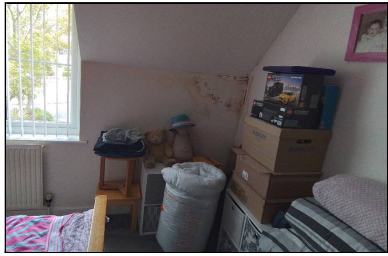
Floor Level	Location Item Position & Description	Survey Date	Item Reference	Material Assessment				Mean Assessment Total	Level of Identification	Asbestos Identification	Extent	Comments	Recommendations	Risk Category	Photograph
				Product Type	Damage Deterioration	Surface Treatment	Asbestos Type								
First Floor	First Floor - Bedroom 1 & cupboard (1) - No suspect materials found	15/07/2025	1	0	0	0	0	0		No Asbestos Detected		Plasterboard ceiling, solid plaster & plasterboard walls, carpet to wood floor.	No Action Required	N/A

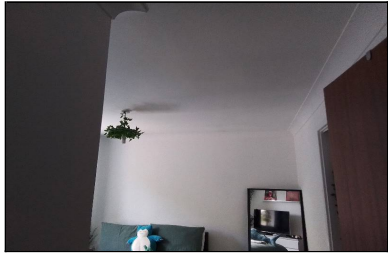
First Floor	First Floor - Bedroom 2 & cupboard (2) - No suspect materials found	15/07/2025	2	0	0	0	0	0		No Asbestos Detected		Plasterboard ceiling, solid plaster & plasterboard walls, carpet to wood floor.	No Action Required	N/A
