Asbestos Management Survey with  
refurbishment element to specified  
area(s) only

N / A 33 Meadowvale, Dursley, Gloucestershire  
GL11 6HQ

REPORT DATE – 7 Jul 2025

PROJECT NUMBER – 804610

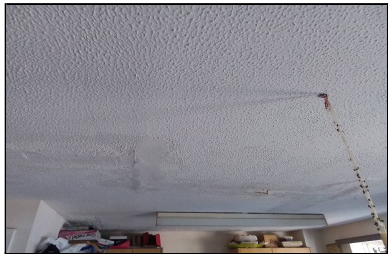
| Floor Level | Location Item Position & Description | Survey Date | Item Reference | Material Assessment | | | | Mean Assessment Total | Level of Identification | Asbestos Identification | Extent | Comments | Recommendations | Risk Category | Photograph |
|---|---|---|---|---|---|---|---|---|---|---|---|---|---|---|---|
| Ground Floor | Ground Floor - Kitchen and cupboard (3) - to the ceiling - Textured coating | 18/06/2025 | ET000087_3 | 0 | 0 | 0 | 0 | 0 | Sampled | No Asbestos Detected | 24m <sup>2</sup> | Sampled textured coating to plasterboard ceiling, plaster skimmed masonry walls. Continues in to cupboard | No Action Required | N/A | |
