Asbestos Management Survey with
refurbishment element to specified
area(s) only
4 Beatty Drive, Reading, Berkshire RG30 6NE

REPORT DATE – 18 Apr 2025
BATCH REF – J037448
PROJECT NUMBER – 803161

Asbestos Summary Report

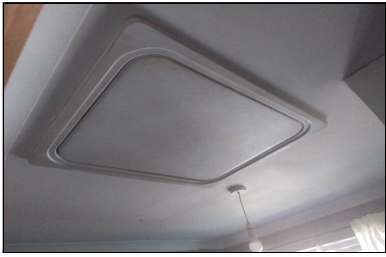
First Floor	First Floor - Bedroom 1 (1) - No suspect materials found	08/04/2025	2	0	0	0	0	0		No Asbestos Detected		Plasterboard panels to ceiling, solid & plasterboard walls, carpet to wood flooring.	No Action Required	N/A

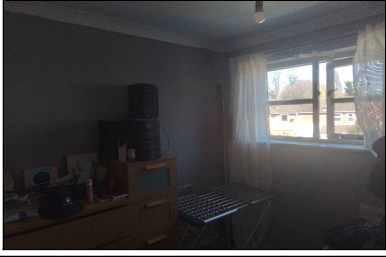
First Floor	First Floor - Bedroom 2 (2) - No suspect materials found	08/04/2025	3	0	0	0	0	0		No Asbestos Detected		Plasterboard panels to ceiling, solid & plasterboard walls, carpet to wood flooring.	No Action Required	N/A

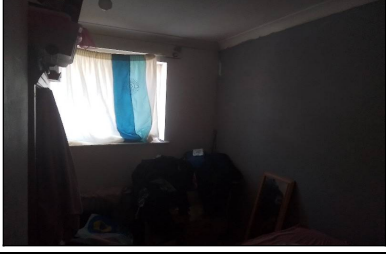
First Floor	First Floor - Bedroom 3 (3) - No suspect materials found	08/04/2025	4	0	0	0	0	0		No Asbestos Detected		Plasterboard panels to ceiling, solid & plasterboard walls, carpet to wood flooring, plasterboard boxing.	No Action Required	N/A

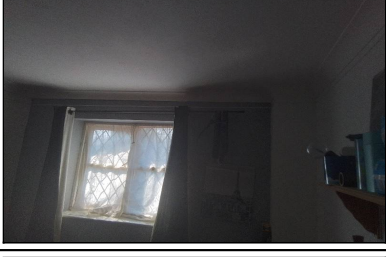
First Floor	First Floor - Landing & cupboard 1 (4) - No suspect materials found	08/04/2025	5	0	0	0	0	0		No Asbestos Detected		Plasterboard panels to ceiling, solid & plasterboard walls, carpet to wood flooring.	No Action Required	N/A

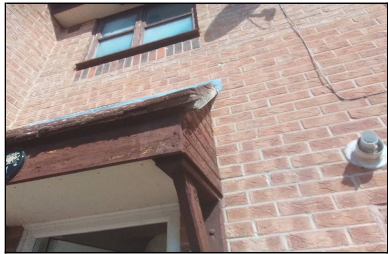
D	Manage	Solid brick walls, concrete slabs, clay roof tiling, plastic guttering and soffits.	2lm	Chrysotile	Sampled	3	1	1	0	1	BC001214_11	08/04/2025	External - Externals (1) - undercloaking - Cement	External

This category indicates that there is a very low risk from the asbestos. As Refurbishment is proposed, the removal of the asbestos will be required. In the interim, the area should be made safe.
