## Asbestos Survey Report Refurbishment Survey

N/A, 441 Devizes Road, Salisbury, Wiltshire,  
SP2 9EN

REPORT DATE – 7 Jul 2025  
BATCH REF – J037764  
PROJECT NUMBER – 804610  
Template: SRR 200120 V18

The reason for the refurbishment survey was Refurbishment survey required to external walkway ceiling for upcoming work

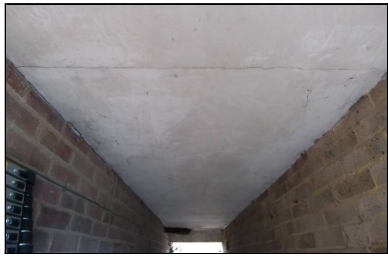
Floor Level	Location Item Position & Description	Survey Date	Item Reference	Material Assessment				Mean Assessment Total	Level of Identification	Asbestos Identification	Extent	Comments	Recommendations	Risk Category	Photograph
				Product Type	Damage Deterioration	Surface Treatment	Asbestos Type								
External	External - Walkway (1) - No suspect materials found	21/06/2025	1	0	0	0	0	0		No Asbestos Detected		Single skinned plasterboard ceiling with a plaster skim finish and timber floorboards above, masonry walls, concrete lintels.	No Action Required	N/A

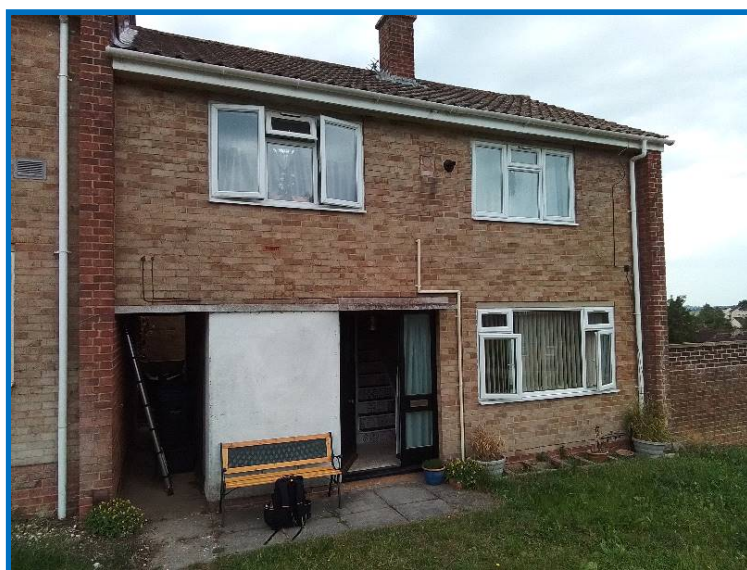
Floor Level	Location	Item, Position & Description	Materials/ Comments	Risk Level Assessment	Sample No	Photo
External	Walkway	No suspect materials found	No Asbestos Detected		1
