Asbestos Management Survey with  
refurbishment element to specified  
area(s) only

N / A 59 Pigeons Farm Road, Thatcham,  
Berkshire RG19 8XD

REPORT DATE – 11 Jun 2025

PROJECT NUMBER – 804610

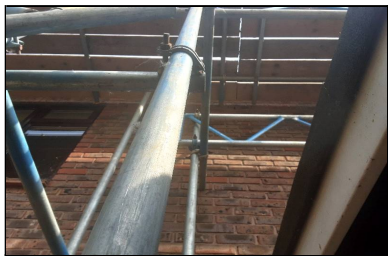
| Floor Level | Location Item Position & Description | Survey Date | Item Reference | Material Assessment | | | | Mean Assessment Total | Level of Identification | Asbestos Identification | Extent | Comments | Recommendations | Risk Category | Photograph |
|---|---|---|---|---|---|---|---|---|---|---|---|---|---|---|---|
| External | External - Roof externals (1) - undercloaking - Cement | 14/05/2025 | AB004465_1 | 0 | 0 | 0 | 0 | 0 | Sampled | No Asbestos Detected | 8lm | Clay roof tiles, timber fascia & soffits, metal flue pipe. | No Action Required | N/A | |

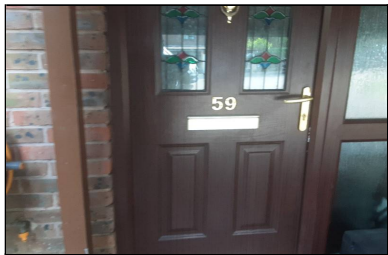
| Floor Level | Location Item Position & Description | Survey Date | Item Reference | Material Assessment | | | | Mean Assessment Total | Level of Identification | Asbestos Identification | Extent | Comments | Recommendations | Risk Category | Photograph |
|---|---|---|---|---|---|---|---|---|---|---|---|---|---|---|---|
| Ground Floor | Ground Floor - Internal of property (1) - Inaccessible | 14/05/2025 | 2 | 0 | 0 | 0 | 0 | 0 | Inaccessible (Presumed) | No Access | | No Access | Further Investigation Required Prior to Works | N/A | |
