Asbestos Management Survey with  
refurbishment element to specified  
area(s) only

N / A Flat 5, Cooper House, Forest Road,  
Bordon, Hampshire GU35 0XR

REPORT DATE – 21 Jul 2025

PROJECT NUMBER – 804610

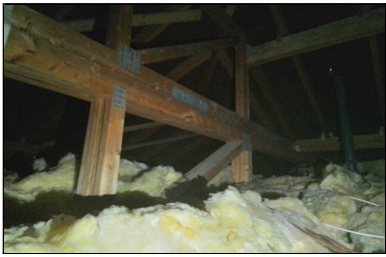
| Floor Level | Location Item Position & Description | Survey Date | Item Reference | Material Assessment | | | | Mean Assessment Total | Level of Identification | Asbestos Identification | Extent | Comments | Recommendations | Risk Category | Photograph |
|---|---|---|---|---|---|---|---|---|---|---|---|---|---|---|---|
| Second Floor | Second Floor - Loft space (1) - No suspect materials found | 15/07/2025 | 1 | 0 | 0 | 0 | 0 | 0 | | No Asbestos Detected | | Solid masonry walls, fibreglass insulation to plasterboard floor, bitumen lining to roof, plastic pipes. Limited access, no walkways throughout | No Action Required | N/A | |

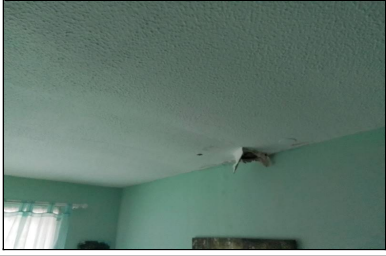
| Floor Level | Location Item Position & Description | Survey Date | Item Reference | Material Assessment | | | | Mean Assessment Total | Level of Identification | Asbestos Identification | Extent | Comments | Recommendations | Risk Category | Photograph |
|---|---|---|---|---|---|---|---|---|---|---|---|---|---|---|---|
| First Floor | First Floor - Bedroom (1) - to ceiling - Textured coating | 15/07/2025 | BC001388_2 | 0 | 0 | 0 | 0 | 0 | Sampled | No Asbestos Detected | 14m <sup>2</sup> | Plasterboard ceiling with textured coating ,solid plaster walls, wood boxing, carpet to concrete flooring. | No Action Required | N/A | |

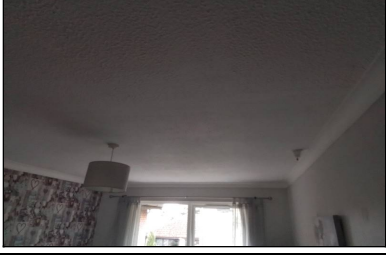
| Floor Level | Location Item Position & Description | Survey Date | Item Reference | Material Assessment | | | | Mean Assessment Total | Level of Identification | Asbestos Identification | Extent | Comments | Recommendations | Risk Category | Photograph |
|---|---|---|---|---|---|---|---|---|---|---|---|---|---|---|---|
| First Floor | First Floor - Lounge (2) - to ceiling - Textured coating | 15/07/2025 | As /BC001388_3 | 0 | 0 | 0 | 0 | 0 | Not sampled. Refer to other sample | N/A | 16m <sup>2</sup> | Plasterboard ceiling with textured coating ,solid plaster walls, carpet to concrete flooring. | No Action Required | N/A | |

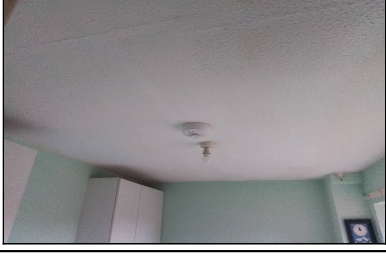
| Floor Level | Location Item Position & Description | Survey Date | Item Reference | Material Assessment | | | | Mean Assessment Total | Level of Identification | Asbestos Identification | Extent | Comments | Recommendations | Risk Category | Photograph |
|---|---|---|---|---|---|---|---|---|---|---|---|---|---|---|---|
| First Floor | First Floor - Kitchen (3) - to ceiling - Textured coating | 15/07/2025 | As /BC001388_4 | 0 | 0 | 0 | 0 | 0 | Not sampled. Refer to other sample | N/A | 8m <sup>2</sup> | Plasterboard ceiling with textured coating ,solid plaster walls, lino to concrete flooring, modern sink. | No Action Required | N/A | |

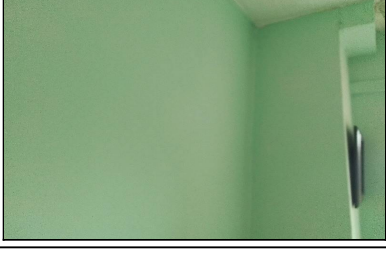
| Floor Level | Location Item Position & Description | Survey Date | Item Reference | Material Assessment | | | | Mean Assessment Total | Level of Identification | Asbestos Identification | Extent | Comments | Recommendations | Risk Category | Photograph |
|---|---|---|---|---|---|---|---|---|---|---|---|---|---|---|---|
| First Floor | First Floor - Kitchen (3) - Riser - Insulating board | 15/07/2025 | BC001389_5 | 0 | 0 | 0 | 0 | 0 | Sampled | No Asbestos Detected | 2lm | Plasterboard ceiling with textured coating ,solid plaster walls, lino to concrete flooring, modern sink. | No Action Required | N/A | |

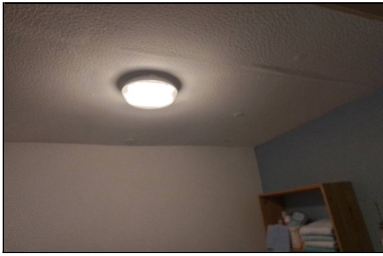
| Floor Level | Location Item Position & Description | Survey Date | Item Reference | Material Assessment | | | | Mean Assessment Total | Level of Identification | Asbestos Identification | Extent | Comments | Recommendations | Risk Category | Photograph |
|---|---|---|---|---|---|---|---|---|---|---|---|---|---|---|---|
| First Floor | First Floor - Bathroom (4) - to ceiling - Textured coating | 15/07/2025 | BC001390_6 | 0 | 0 | 0 | 0 | 0 | Sampled | No Asbestos Detected | 5m <sup>2</sup> | Plasterboard ceiling with textured coating ,solid plaster walls, lino to concrete flooring, plasterboard boxing, wood bath panel, plastic pipes, ceramic toilet cistern. | No Action Required | N/A | |

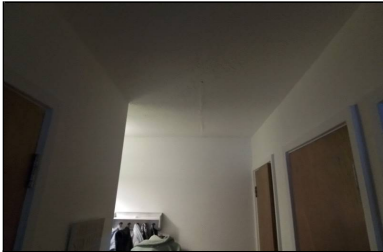
| Floor Level | Location Item Position & Description | Survey Date | Item Reference | Material Assessment | | | | Mean Assessment Total | Level of Identification | Asbestos Identification | Extent | Comments | Recommendations | Risk Category | Photograph |
|---|---|---|---|---|---|---|---|---|---|---|---|---|---|---|---|
| First Floor | First Floor - Hallway & cupboards 1,2,3 & 4 (5) - to ceiling - Textured coating | 15/07/2025 | As /BC001390_7 | 0 | 0 | 0 | 0 | 0 | Not sampled. Refer to other sample | N/A | 10m <sup>2</sup> | Plasterboard ceiling with textured coating ,solid plaster walls, lino to concrete flooring, new electrics. | No Action Required | N/A | |
