ADDRESS:	65-103 Odds Galsworthy Close Swindon SN3 6PG	CLIENT:	Sanctuary Maintenance PO Box 2039 2 Marybone Liverpool L69 3AQ
UPRN:	003362/0001	TELEPHONE NO:	0800 916 1525
BUILD DATE / CONSTRUCTION:	Communal	E-MAIL ADDRESS:	Lisa.McFarlane@sanctuary.co.uk
SURVEY TEAM:	Kallum Beattie	CLIENT CONTACT:	Lisa McFarlane
SURVEY DATE:	23 Apr 2025	PRINT DATE:	28 Apr 2025

SURVEY SCOPE OF WORKS: Targeted Refurbishment survey to the undercloaking near flat roof above communal stairwell

Asbestos Refurbishment Survey

REPORT NO J294100 ISSUE 001

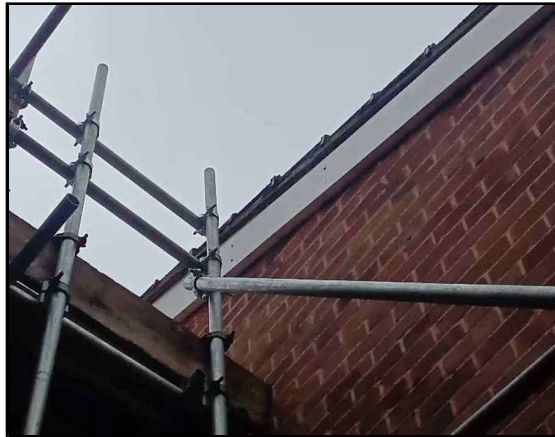
ROOM USE: External			FLOOR: External			ROOM NO: E/001		
Sample Point	Product Type	Result	Level of ID	Sample No.	Condition	Surface Treatment	Risk Score	Qty
Undercloak Cement	Cement Products	1 Chrysotile	ID	LW002030	1 Low Damage	1 Surface Sealed	4	10lm

External External (E.001)
Cement Products
Undercloak, Cement

Room Code	Room	Floor	Description	Recommended Action
E.001	External	External	Cement Products Undercloak Cement	Consider labelling, and manage in place
