<b>ADDRESS:</b>	7 Pigeons Farm Road Greenham Thatcham Berkshire RG19 8XG	<b>CLIENT:</b>	Sanctuary Maintenance  PO Box 2039 2 Marybone Liverpool L69 3AQ
<b>UPRN:</b>	004160/0015	<b>TELEPHONE NO:</b>	0800 916 1525
<b>BUILD DATE / CONSTRUCTION:</b>	2 storey semi detached	<b>E-MAIL ADDRESS:</b>	Lisa.McFarlane@sanctuary.co.uk
<b>SURVEY TEAM:</b>	Daniel Jacobs	<b>CLIENT CONTACT:</b>	Lisa McFarlane
<b>SURVEY DATE:</b>	30 Apr 2024	<b>PRINT DATE:</b>	8 May 2024

**SURVEY INTRODUCTION:** The client Sanctuary Maintenance (Lisa McFarlane) has requested an asbestos survey to support planned work at this property. An Asbestos Refurbishment Survey, in accordance with HSG264 and SGS in-house procedure EHS-UK-QMP-16 was deemed the most appropriate survey type. This survey was carried out under a Service Agreement with the client that sets out the scope and limitations of the survey. This document should be read in conjunction with this survey report, with reference to extent of intrusion and location of checking and sample points.

**SURVEY SCOPE OF WORKS:** Targeted Refurbishment to all ceilings especially in the bathroom with management to the remainder of the property

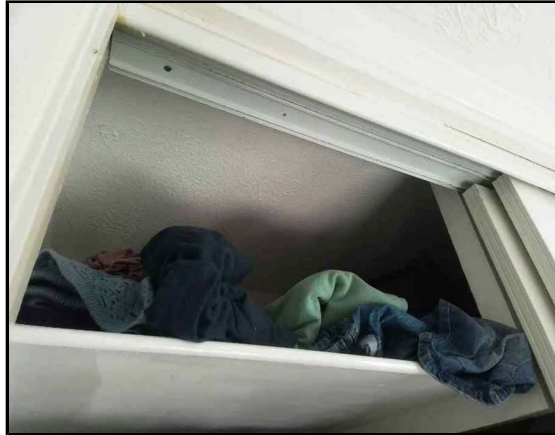
Sample Point	Product Type	Result	Level of ID	Sample No.	Condition	Surface Treatment	Risk Score	Qty
Ceiling	Plasterboard							
Ceiling	Textured Coating/Paint	NAD	ID	SO000138				
Ceiling Within cupboard	Textured Coating/Paint	1 Chrysotile	SP	SP SO000137	1 Low Damage	1 Surface Sealed	4	2m <sup>2</sup>
Door	Wood/Timber							
Floor	Wood/Timber							
Floor - Covering	Carpet							
Pipework	Metal							
Wall	Brick/Block and Plaster							
Wall	Plasterboard							
Wall - Skirting	Wood/Timber							
Window	Plastic							
Window - Sill	Plastic

1st Floor Bedroom 1 (1.001)  
Textured Coating/Paint  
Ceiling, Within cupboard

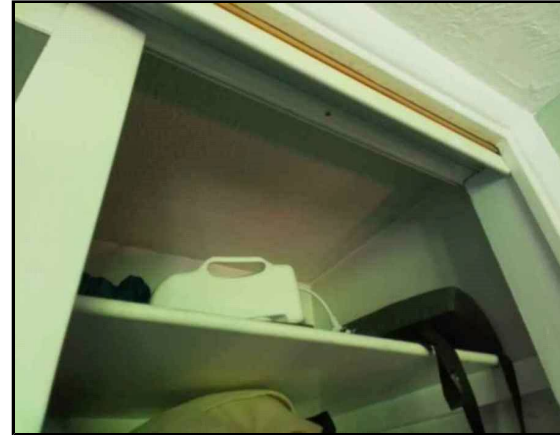
ID	SO000137/002	4m <sup>2</sup>	30/04/2024	N/A			
<b>Product: 1</b>	<b>Condition: 1</b>	<b>Surface Treatment: 1</b>	<b>Result: 1</b>	<b>Total MA</b>	<b>Recommended Action:</b> Consider labelling, and manage in place		
Textured Coating	Low Damage	Surface Sealed	Chrysotile	4			
<b>Main Activity:</b>	<b>Location:</b>	<b>Number of Occupants:</b>	<b>Maintenance:</b>	<b>Total PA</b>			
<b>2nd Activity:</b>	<b>Accessibility:</b>	<b>Frequency of Use:</b>	<b>Frequency:</b>	(averages)			
	<b>Extent/Amount:</b>	<b>Average Time Each Use:</b>

<b>Location:</b> 7 Pigeons Farm Road, 1st Floor, Bedroom 2, 1.002			<b>Material:</b> Ceiling Within cupboard			<b>Photo 1:</b> Wide Angle	<b>Photo 2:</b> Close-up
<b>Level of ID:</b>	<b>Sample No.:</b>	<b>Quantity:</b>	<b>Survey Date:</b>	<b>Review Date:</b>	<b>RISK (MA+PA)</b>	 	 
SP	As SO000137/004	2m <sup>2</sup>	30/04/2024	N/A			
<b>Product: 1</b>	<b>Condition: 1</b>	<b>Surface Treatment: 1</b>	<b>Result: 1</b>	<b>Total MA</b>	<b>Recommended Action:</b> Consider labelling, and manage in place		
Textured Coating	Low Damage	Surface Sealed	Chrysotile	4			
<b>Main Activity:</b>	<b>Location:</b>	<b>Number of Occupants:</b>	<b>Maintenance:</b>	<b>Total PA</b>			
<b>2nd Activity:</b>	<b>Accessibility:</b>	<b>Frequency of Use:</b>	<b>Frequency:</b>	(averages)			
	<b>Extent/Amount:</b>	<b>Average Time Each Use:</b>

1st Floor Bedroom 2 (1.002)  
Textured Coating/Paint  
Ceiling, Within cupboard

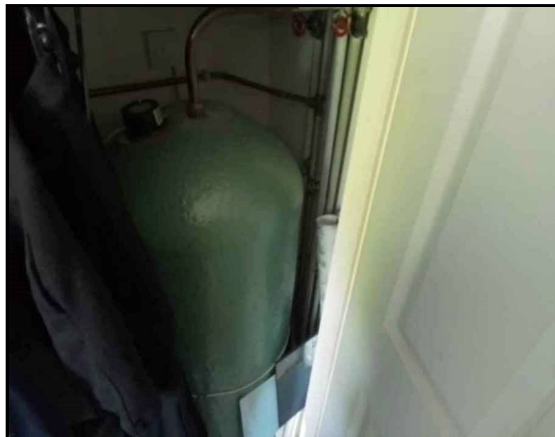
Sample Point	Product Type	Result	Level of ID	Sample No.	Condition	Surface Treatment	Risk Score	Qty
Calorifier Presumed due to live unit	Joint/Gasket	1 Chrysotile	P		1 Low Damage	1 Surface Sealed	4	2no.
Ceiling	Plasterboard							
Ceiling	Textured Coating/Paint	NAD	SP	SP SO000136				
Door	Wood/Timber							
Floor No access below sealed floor	Inaccessible Floor	Inaccessible						
Floor - Covering	Composite Vinyl Tile, Vinyl/Lino - Modern							
Pipework	Metal							
Pipework	Plastic							
Toilet Cistern(s)	Ceramic							
Wall	Brick/Block and Plaster							
Wall	Plasterboard							
Window	Plastic

P	Visual/008	2no.	30/04/2024	N/A					
<b>Product: 1</b>	<b>Condition: 1</b>	<b>Surface Treatment: 1</b>		<b>Result: 1</b>	<b>Total MA</b>				
Gasket CAF Joint/Gasket	Low Damage	Surface Sealed		Chrysotile		4			
<b>Main Activity:</b>	<b>Location:</b>	<b>Number of Occupants:</b>		<b>Maintenance:</b>	<b>Total PA</b> (averages)	<b>Recommended Action:</b> Inspect prior disturbance			
<b>2nd Activity:</b>	<b>Accessibility:</b> <b>Extent/Amount:</b>	<b>Frequency of Use:</b> <b>Average Time Each Use:</b>		<b>Frequency:</b>

1st Floor Bathroom (1.004)  
Joint/Gasket  
Calorifier, Presumed due to live unit

Room Code	Room	Floor	Description	Recommended Action
1.004	Bathroom	1st Floor	Joint/Gasket Calorifier Presumed due to live unit	Inspect prior disturbance

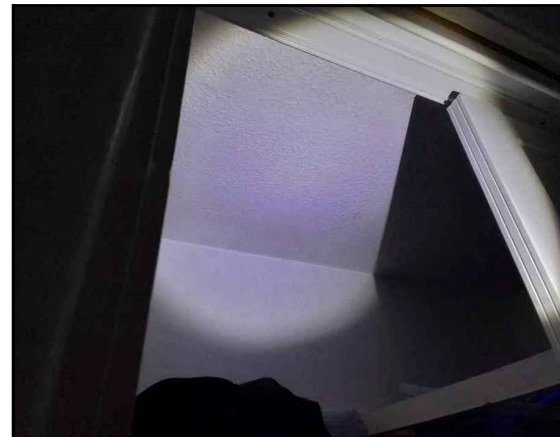
SP	As SO000137/011	2m <sup>2</sup>	30/04/2024	N/A					
<b>Product: 1</b>	<b>Condition: 1</b>	<b>Surface Treatment: 1</b>		<b>Result: 1</b>	<b>Total MA</b>				
Textured Coating	Low Damage	Surface Sealed		Chrysotile		4			
<b>Main Activity:</b>	<b>Location:</b>	<b>Number of Occupants:</b>		<b>Maintenance:</b>	<b>Total PA</b> (averages)	<b>Recommended Action:</b> Consider labelling, and manage in place			
<b>2nd Activity:</b>	<b>Accessibility:</b> <b>Extent/Amount:</b>	<b>Frequency of Use:</b> <b>Average Time Each Use:</b>		<b>Frequency:</b>

1st Floor Bedroom 3 (1.005)  
Textured Coating/Paint  
Ceiling, Within cupboard

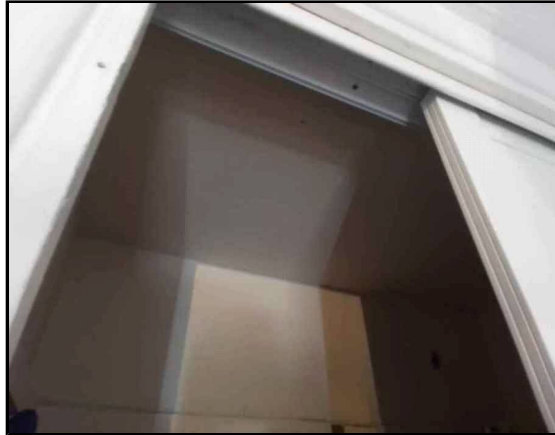
SP	As SO000137/013	1m <sup>2</sup>	30/04/2024	N/A			
<b>Product: 1</b>	<b>Condition: 1</b>	<b>Surface Treatment: 1</b>		<b>Result: 1</b>	<b>Total MA</b>	<b>Recommended Action:</b> Consider labelling, and manage in place	
Textured Coating	Low Damage	Surface Sealed		Chrysotile	4		
<b>Main Activity:</b>	<b>Location:</b>	<b>Number of Occupants:</b>		<b>Maintenance:</b>	<b>Total PA</b>		
<b>2nd Activity:</b>	<b>Accessibility:</b>	<b>Frequency of Use:</b>		<b>Frequency:</b>	(averages)		
	<b>Extent/Amount:</b>	<b>Average Time Each Use:</b>

1st Floor Bedroom 4 (1.006)  
Textured Coating/Paint  
Ceiling, Within cupboard

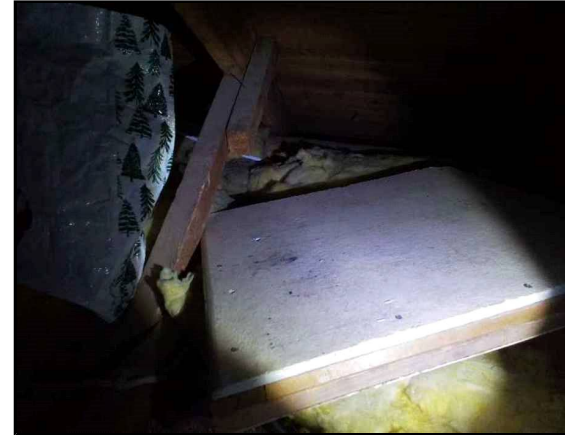
Sample Point	Product Type	Result	Level of ID	Sample No.	Condition	Surface Treatment	Risk Score	Qty
Access Panel/Loft Hatch	Wood/Timber							
Access Panel/Loft Hatch Back of hatch	Insulating Board	2 Amosite	ID	SO000139	1 Low Damage	1 Unsealed	6	1m <sup>2</sup>
Ceiling	Wood/Timber							
Floor Vermiculite pellets	Insulating Board	2 Amosite	ID	SO000140	1 Low Damage	1 Surface Sealed	6	30m <sup>2</sup>
Floor - Ceiling Below	Plasterboard							
Loft Insulation	Fibre-glass/Rockwool							
Pipework	Metal							
Pipework	Plastic							
Pipework - Insulation	Foam							
Roof Limited inspection due to stored items	Inaccessible Roof	Inaccessible						
Tank	Plastic							
Wall	Brick/Block

ID	SO000139/017	1m <sup>2</sup>	30/04/2024	N/A			
<b>Product: 2</b>	<b>Condition: 1</b>	<b>Surface Treatment: 1</b>		<b>Result: 2</b>	<b>Total MA</b>	<b>Recommended Action:</b> Seal/protect, label and manage	
Asbestos Insulating Board	Low Damage	Unsealed		Amosite	6		
<b>Main Activity:</b>	<b>Location:</b>	<b>Number of Occupants:</b>		<b>Maintenance:</b>	<b>Total PA</b>		
<b>2nd Activity:</b>	<b>Accessibility:</b>	<b>Frequency of Use:</b>		<b>Frequency:</b>	(averages)		
	<b>Extent/Amount:</b>	<b>Average Time Each Use:</b>

Roof Void Loft Space (R.001)  
Insulating Board  
Access Panel/Loft Hatch, Back of hatch

Room Code	Room	Floor	Description	Recommended Action
R.001	Loft Space	Roof Void	Insulating Board Access Panel/Loft Hatch Back of hatch	Seal/protect, label and manage
R.001	Loft Space	Roof Void	Insulating Board Floor Vermiculite pellets	Removal by licensed contractor

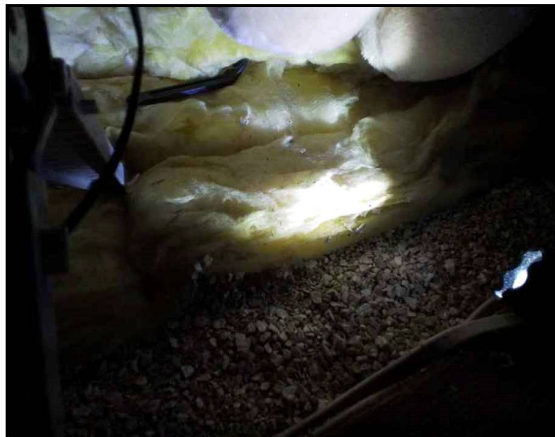
<b>Location:</b> 7 Pigeons Farm Road, Roof Void, Loft Space, R.001			<b>Material:</b> Floor Vermiculite pellets		<b>Photo 1:</b> Wide Angle	<b>Photo 2:</b> Close-up
<b>Level of ID:</b>	<b>Sample No.:</b>	<b>Quantity:</b>	<b>Survey Date:</b>	<b>Review Date:</b>	<b>RISK (MA+PA)</b>	
ID	SO000140/018	30m <sup>2</sup>	30/04/2024	N/A		
<b>Product: 2</b> Asbestos Insulating Board	<b>Condition: 1</b> Low Damage	<b>Surface Treatment: 1</b> Surface Sealed		<b>Result: 2</b> Amosite	<b>Total MA</b>  6	
<b>Main Activity:</b> <b>2nd Activity:</b>	<b>Location:</b> <b>Accessibility:</b> <b>Extent/Amount:</b>	<b>Number of Occupants:</b> <b>Frequency of Use:</b> <b>Average Time Each Use:</b>	<b>Maintenance:</b> <b>Frequency:</b>	<b>Total PA</b>  (averages)	<b>Recommended Action:</b> Removal by licensed contractor

Roof Void Loft Space (R.001)  
Insulating Board  
Floor, Vermiculite pellets

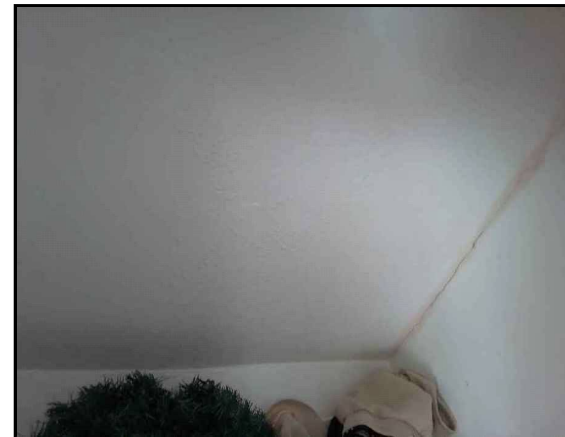
Sample Point	Product Type	Result	Level of ID	Sample No.	Condition	Surface Treatment	Risk Score	Qty
Ceiling	Plasterboard							
Ceiling	Textured Coating/Paint	1 Chrysotile	ID	SO000142	1 Low Damage	1 Surface Sealed	4	1 m <sup>2</sup>
Door	Wood/Timber							
Floor	Concrete

ID	SO000142/026	1 m <sup>2</sup>	30/04/2024	N/A					
<b>Product: 1</b>	<b>Condition: 1</b>	<b>Surface Treatment: 1</b>		<b>Result: 1</b>	<b>Total MA</b>				
Textured Coating	Low Damage	Surface Sealed		Chrysotile					
<b>Main Activity:</b> <b>2nd Activity:</b>	<b>Location:</b> <b>Accessibility:</b> <b>Extent/Amount:</b>	<b>Number of Occupants:</b> <b>Frequency of Use:</b> <b>Average Time Each Use:</b>		<b>Maintenance:</b> <b>Frequency:</b>	<b>Total PA</b>  (averages)	<b>Recommended Action:</b> Consider labelling, and manage in place

Ground Floor Cupboard - Under Stairs (G.004)  
Textured Coating/Paint  
Ceiling,

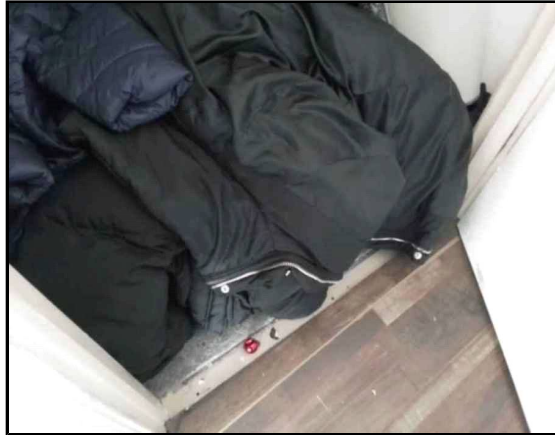
Floor	Composite Vinyl Tile, Vinyl/Lino with adhesive	1 Chrysotile	ID	SO000143	1 Low Damage	0 Completely Sealed	3	1 m <sup>2</sup>
Floor - Covering	Carpet							
Wall	Brick/Block and Plaster							
Wall	Plasterboard							
Wall - Skirting	Wood/Timber

ID	SO000143/027	1 m <sup>2</sup>	30/04/2024	N/A					
<b>Product: 1</b>	<b>Condition: 1</b>	<b>Surface Treatment: 0</b>		<b>Result: 1</b>	<b>Total MA</b>				
Composite Vinyl Tile, Vinyl/Lino with adhesive	Low Damage	Completely Sealed		Chrysotile					
<b>Main Activity:</b> <b>2nd Activity:</b>	<b>Location:</b> <b>Accessibility:</b> <b>Extent/Amount:</b>	<b>Number of Occupants:</b> <b>Frequency of Use:</b> <b>Average Time Each Use:</b>		<b>Maintenance:</b> <b>Frequency:</b>	<b>Total PA</b>  (averages)	<b>Recommended Action:</b> Consider labelling, and manage in place

Ground Floor Cupboard - Under Stairs (G.004)  
Composite Vinyl Tile, Vinyl/Lino with adhesive  
Floor,

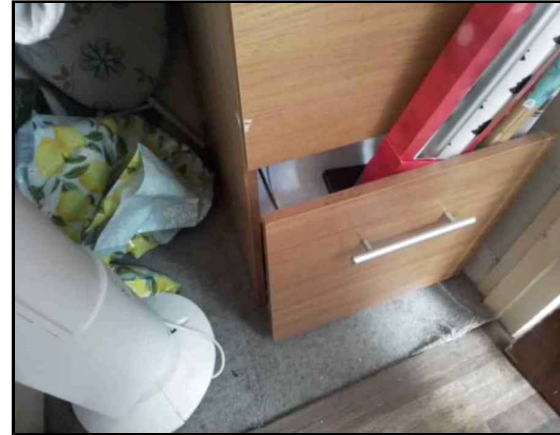
<b>Location:</b> 7 Pigeons Farm Road, Ground Floor, Cupboard - Store, G.005			<b>Material:</b> Floor			<b>Photo 1:</b> Wide Angle	<b>Photo 2:</b> Close-up
<b>Level of ID:</b>	<b>Sample No.:</b>	<b>Quantity:</b>	<b>Survey Date:</b>	<b>Review Date:</b>	<b>RISK (MA+PA)</b>	 	 
ID	SO000144/029	1m <sup>2</sup>	30/04/2024	N/A			
<b>Product: 1</b> Composite Vinyl Tile, Vinyl/Lino with adhesive	<b>Condition: 1</b> Low Damage	<b>Surface Treatment: 0</b> Completely Sealed		<b>Result: 1</b> Chrysotile	<b>Total MA</b> 3		
<b>Main Activity:</b> <b>2nd Activity:</b>	<b>Location:</b> <b>Accessibility:</b> <b>Extent/Amount:</b>	<b>Number of Occupants:</b> <b>Frequency of Use:</b> <b>Average Time Each Use:</b>	<b>Maintenance:</b> <b>Frequency:</b>	<b>Total PA</b> (averages)	<b>Recommended Action:</b> Consider labelling, and manage in place

Ground Floor Cupboard - Store (G.005)  
Composite Vinyl Tile, Vinyl/Lino with adhesive  
Floor,

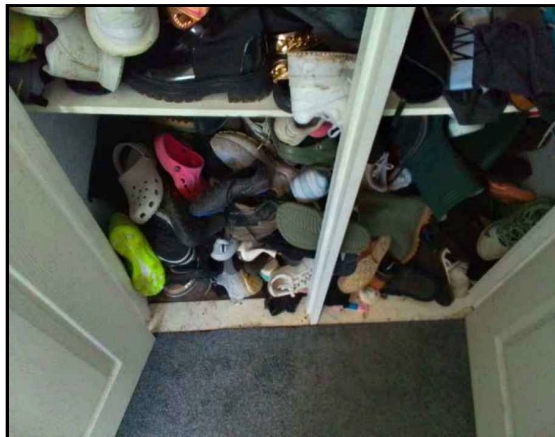
Ground Floor Living Room/Lounge (G.006)  
Composite Vinyl Tile, Vinyl/Lino with adhesive  
Floor, Within cupboards

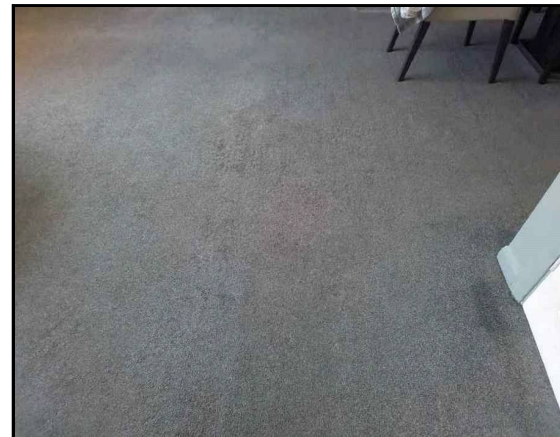
<b>Location:</b> 7 Pigeons Farm Road, Ground Floor, Living Room/Lounge, G.006			<b>Material:</b> Floor			<b>Photo 1:</b> Wide Angle	<b>Photo 2:</b> Close-up
<b>Level of ID:</b>	<b>Sample No.:</b>	<b>Quantity:</b>	<b>Survey Date:</b>	<b>Review Date:</b>	<b>RISK (MA+PA)</b>	 	 
SP	As SO000143/032	20m <sup>2</sup>	30/04/2024	N/A			
<b>Product: 1</b> Composite Vinyl Tile, Vinyl/Lino with adhesive	<b>Condition: 1</b> Low Damage	<b>Surface Treatment: 0</b> Completely Sealed	<b>Result: 1</b> Chrysotile	<b>Total MA</b>  3			
<b>Main Activity:</b> <b>2nd Activity:</b>	<b>Location:</b> <b>Accessibility:</b> <b>Extent/Amount:</b>	<b>Number of Occupants:</b> <b>Frequency of Use:</b> <b>Average Time Each Use:</b>	<b>Maintenance:</b> <b>Frequency:</b>	<b>Total PA</b>  (averages)	<b>Recommended Action:</b> Consider labelling, and manage in place

Ground Floor Living Room/Lounge (G.006)  
Composite Vinyl Tile, Vinyl/Lino with adhesive  
Floor,

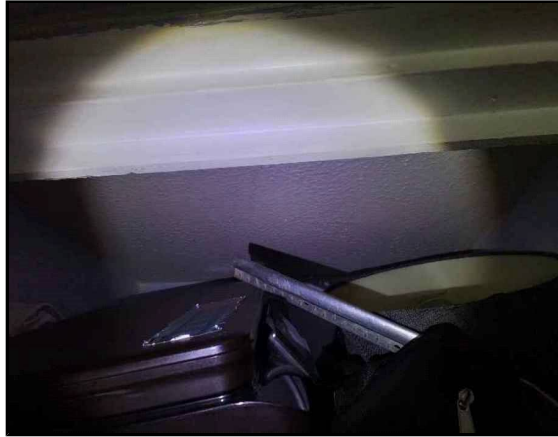
SP	As SO000142/033	2m <sup>2</sup>	30/04/2024	N/A			
<b>Product: 1</b> Textured Coating	<b>Condition: 1</b> Low Damage	<b>Surface Treatment: 1</b> Surface Sealed	<b>Result: 1</b> Chrysotile	<b>Total MA</b>  4			
<b>Main Activity:</b> <b>2nd Activity:</b>	<b>Location:</b> <b>Accessibility:</b> <b>Extent/Amount:</b>	<b>Number of Occupants:</b> <b>Frequency of Use:</b> <b>Average Time Each Use:</b>	<b>Maintenance:</b> <b>Frequency:</b>	<b>Total PA</b>  (averages)	<b>Recommended Action:</b> Consider labelling, and manage in place

Ground Floor Living Room/Lounge (G.006)  
Textured Coating/Paint  
Ceiling, Within cupboards

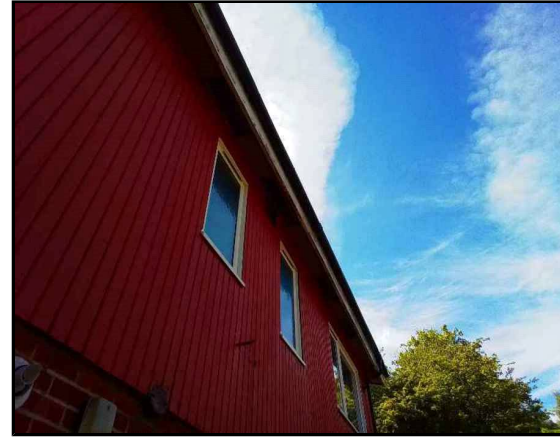
<b>Location:</b> 7 Pigeons Farm Road, External, External, E.001			<b>Material:</b> Soffits		<b>Photo 1:</b> Wide Angle	<b>Photo 2:</b> Close-up
<b>Level of ID:</b>	<b>Sample No.:</b>	<b>Quantity:</b>	<b>Survey Date:</b>	<b>Review Date:</b>	<b>RISK (MA+PA)</b>	
ID	SO000147/039	30lm	30/04/2024	N/A		
<b>Product: 1</b> Asbestos Cement	<b>Condition: 1</b> Low Damage	<b>Surface Treatment: 1</b> Surface Sealed		<b>Result: 1</b> Chrysotile	<b>Total MA</b>  4	
<b>Main Activity:</b> <b>2nd Activity:</b>	<b>Location:</b> <b>Accessibility:</b> <b>Extent/Amount:</b>	<b>Number of Occupants:</b> <b>Frequency of Use:</b> <b>Average Time Each Use:</b>	<b>Maintenance:</b> <b>Frequency:</b>	<b>Total PA</b>  (averages)	<b>Recommended Action:</b> Consider labelling, and manage in place

External External (E.001)  
Cement Products  
Soffits,

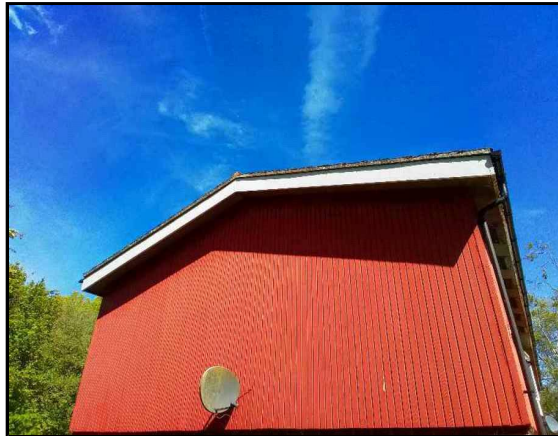
P	Visual/040	12lm	30/04/2024	N/A			
<b>Product: 1</b>	<b>Condition: 1</b>	<b>Surface Treatment: 1</b>		<b>Result: 1</b>	<b>Total MA</b>	<b>Recommended Action:</b> Inspect prior disturbance	
Cement Products	Low Damage	Surface Sealed		Chrysotile	4		
<b>Main Activity:</b>	<b>Location:</b>	<b>Number of Occupants:</b>		<b>Maintenance:</b>	<b>Total PA</b>		
<b>2nd Activity:</b>	<b>Accessibility:</b>	<b>Frequency of Use:</b>		<b>Frequency:</b>	(averages)		
	<b>Extent/Amount:</b>	<b>Average Time Each Use:</b>

External External (E.001)  
Cement Products  
Undercloak, Presumed due to height

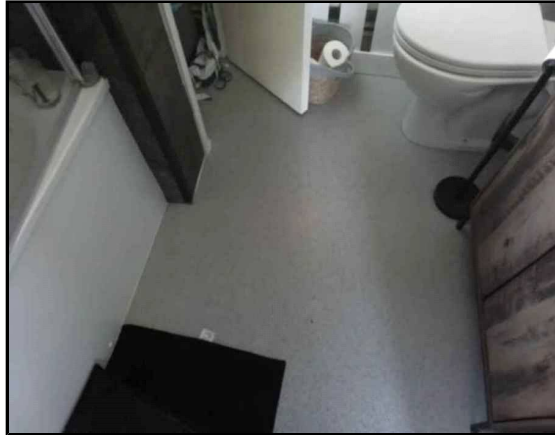
1st Floor Bathroom (1.003)  
Inaccessible  
Floor  
No access below sealed floor

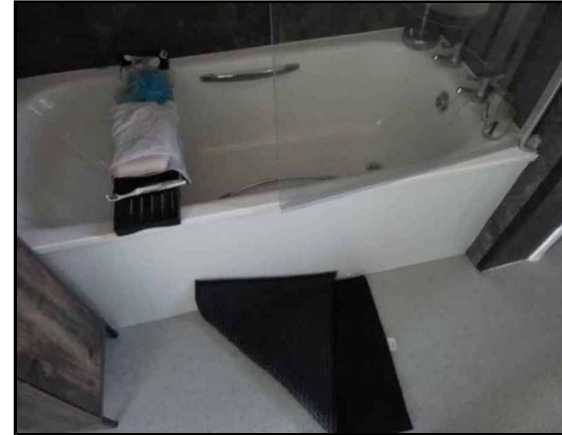
1st Floor Bathroom (1.003)  
Inaccessible  
Bath Panel  
No access behind plastic bath panel

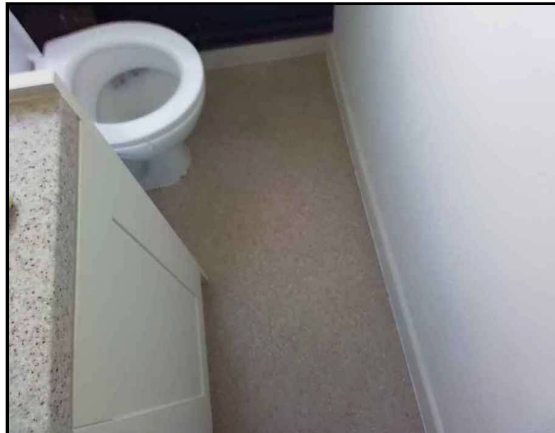
1st Floor Bathroom (1.004)  
Inaccessible  
Floor

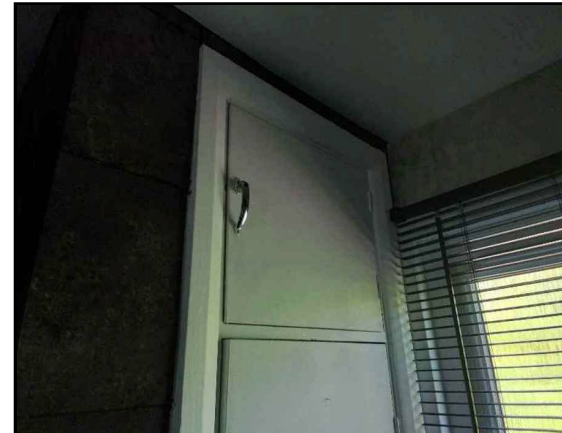
1st Floor Bathroom (1.003)  
Inaccessible  
Bulkhead

No access within top cupboard due to being sealed shut

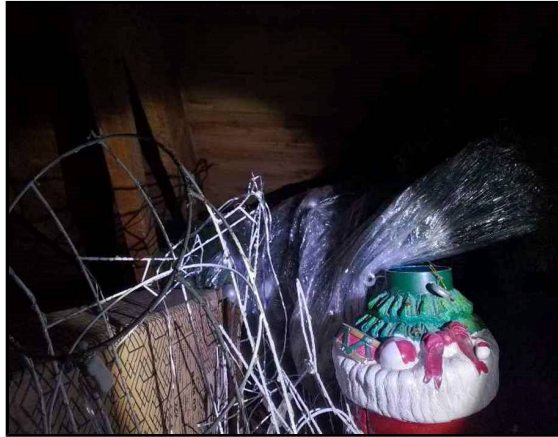
Roof Void Loft Space (R.001)  
Inaccessible  
Roof

Limited inspection due to stored items

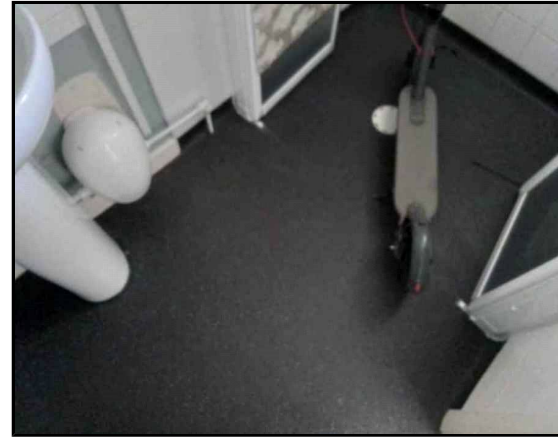
Ground Floor Bathroom (G.001)  
Inaccessible  
Floor

No access below sealed floor

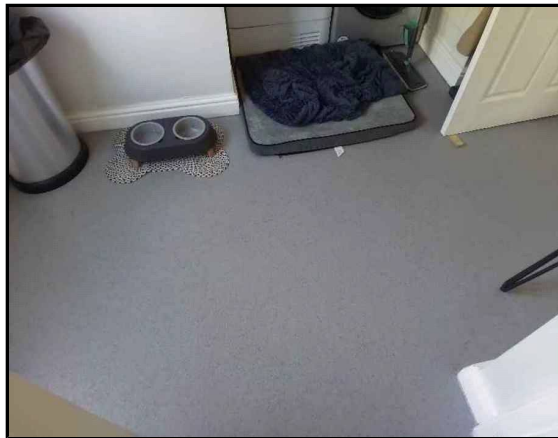
Ground Floor Utility Room (G.002)  
Inaccessible  
Floor

No access below sealed floor

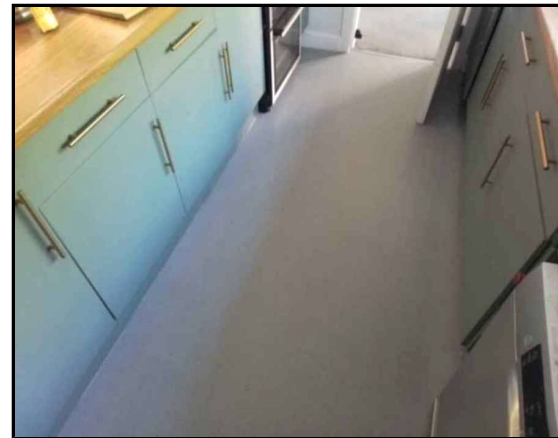
Ground Floor Kitchen (G.003)  
Inaccessible  
Floor

No access below sealed floor

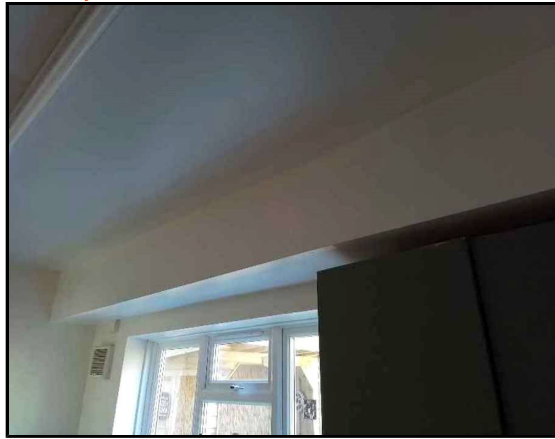
Ground Floor Kitchen (G.003)  
Inaccessible  
Bulkhead  
No access within sealed boxing

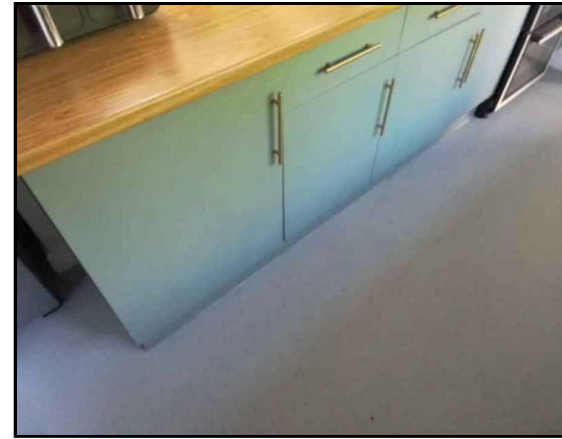
Ground Floor Kitchen (G.003)  
Inaccessible  
Boxing  
No access behind sealed timber kickboards

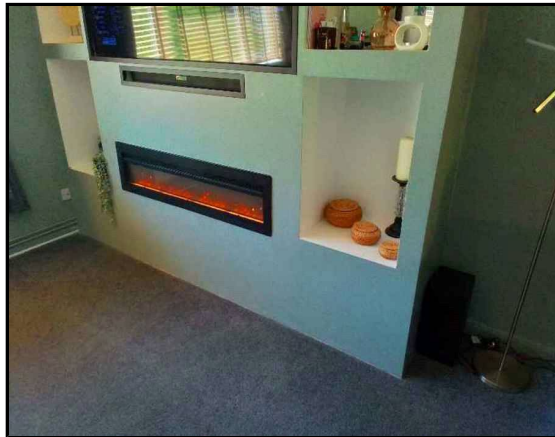
Ground Floor Living Room/Lounge (G.006)  
Inaccessible  
Boxing  
No access within sealed boxing

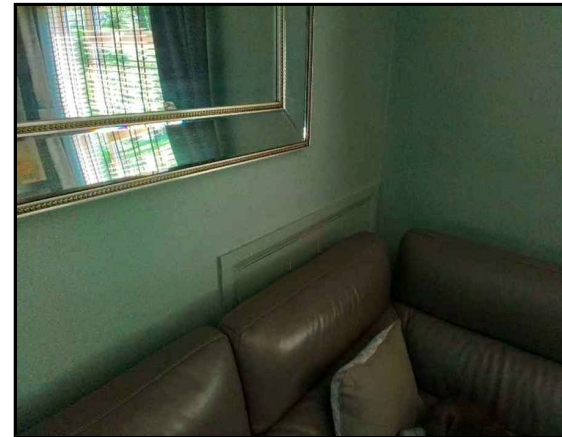
Ground Floor Living Room/Lounge (G.006)  
Inaccessible  
Access Panel  
No access behind access panel

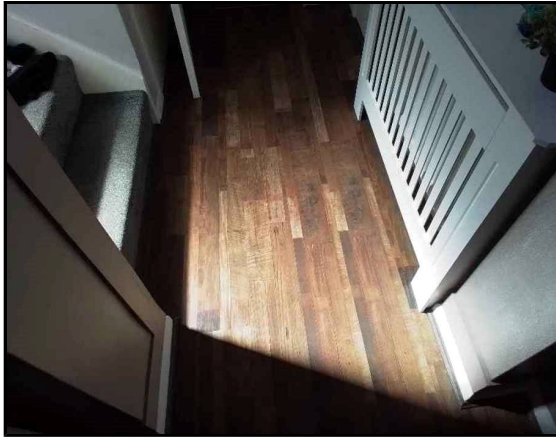
Ground Floor Entrance Hall/Foyer/Lobby (G.007)  
Inaccessible  
Floor  
No access below timber laminate flooring

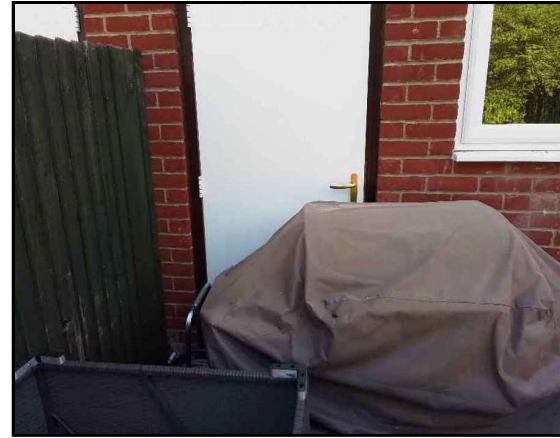
Sample Point	Product Type	Result	Level of ID	Sample No.	Condition	Surface Treatment	Risk Score	Qty
No access due to building works blocking door	Inaccessible	Inaccessible

Ground Floor Cupboard - Store (G.008)  
Inaccessible
