| ADDRESS: | Flat 2 Stoneleigh House Jacobs Wells Road Bristol BS8 1DL | CLIENT: | Sanctuary Maintenance PO Box 2039 2 Marybone Liverpool L69 3AQ |

SURVEY INTRODUCTION: The client Sanctuary Maintenance (Lisa McFarlane) has requested an asbestos survey to support planned work at this property. An Asbestos Refurbishment Survey, in accordance with HSG264 and SGS in-house procedure EHS-UK-QMP-16 was deemed the most appropriate survey type. This survey was carried out under a Service Agreement with the client that sets out the scope and limitations of the survey. This document should be read in conjunction with this survey report, with reference to extent of intrusion and location of checking and sample points.

SURVEY SCOPE OF WORKS: Targeted Refurbishment to the window frames (putty) Management to the remainder of the property

Job No. J290297

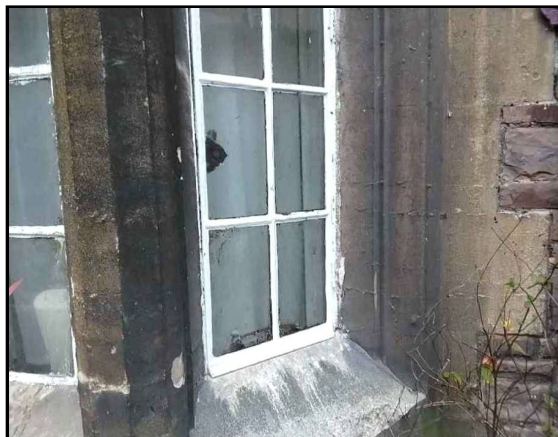
| | | | ID | | Score |
|---|---|---|---|---|---|
| Window | Composite Mastics | NAD | ID | ST001304 | |

External External (E.001)
Composite Mastics
Window,

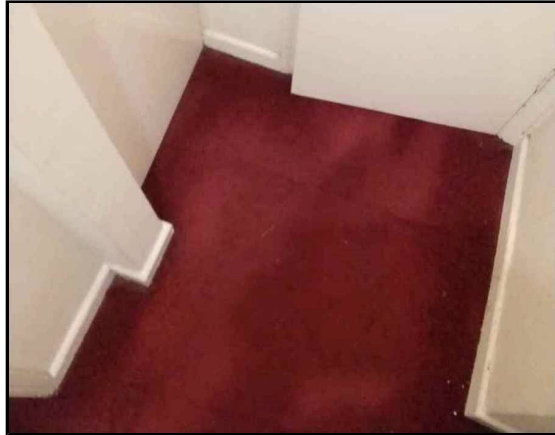
Ground Floor Entrance Hall/Foyer/Lobby (G.001)
Inaccessible
No access below sealed carpet

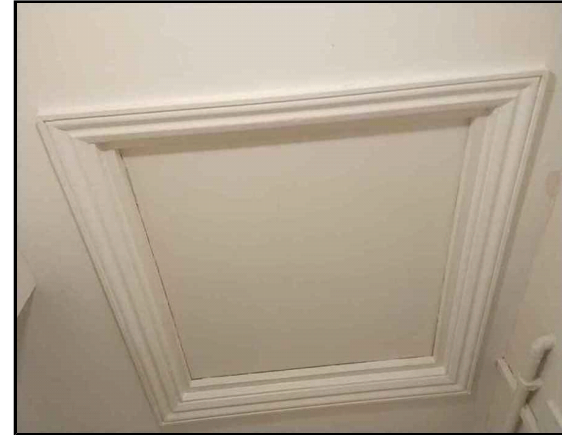
Roof Void Loft Space (R.001)
Inaccessible

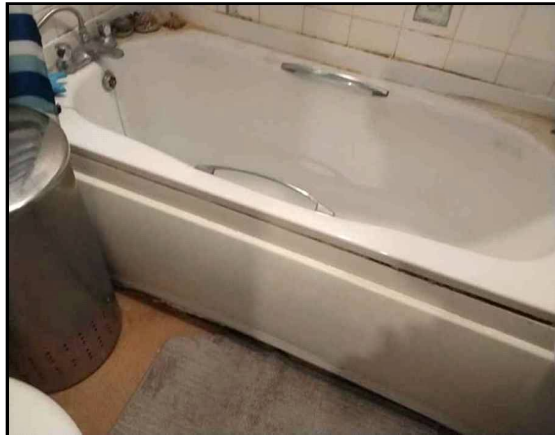
Ground Floor Bathroom (G.002)
Inaccessible
No access behind bath panel

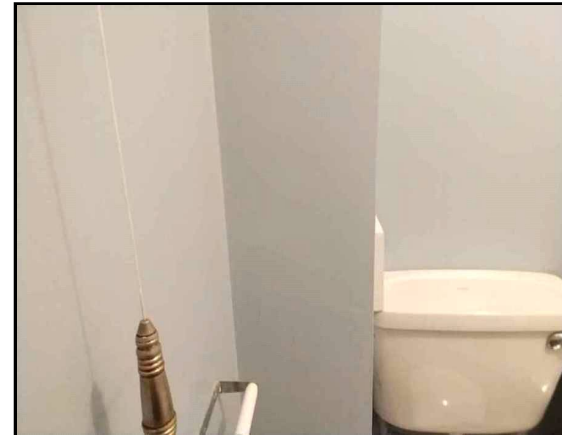
Ground Floor Bathroom (G.002)
Inaccessible
No access into boxing

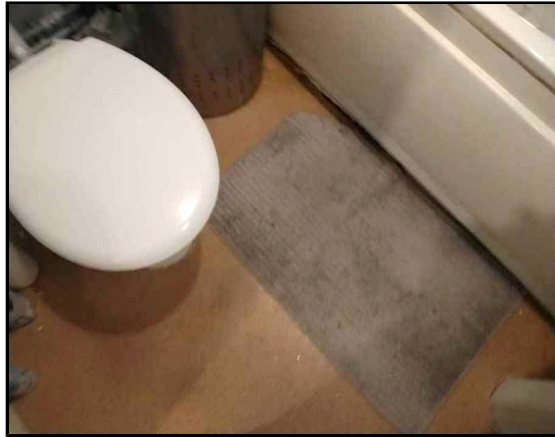
Ground Floor Bathroom (G.002)
Inaccessible
No access below sealed lino

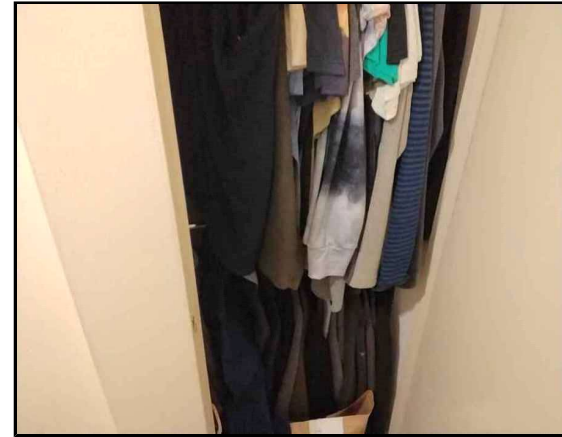
Ground Floor Cupboard - Electrical (G.003)
Inaccessible
Limited access due to stored items blocking

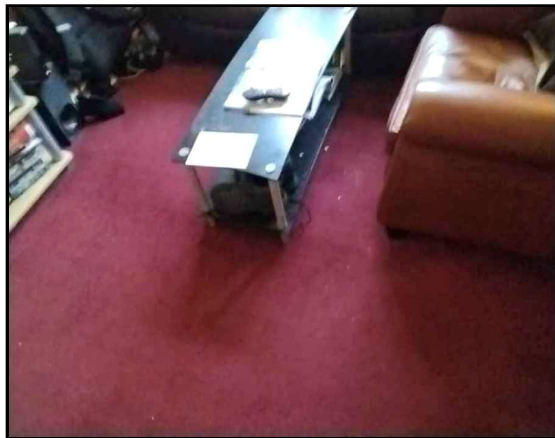
Ground Floor Living Room/Lounge (G.004)
Inaccessible
No access below sealed carpet

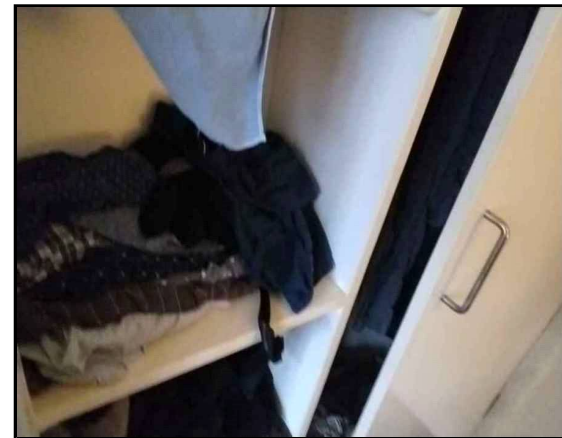
Ground Floor Cupboard (G.005)
Inaccessible
Little to no access into cupboard

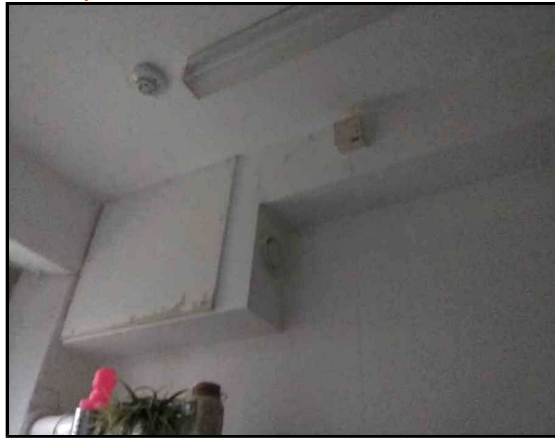
Ground Floor Kitchen (G.006)
Inaccessible
No access into boxing

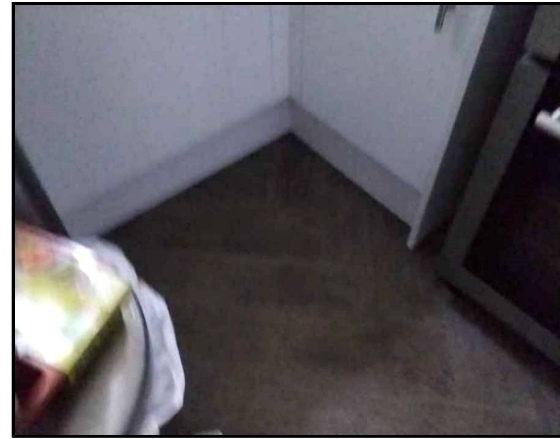
Ground Floor Kitchen (G.006)
Inaccessible
No access behind kickboards

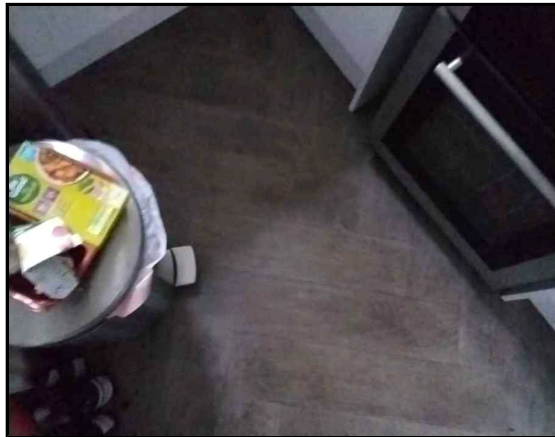
Ground Floor Kitchen (G.006)
Inaccessible
No access below sealed lino
