# Site ID: a-189610 Management Survey

10 Galsworthy Close  
Swindon  
SN3 6PB  
United Kingdom

**17th January 2019**

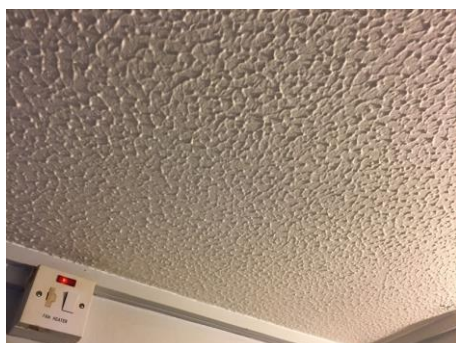
**a-189610-i01-01**

TC Ceiling

The material was seen to be in fair condition at the time of the initial inspection.

The condition of the material should be managed by a competent person/company and its presence made aware to those at risk, as part of a Control of Asbestos Regulations (CAR) 2012 compliant management strategy.

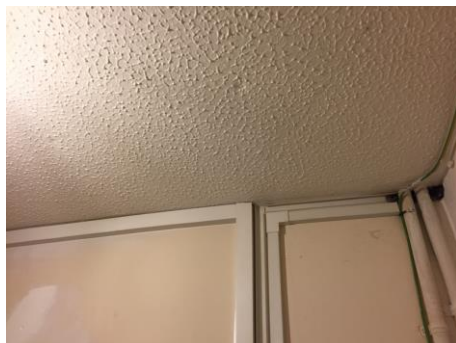
**a-189610-i02-02\_c01**

TC Ceiling

The material was seen to be in fair condition at the time of the initial inspection.

The condition of the material should be managed by a competent person/company and its presence made aware to those at risk, as part of a Control of Asbestos Regulations (CAR) 2012 compliant management strategy.

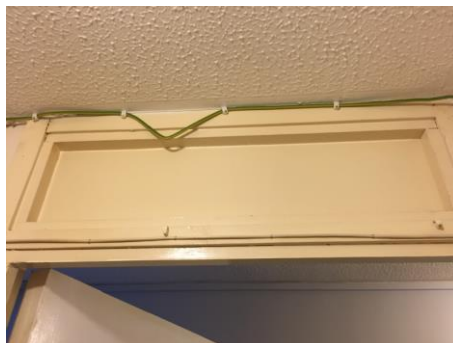
**a-189610-i02-03**

Door Header Panels (Double Skinned)

The material was seen to be in fair condition at the time of the initial inspection.

The condition of the material should be managed by a competent person/company and its presence made aware to those at risk, as part of a Control of Asbestos Regulations (CAR) 2012 compliant management strategy.

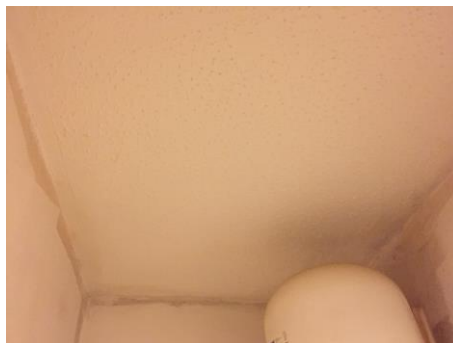
**a-189610-i03-04\_c01**

TC Ceiling

The material was seen to be in fair condition at the time of the initial inspection.

The condition of the material should be managed by a competent person/company and its presence made aware to those at risk, as part of a Control of Asbestos Regulations (CAR) 2012 compliant management strategy.

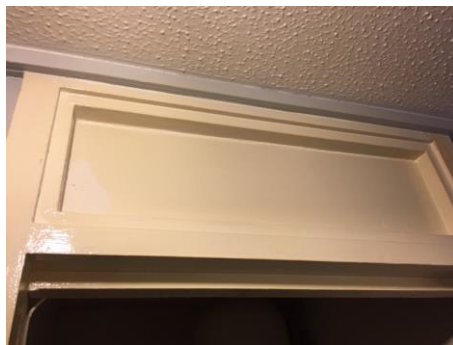
**a-189610-i03-05\_c03**

Door Header Panels (Double Skinned)

The material was seen to be in fair condition at the time of the initial inspection.

The condition of the material should be managed by a competent person/company and its presence made aware to those at risk, as part of a Control of Asbestos Regulations (CAR) 2012 compliant management strategy.

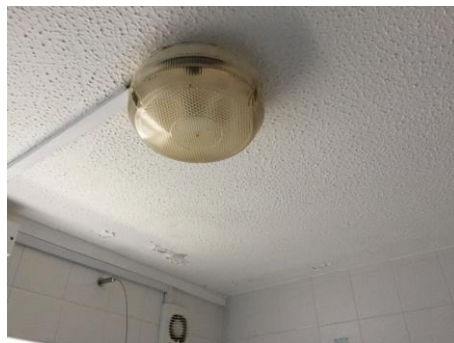
**a-189610-i04-06\_c01**

TC Ceiling

The material was seen to be in poor condition at the time of the initial inspection.

It is recommended that the material has remedial action undertaken by a HSE licensed asbestos contractor. As an ACM (asbestos Containing Material), it's condition should be monitored by a competent person/company and it's presence made aware to those at risk, as part of a Control of Asbestos Regulations (CAR) 2012 compliant management strategy.

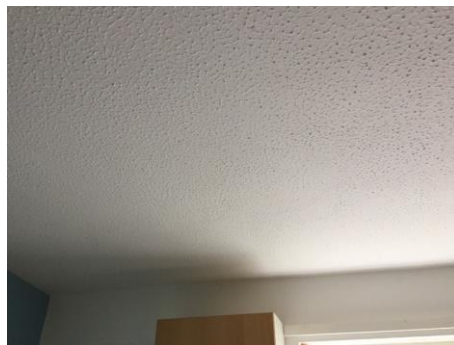
**a-189610-i05-07\_c01**

TC Ceiling

The material was seen to be in fair condition at the time of the initial inspection.

The condition of the material should be managed by a competent person/company and its presence made aware to those at risk, as part of a Control of Asbestos Regulations (CAR) 2012 compliant management strategy.

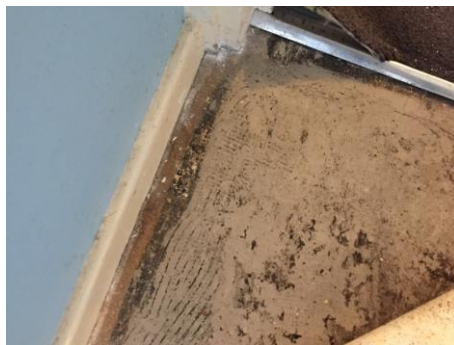
Bitumen Adhesive, treat as uniform throughout property

The material was seen to be in fair condition at the time of the initial inspection.

The condition of the material should be managed by a competent person/company and its presence made aware to those at risk, as part of a Control of Asbestos Regulations (CAR) 2012 compliant management strategy.

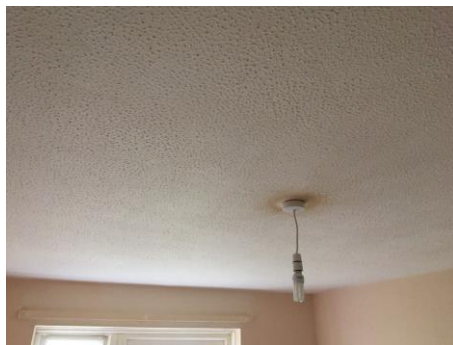
TC Ceiling

The material was seen to be in fair condition at the time of the initial inspection.

The condition of the material should be managed by a competent person/company and its presence made aware to those at risk, as part of a Control of Asbestos Regulations (CAR) 2012 compliant management strategy.

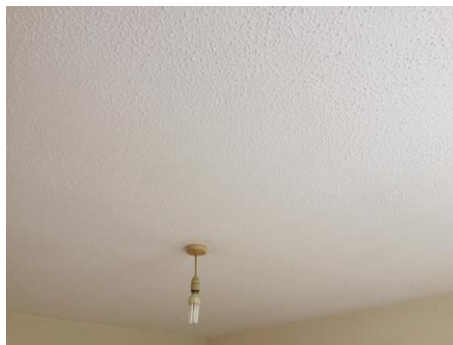
TC Ceiling

The material was seen to be in fair condition at the time of the initial inspection.

The condition of the material should be managed by a competent person/company and its presence made aware to those at risk, as part of a Control of Asbestos Regulations (CAR) 2012 compliant management strategy.

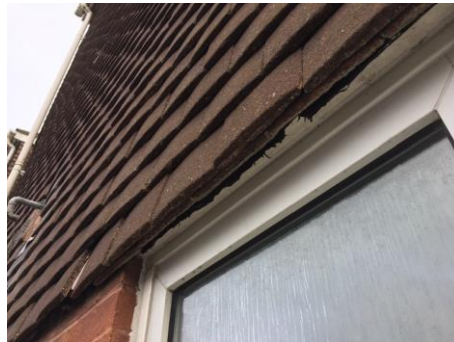
Bitumen Felt, underside of concrete tiles

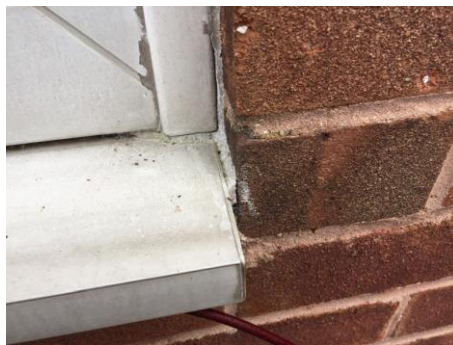
Original window and door sealant residue throughout
