## Re-Inspection of Surveys

1-4, 53, County Road  
Swindon  
SN1 2EG  
United Kingdom

**003468/0002**

**9th December 2019**

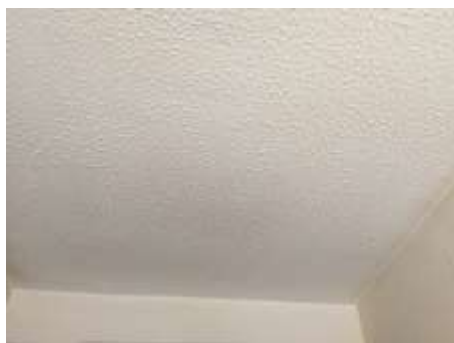
**a-231365-i01-01**

Sample taken? ..... **Yes**Product Type ..... **Textured Coating - Ceiling**Surface Treatment **Sealed Composite Material**Condition ..... **Low Damage**Surface ..... **Ceiling**Material Risk Assessment ..... **3**Quantity: ..... **10 SQ M**Next Inspection Date: ..... **As per client policy/plan.**

Stipple pattern to the ceiling Original item number 6

The material was seen to be in fair condition at the time of the initial inspection.

The condition of the material should be managed by a competent person/company and its presence made aware to those at risk, as part of a Control of Asbestos Regulations (CAR) 2012 compliant management strategy.

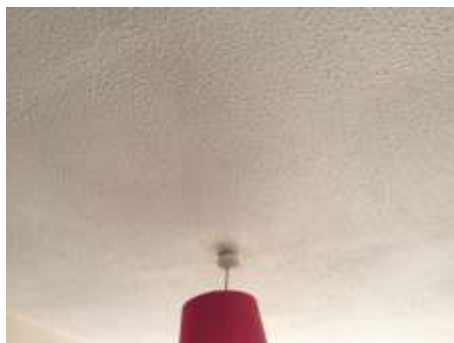
**a-231365-i02-02\_c01**

Product Type ..... **Textured Coating - Ceiling**

Condition ..... **Low Damage**

Material Risk Assessment ..... **3**

Stipple pattern to the ceiling Original item number 10

The material was seen to be in fair condition at the time of the initial inspection.

The condition of the material should be managed by a competent person/company and its presence made aware to those at risk, as part of a Control of Asbestos Regulations (CAR) 2012 compliant management strategy.

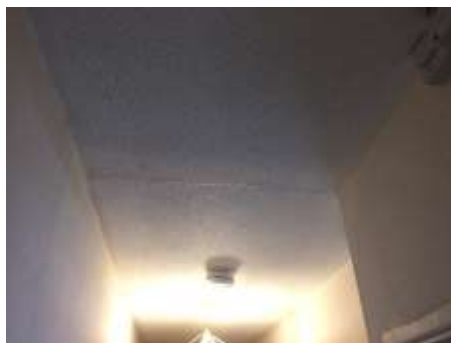
**a-231365-i03-03**

Product Type ..... **Textured Coating - Ceiling**

Condition ..... **Low Damage**

Material Risk Assessment ..... **3**

Stipple pattern to the ceiling Original item number 12

The material was seen to be in fair condition at the time of the initial inspection.

The condition of the material should be managed by a competent person/company and its presence made aware to those at risk, as part of a Control of Asbestos Regulations (CAR) 2012 compliant management strategy.

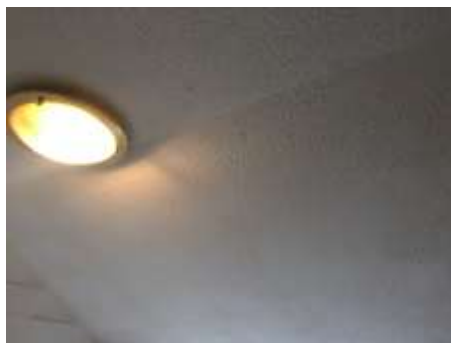
**a-231365-i04-04\_c03**

Product Type ..... **Textured Coating - Ceiling**

Condition ..... **Low Damage**

Material Risk Assessment ..... **3**

Stipple pattern to the ceiling Original item number 14

The material was seen to be in fair condition at the time of the initial inspection.

The condition of the material should be managed by a competent person/company and its presence made aware to those at risk, as part of a Control of Asbestos Regulations (CAR) 2012 compliant management strategy.

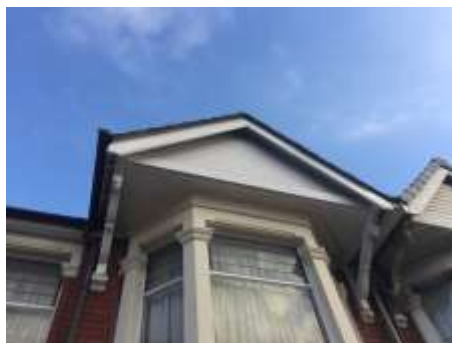
**a-231365-e01-05**

Product Type ..... **Insulating Board**

Condition ..... **Low Damage**

Material Risk Assessment ..... **9**

Undercloaking Original item number 19

It has been noted in previous experience that this type of material has been known to contain asbestos.

Until such time as proven otherwise, the material should be managed as an asbestos containing product in accordance with CAR 2012 and subject to regular inspection.
