Site ID: **r1-360431** Updated Management with Targeted Refurbishment Survey

Flat 1, Penrhyn
37 Knyveton
Bournemouth
BH1 3QJ
United Kingdom

2nd September 2022

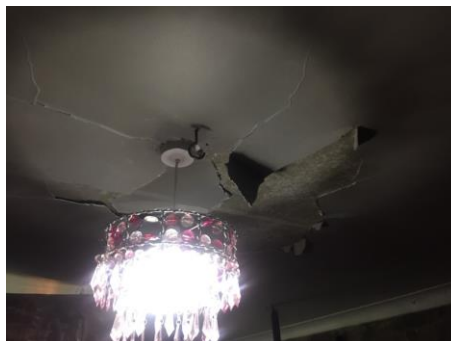
r1-360431-i04-01

Plaster to ceiling

No asbestos was detected in the material tested.

No further action is required.
