**103 Partridge Way, Old Sarum, Salisbury, SP4
6PX**

Prepared For Sanctuary Housing.

39 Issues Identified

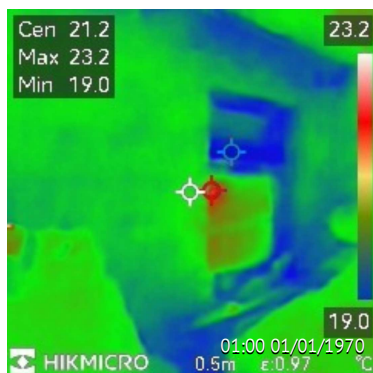
Back Bedroom External Wall.

There seems to be various cold spots across the external wall although the temperature differences are minimal on thermal imaging camera. Outside wall temp. 14°, internal wall temp. 20°. Personal belongings and furniture against external walls restricting air flow possibly leading to mould build up behind.

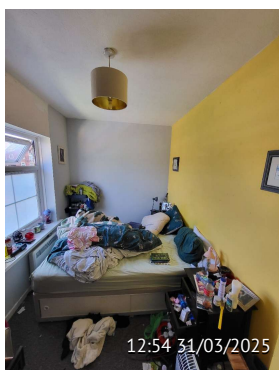
Back Bedroom Cont.

Dimplex electric heater with programmer.

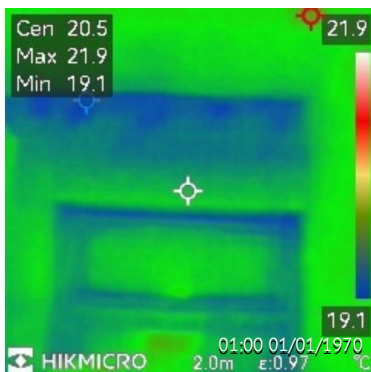
Bathroom Cont.

As before thermal imaging camera is showing different temperature spots across surface of wall. Again would advise checking cavity wall insulation for complete coverage. Extractor fan in full working order and is an in-line loft mounted unit. Dimplex convector heater with built in programmer.

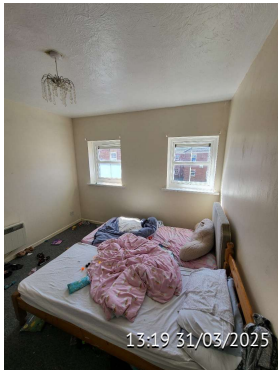
Front Large Bedroom

External wall showing some irregular surfaces temperatures indicating possible cold spots or missing insulation within cavity.
Room dimensions 3550mm x 3250mm.

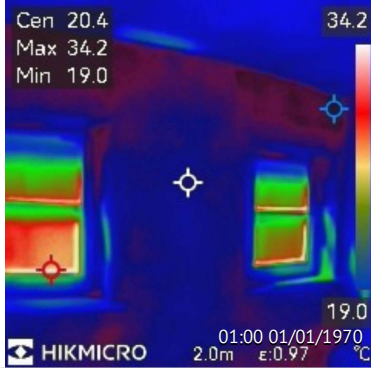
Front Large Bedroom cont.

Internal wall temp. 20° Outside Wall temp. 25°

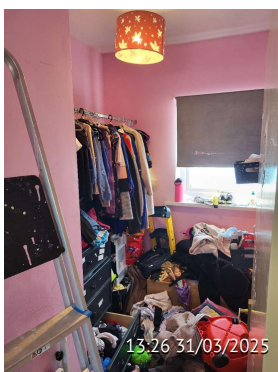
Front Small Bedroom

Room dimensions 2.4m x 2.8m. Lots of personal belongings and furniture up against external wall which could be contributing to mould build up from lack of ventilation. As mentioned before all windows and trickle vents were closed at time of survey.

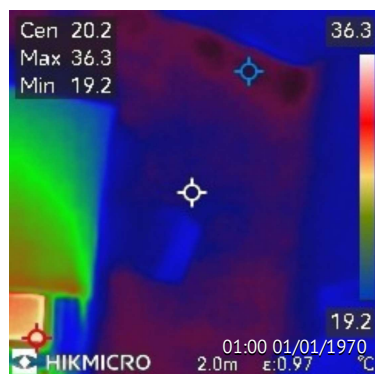
Front Small Bedroom Cont

As before there is small irregularities between surface temps across the wall.

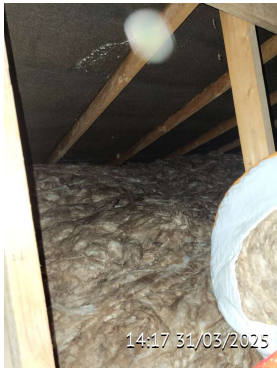
Loft Space

Loft insulation is laid well and is approx. 270mm thick. There is a lack of ventilation within the roof space and previous signs of condensation marks on the underfelt. Would benefit from installing roof tile vents to both front and rear roof elevations. Tenant complains of the tops of 1st floor walls front and back getting damp in the winter period. This could be due to condensation building up on underside of felt and running down to eaves.

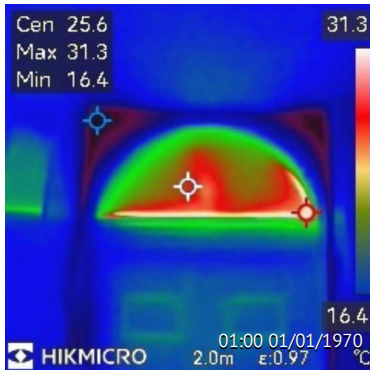
Hallway And Front Door.

There is evidence of cold spotting to top of front door, this is due to the pvc cladding around the arch window. This is only 70mm thick and is contributing to heat loss.

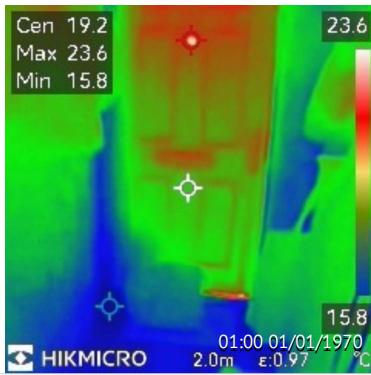
Hallway And Front Door Cont

Again various temperature differences around the front door wall. Would benefit from visual inspection of cavity wall pumped insulation at various points to determine if full coverage has been achieved.

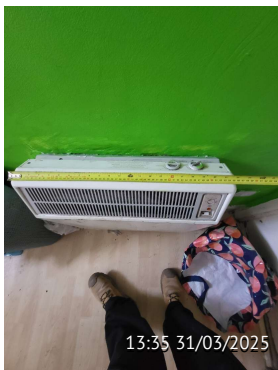
Hallway And Front Door Cont

Storage heater. Dimplex. Storage heaters were cold at time of survey but Tenant says they don't get very hot. Could benefit from more modern versions which have increased efficiency, better insulation and advanced control features making them retain heat longer.

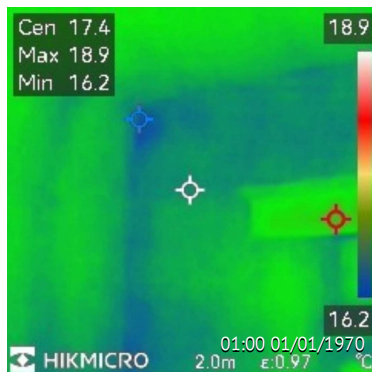
Kitchen Cont

As before there are some cold spots evident across the external wall.

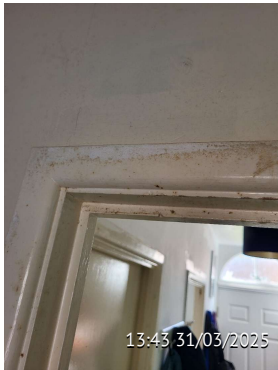
Downstairs Bedroom Cont

There is high levels of condensation/mould to this bedroom to ceilings and walls. The window and trickle vents where closed and there is a freestanding freezer in the corner. I feel this room has been restricted from air flow combined with high humidity levels and thus has caused condensation build up with no ventilation. Would suggest a passive through wall vent to encourage airflow and reduce the risk of tenant closing windows and doors etc.. Will require mould treatment and redecorating.

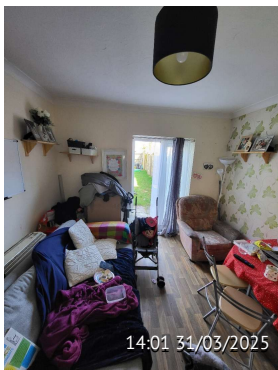
Lounge

Room dimensions 4.1m x 4.1m. Storage heater Dimplex, again older style could benefit from modern upgrade.

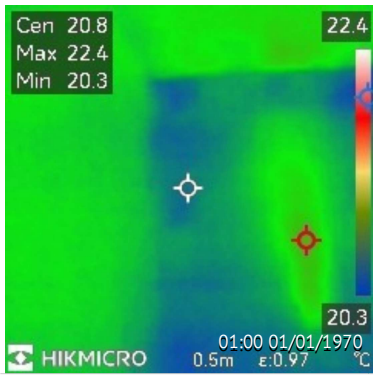
Lounge

Various temperatures difference across wall surface again could be indication of partial fill pumped cavity insulation. Inside wall temp. 16.8° external wall temp. 14.1°
