RBS Inspection

Work Order Number 00000524

Property Address 113 Lower Ashley Road, Easton, Bristol, BS5 0FH

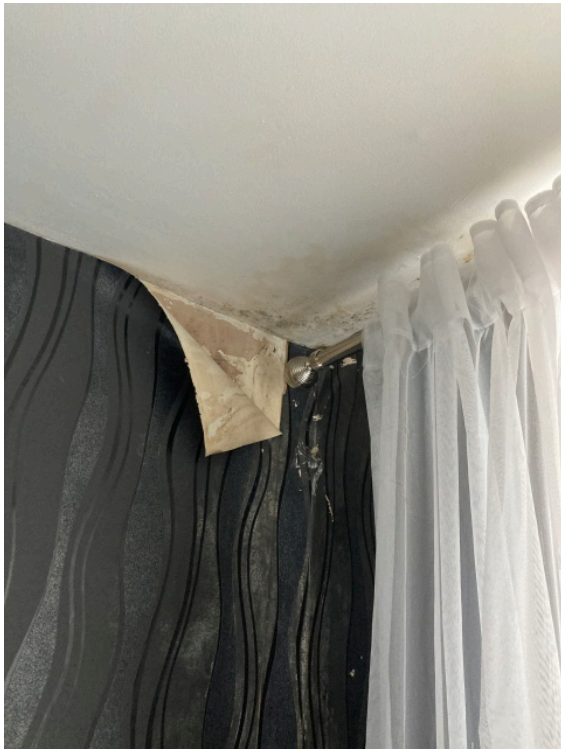
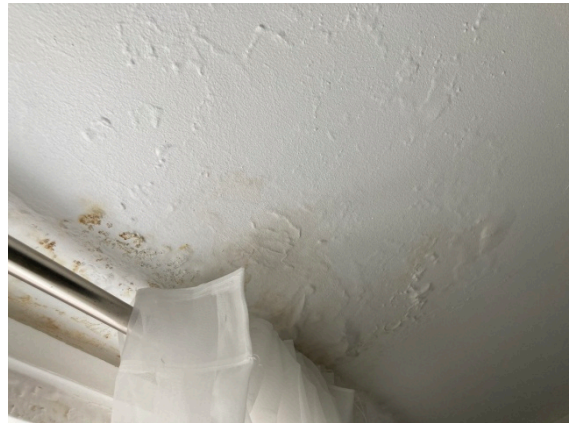
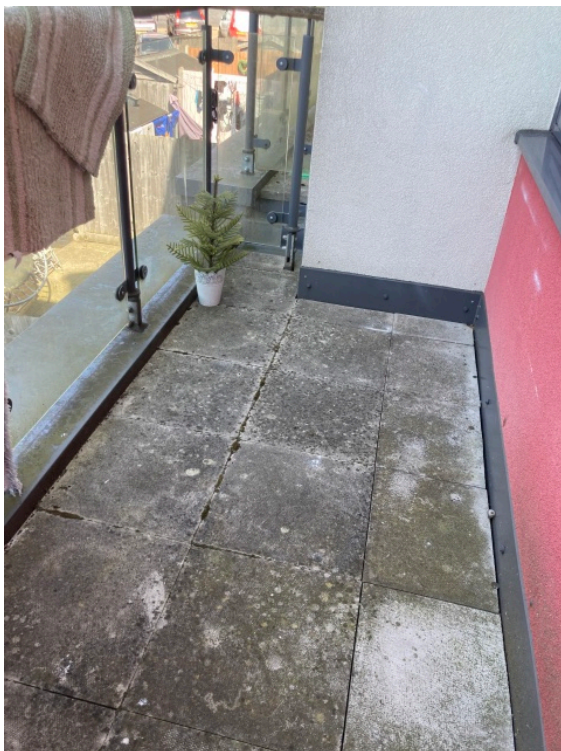
Issue(s) or Defect(s) Identified On inspecting the balcony, it was clear it would not be possible to identify the cause of the water ingress internally directly below in the lounge. There are 18x18 slabs covering the balcony which will need to have approx 9 removed to further investigate where water may be getting in. Internally, it was agreed a section of ceiling (now degraded) be removed to 1. get sight into the ceiling void and 2. prepare for the replacement of that rotten section.

Works to be raised Respond back to Specialist with this report to instruct BPM to continue as described.
