## R&D SURVEY TO ENTRANCE ARCH SOFFIT

10 Hanover Place  
Bristol

BS1 6XT  
UPRN: 1560051002P

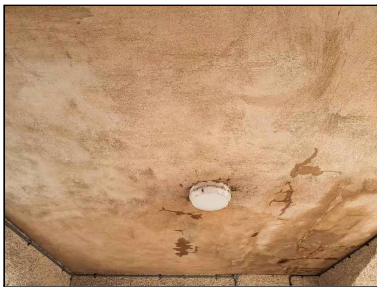
| | 10 Jun 2025 | | Daniel Road | Refurbishment/Demolition Survey | External | No Asbestos Detected | |

| Recommendation | No further action required | | | | | | |
