**An Asbestos Management Survey with part Refurbishment/Demolition (MA and PA) to  
the areas affected by external painting and decorating  
of  
16 Lumley Walk  
Butterfield Down  
Amesbury  
Wilts  
SP4 7SB  
11386**

<b>Survey Carried Out On:</b>	<b>11 March 2019</b>	 
<b>Commissioned By:</b>	<b>Daniel Edwards Guinness Partnership The Guinness Partnership 30 Brock Street Regents Place London NW1 3FG</b>	
<b>Date:</b>	<b>21 March 2019</b>	
<b>Our Reference:</b>	<b>J148735</b>	
<b>Surveyed By:</b>	<b>Fiona Williamson</b>

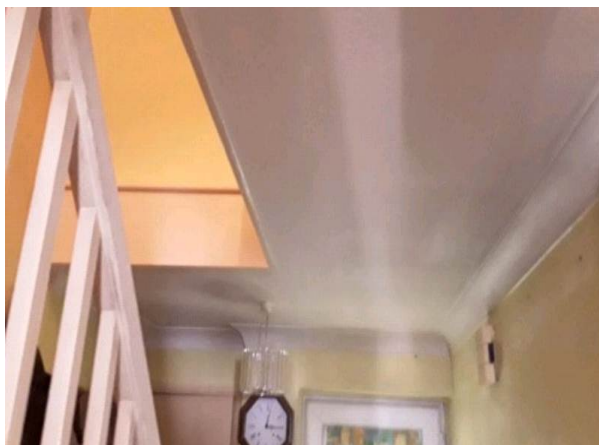
<b>Building:</b> Building 1	<b>Floor Level:</b> Ground	<b>Room Name:</b> (001) Hall
<b>Component:</b> Textured Coating (Reinforced Composite)

Sample Reference	Asbestos Type	Material	Surface Treatment Score	
AZ004442 (Sample 3)	No Asbestos Detected			
Extent of damage	Material Assessment**	Accessibility	Extent/amount	Location
Occupant Activity	No. of Occupants	Frequency of Use	Average Time Area is in Use	
Type of Maintenance	Frequency of Maintenance		Priority Assessment	
Recommendations				
Who	What		When	
-	No further action required		-	
<b>Further Recommendations:</b> None				
<b>General Notes:</b> Textured coating to plasterboard ceiling Plaster to brick and plasterboard walls Carpet to concrete floor Wooden stairs uPVC front door Modern radiator

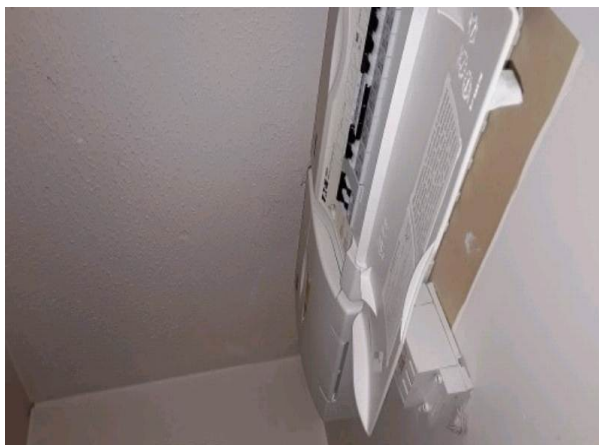
<b>Building:</b> Building 1	<b>Floor Level:</b> Ground	<b>Room Name:</b> (002) Cupboard
<b>Component:</b> Textured Coating (Reinforced Composite)

Sample Reference	Asbestos Type	Material	Surface Treatment Score	
As AZ004442 (Ref Sample 3)	No asbestos detected in visually consistent material			
Extent of damage	Material Assessment**	Accessibility	Extent/amount	Location
Occupant Activity	No. of Occupants	Frequency of Use	Average Time Area is in Use	
Type of Maintenance		Frequency of Maintenance	Priority Assessment	
Recommendations				
Who	What		When	
-	No further action required		-	
Further Recommendations: None				
<b>General Notes:</b> Textured coating to plasterboard ceiling Plaster to brick and plasterboard walls Concrete floor Modern electrics

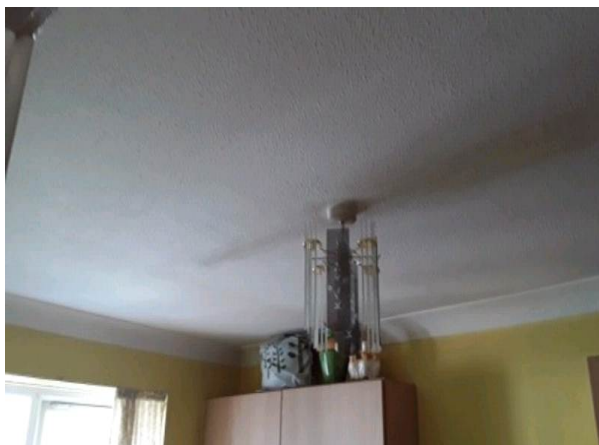
<b>Building:</b> Building 1	<b>Floor Level:</b> Ground	<b>Room Name:</b> (003) Kitchen
<b>Component:</b> Textured Coating (Reinforced Composite)

Sample Reference	Asbestos Type		Material	Surface Treatment Score	
As AZ004442 (Ref Sample 3)	No asbestos detected in visually consistent material				
Extent of damage	Material Assessment**		Accessibility	Extent/amount	Location
Occupant Activity	No. of Occupants		Frequency of Use	Average Time Area is in Use	
Type of Maintenance		Frequency of Maintenance		Priority Assessment	
Recommendations					
Who		What			When
-		No further action required			-
Further Recommendations: None					
<b>General Notes:</b> Textured coating to plasterboard ceiling Plaster to brick and plasterboard walls Modern flooring to concrete floor Plasterboard boxing adjacent to cabinets - no access within boxing (excessive damage) Modern sink pad uPVC window and ceramic tile sill Modern radiator

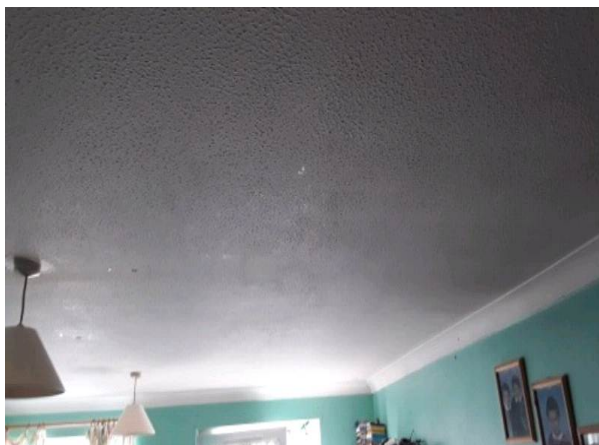
<b>Building:</b> Building 1	<b>Floor Level:</b> Ground	<b>Room Name:</b> (004) Lounge
<b>Component:</b> Textured Coating (Reinforced Composite)

Sample Reference		Asbestos Type		Material		Surface Treatment Score			
As AZ004442 (Ref Sample 3)		No asbestos detected in visually consistent material							
Extent of damage		Material Assessment**		Accessibility		Extent/amount		Location	
Occupant Activity		No. of Occupants		Frequency of Use		Average Time Area is in Use			
Type of Maintenance			Frequency of Maintenance			Priority Assessment			
Recommendations									
Who		What				When			
-		No further action required				-			
Further Recommendations: None									
<b>General Notes:</b> Textured coating to plasterboard ceiling Plaster to brick and plasterboard walls Carpet to concrete floor uPVC window and wooden sill uPVC door to garden Modern radiators

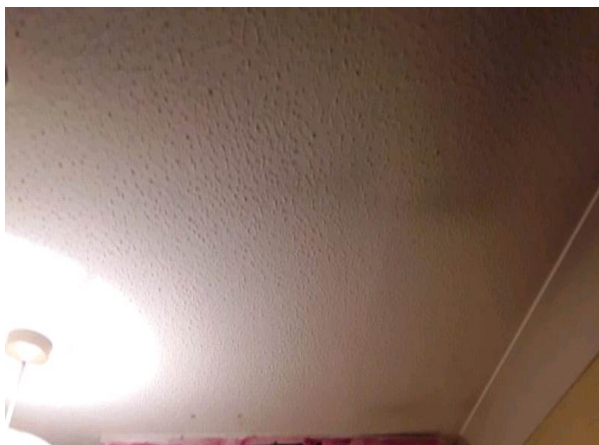
<b>Building:</b> Building 1	<b>Floor Level:</b> First	<b>Room Name:</b> (006) Landing
<b>Component:</b> Textured Coating (Reinforced Composite)

Sample Reference	Asbestos Type	Material	Surface Treatment Score	
AZ004443 (Sample 4)	No Asbestos Detected			
Extent of damage	Material Assessment**	Accessibility	Extent/amount	Location
Occupant Activity	No. of Occupants	Frequency of Use	Average Time Area is in Use	
Type of Maintenance		Frequency of Maintenance	Priority Assessment	
Recommendations				
Who	What		When	
-	No further action required		-	
Further Recommendations: None				
General Notes: Textured coating to plasterboard ceiling Plaster to brick and plasterboard walls Carpet to hardboard floor Wooden stairs

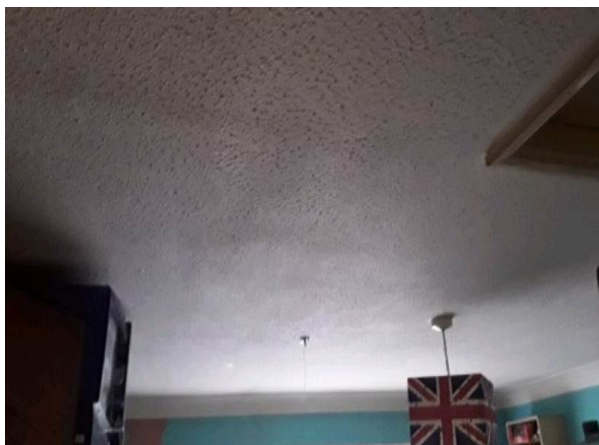
<b>Building:</b> Building 1	<b>Floor Level:</b> First	<b>Room Name:</b> (007) Bedroom
<b>Component:</b> Textured Coating (Reinforced Composite)

Sample Reference	Asbestos Type		Material	Surface Treatment Score	
As AZ004443 (Ref Sample 4)	No asbestos detected in visually consistent material				
Extent of damage	Material Assessment**		Accessibility	Extent/amount	Location
Occupant Activity	No. of Occupants		Frequency of Use	Average Time Area is in Use	
Type of Maintenance		Frequency of Maintenance		Priority Assessment	
Recommendations					
Who	What			When	
-	No further action required			-	
Further Recommendations: None					
<b>General Notes:</b> Textured coating to plasterboard ceiling Plaster to brick and plasterboard walls Carpet to hardboard floor uPVC window and wooden sill Wooden loft hatch access panel Modern radiator

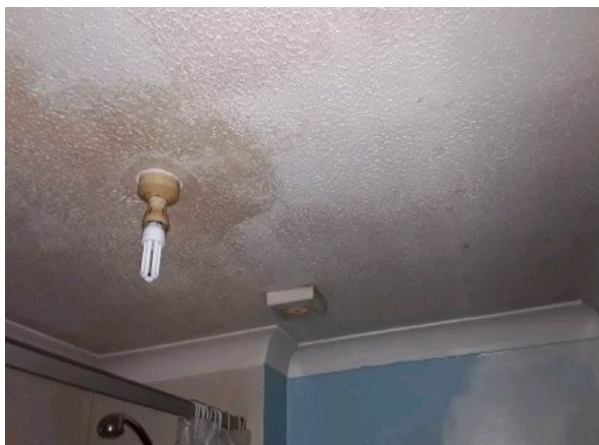
<b>Building:</b> Building 1	<b>Floor Level:</b> First	<b>Room Name:</b> (008) Bathroom
<b>Component:</b> Textured Coating (Reinforced Composite)

Sample Reference	Asbestos Type	Material	Surface Treatment Score	
As AZ004443 (Ref Sample 4)	No asbestos detected in visually consistent material			
Extent of damage	Material Assessment**	Accessibility	Extent/amount	Location
Occupant Activity	No. of Occupants	Frequency of Use	Average Time Area is in Use	
Type of Maintenance		Frequency of Maintenance	Priority Assessment	
Recommendations				
Who	What		When	
-	No further action required		-	
Further Recommendations: None				
<b>General Notes:</b> Textured coating to plasterboard ceiling Plaster to brick and plasterboard walls Hardboard floor Plasterboard boxing to bath - no access within boxing (excessive damage) Wooden bath panel - no access behind bath panel (excessive damage) Modern extract fan in ceiling Modern radiator

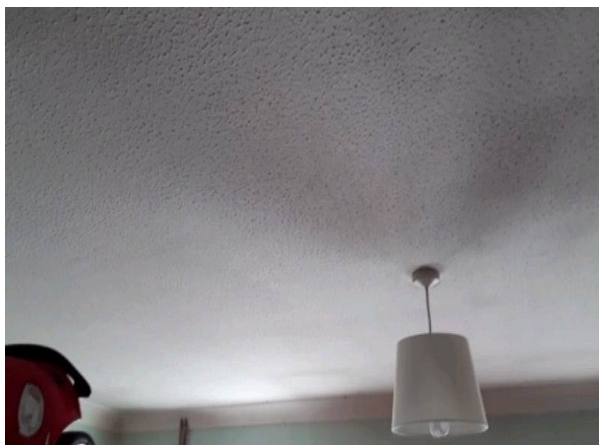
<b>Building:</b> Building 1	<b>Floor Level:</b> First	<b>Room Name:</b> (009) Bedroom
<b>Component:</b> Textured Coating (Reinforced Composite)

Sample Reference	Asbestos Type	Material	Surface Treatment Score	
As AZ004443 (Ref Sample 4)	No asbestos detected in visually consistent material			
Extent of damage	Material Assessment**	Accessibility	Extent/amount	Location
Occupant Activity	No. of Occupants	Frequency of Use	Average Time Area is in Use	
Type of Maintenance		Frequency of Maintenance	Priority Assessment	
Recommendations				
Who	What		When	
-	No further action required		-	
Further Recommendations: None				
<b>General Notes:</b> Textured coating to plasterboard ceiling Plaster to brick and plasterboard walls Carpet to hardboard floor uPVC window and wooden sill Modern radiator

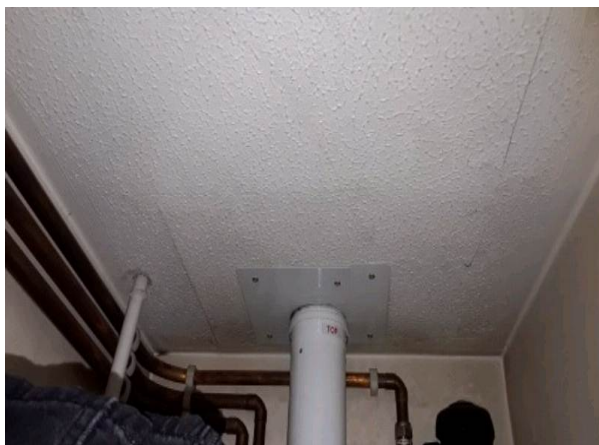
<b>Building:</b> Building 1	<b>Floor Level:</b> First	<b>Room Name:</b> (010) Cupboard
<b>Component:</b> Textured Coating (Reinforced Composite)

Sample Reference	Asbestos Type	Material	Surface Treatment Score	
As AZ004443 (Ref Sample 4)	No asbestos detected in visually consistent material			
Extent of damage	Material Assessment**	Accessibility	Extent/amount	Location
Occupant Activity	No. of Occupants	Frequency of Use	Average Time Area is in Use	
Type of Maintenance		Frequency of Maintenance	Priority Assessment	
Recommendations				
Who	What		When	
-	No further action required		-	
Further Recommendations: None				
<b>General Notes:</b> Textured coating to plasterboard ceiling Plaster to brick and plasterboard walls Hardboard floor Modern Worcester boiler with plastic flue

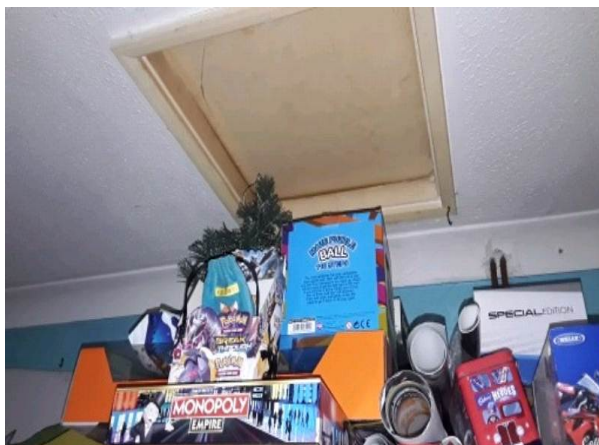
<b>Building:</b> Building 1	<b>Floor Level:</b> Roof Void	<b>Room Name:</b> (011) Loft
<b>Component:</b> No Access

Location	No/Limited Access
Building 1 Roof Void (011) Loft	Unable to access as block by full wardrobe that I was not allowed to move

Sample Reference	Asbestos Type	Material	Surface Treatment Score	
Inaccessible (Presumed)	Presumed Asbestos			
Extent of damage	Material Assessment**	Accessibility	Extent/amount	Location
Occupant Activity	No. of Occupants	Frequency of Use	Average Time Area is in Use	
Type of Maintenance		Frequency of Maintenance	Priority Assessment	
Recommendations				
Who	What		When	
-	Further Inspection Required.		-	
Further Recommendations: None				
General Notes:				
Unable to access as block by full wardrobe that I was not allowed to move

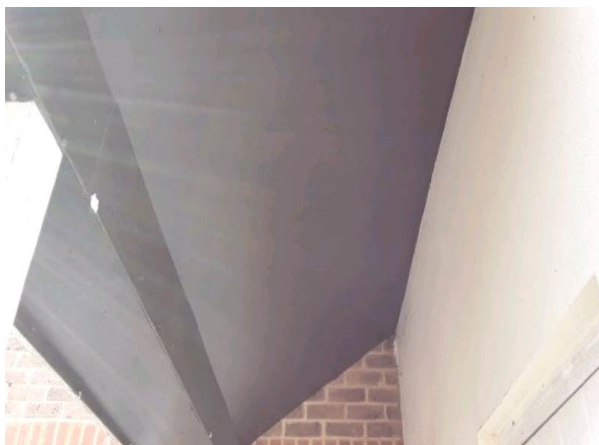
<b>Building:</b> Building 1	<b>Floor Level:</b> External	<b>Room Name:</b> (012) External
<b>Component:</b> Insulating Board

Sample Reference	Asbestos Type	Material	Surface Treatment Score	
AZ004440 (Sample 1)	No Asbestos Detected			
Extent of damage	Material Assessment**	Accessibility	Extent/amount	Location
Occupant Activity	No. of Occupants	Frequency of Use	Average Time Area is in Use	
Type of Maintenance		Frequency of Maintenance	Priority Assessment	
Recommendations				
Who	What		When	
-	No further action required		-	
Further Recommendations: None				
<b>General Notes:</b> Modern roof tiles Insulation board soffit to roof Cement undercloak to roof over cupboards and entrance canopy Plastic drainpipes and guttering Wooden panelling to rear of guttering Wooden fascia panels Insulation board ceiling panels to entrance canopy Wooden support to entrance canopy uPVC windows and sills uPVC front and rear doors

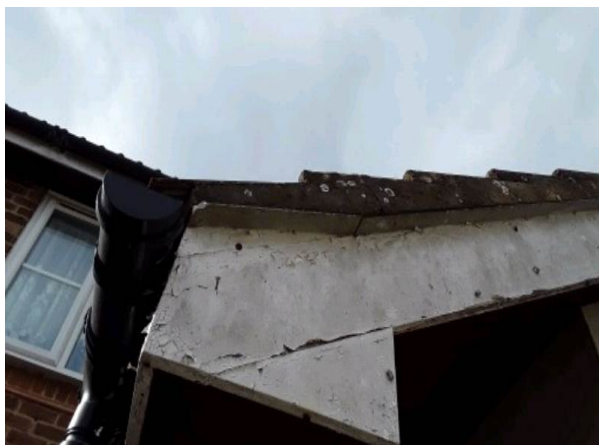
<b>Building:</b> Building 1	<b>Floor Level:</b> External	<b>Room Name:</b> (012) External
<b>Component:</b> Cement (Reinforced Composite)

Location	Result (asbestos type)	Action	Sample Ref
Building 1 External (012) External Cement (Reinforced Composite)	Chrysotile	Remediate in-line with refurb scope	AZ004441 (Sample 2)

Sample Reference	Asbestos Type	Material	Surface Treatment Score	
AZ004441 (Sample 2)	Chrysotile (1)	Cement (1)	1	
Extent of damage	Material Assessment**	Accessibility	Extent/amount	Location
Low Damage (1)	Very Low (4)	1	3m² (1)	0
Occupant Activity	No. of Occupants	Frequency of Use	Average Time Area is in Use	
1 (Low disturbance)	1 (1 to 3)	3 (Daily)	0 (<1 hour)	
Type of Maintenance		Frequency of Maintenance	Priority Assessment	
1 (Low disturbance)		1 (<1 per year)	5	
Recommendations				
Who	What		When	
Licensed contractor	Remediate in-line with refurb scope		Prior to refurbishment if likely to be disturbed	
Further Recommendations: Cement undercloak to roof over cupboard and entrance canopy				
<b>General Notes:</b> Modern roof tiles Insulation board soffit to roof Cement undercloak to roof over cupboards and entrance canopy Plastic drainpipes and guttering Wooden panelling to rear of guttering Wooden fascia panels Insulation board ceiling panels to entrance canopy Wooden support to entrance canopy uPVC windows and sills uPVC front and rear doors

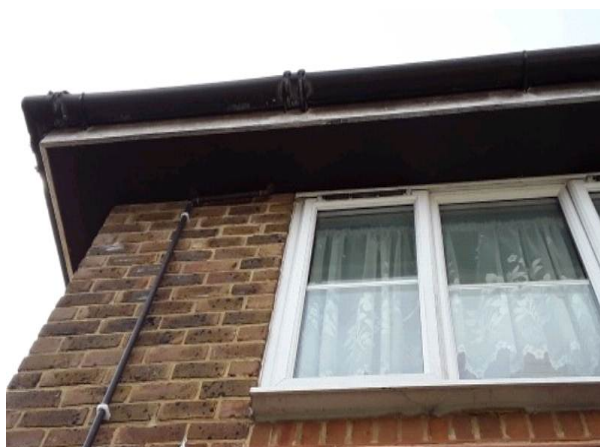
<b>Building:</b> Building 1	<b>Floor Level:</b> External	<b>Room Name:</b> (012) External
<b>Component:</b> Insulating Board

Sample Reference	Asbestos Type	Material	Surface Treatment Score	
As AZ004440 (Ref Sample 1)	No asbestos detected in visually consistent material			
Extent of damage	Material Assessment**	Accessibility	Extent/amount	Location
Occupant Activity	No. of Occupants	Frequency of Use	Average Time Area is in Use	
Type of Maintenance		Frequency of Maintenance	Priority Assessment	
Recommendations				
Who	What		When	
-	No further action required		-	
Further Recommendations: None				
<b>General Notes:</b> Modern roof tiles Insulation board soffit to roof Cement undercloak to roof over cupboards and entrance canopy Plastic drainpipes and guttering Wooden panelling to rear of guttering Wooden fascia panels Insulation board ceiling panels to entrance canopy Wooden support to entrance canopy uPVC windows and sills uPVC front and rear doors
