## AM TGP Pre-inspection form

18 Boulters Road, Hartcliffe, Bristol, BS13 0HN / Eloise Lawrence

| Date | | 14.04.2025 00:00 BST | | | |

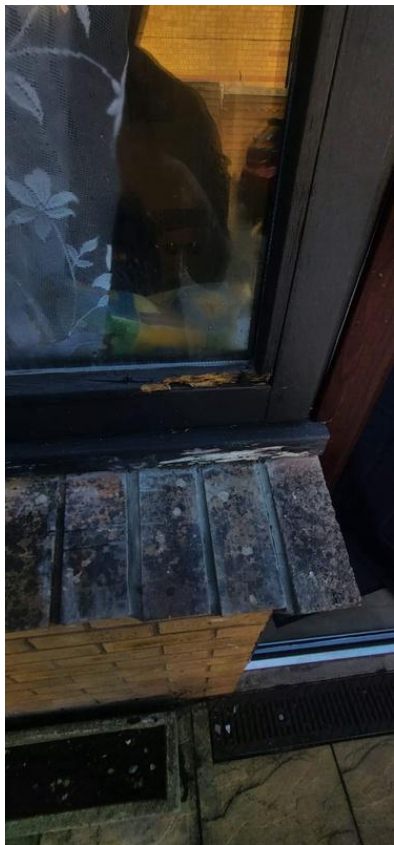
Photo 1

Timber windows throughout the property are rotten and leaving the glass edges exposed in places.

rejected from Capex replacement - to be repaired only.
