# Refurbishment and Demolition

## Asbestos Survey

(Carried out on behalf of the Voids Dept of  
Swindon Commercial Services Ltd)  
19A Oxford Street, Railway Village, Swindon,  
SN1 5DA

Surveyor:	<b>Andy Balfe</b>
Verified/Signature:	<i>ABalfe</i>
Date:	<b>8<sup>th</sup> September 2010</b>
<u>Our Reference:</u>	<b><u>SAS4208/10386372</u></b>
Authorised by:	<b>Jayne O'Sullivan</b>
Verified/Signature:	<i>JOSullivan</i>

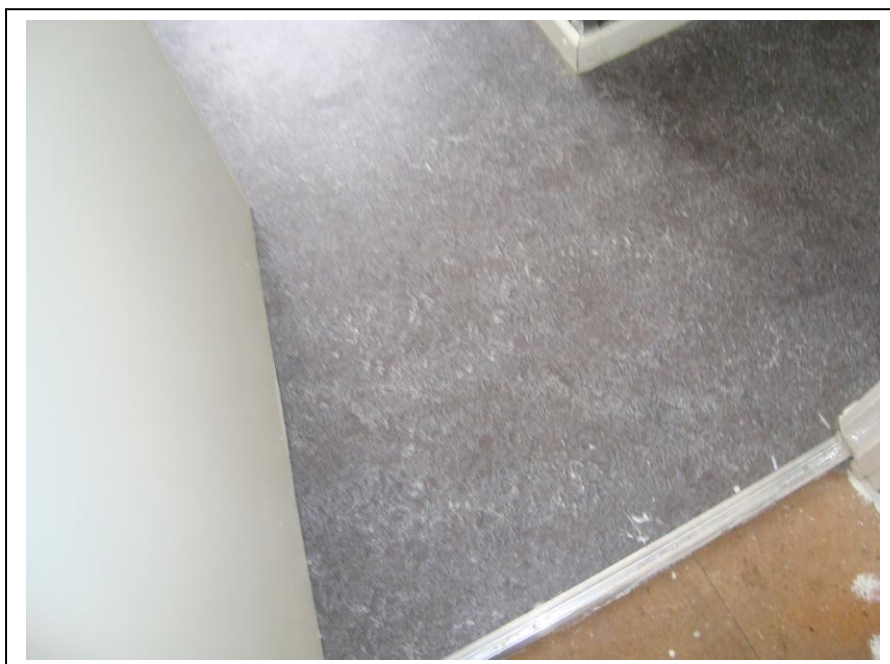
ID REF NO	SAMPLE/VISUAL REF.	FLOOR/LEVEL	LOCATION	DESCRIPTION	APPROX EXTENT	ANALYSIS RESULT	MATERIAL TYPE	NOTIFIABLE MATERIAL Y/N
3200/1	89354	1 <sup>st</sup> Floor	Bathroom	Floor Tile	3 m <sup>2</sup>	Chrysotile	Marley Vinyl	N

If this material is going to be interfered with during works to this property it needs to be removed before demolition/refurbishment takes place. This requires removal by trained asbestos operatives following the latest ACOPS and HSE Guidance Notes and disposed of as asbestos waste.

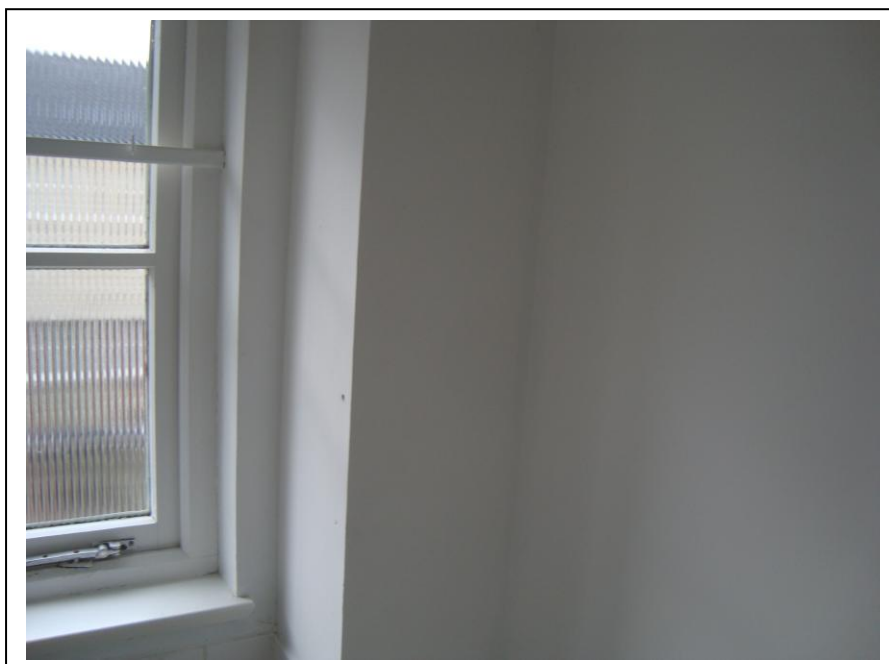
ID REF NO	SAMPLE/VISUAL REF.	FLOOR/LEVEL	LOCATION	DESCRIPTION	APPROX EXTENT	ANALYSIS RESULT	MATERIAL TYPE	NOTIFIABLE MATERIAL Y/N
Visual	Visual	1 <sup>st</sup> Floor	Bathroom	Wall Boxing (plaster board)	2 m <sup>2</sup>	No asbestos detected	N/A	N/A

This material is plaster board therefore no asbestos detected. No further action required.

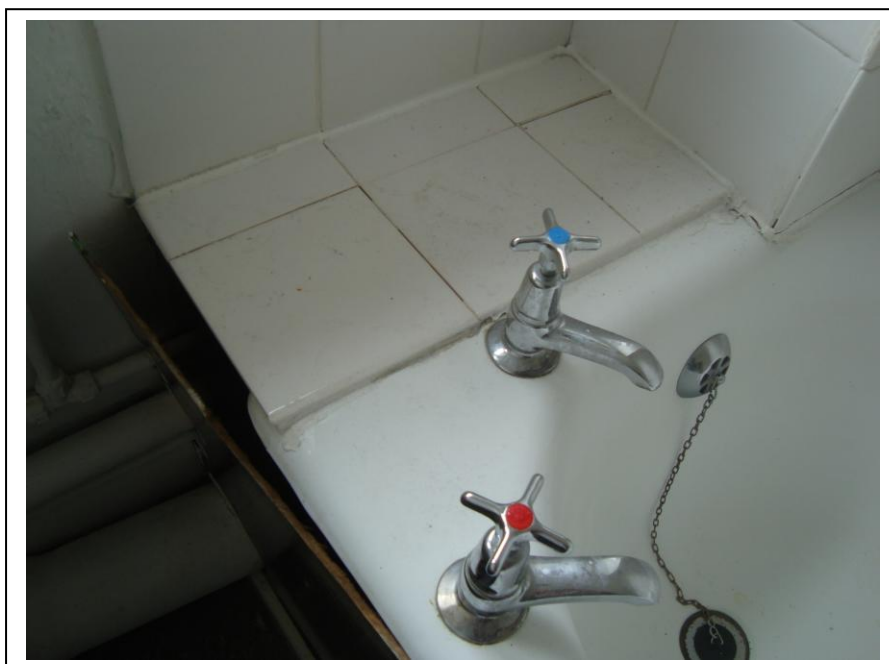
ID REF NO	SAMPLE/VISUAL REF.	FLOOR/LEVEL	LOCATION	DESCRIPTION	APPROX EXTENT	ANALYSIS RESULT	MATERIAL TYPE	NOTIFIABLE MATERIAL Y/N
Visual	Visual	1 <sup>st</sup> Floor	Bathroom	End of Bath Shelf (tiles & plywood)	0.5 m <sup>2</sup>	No asbestos detected	N/A	N/A

No asbestos detected.

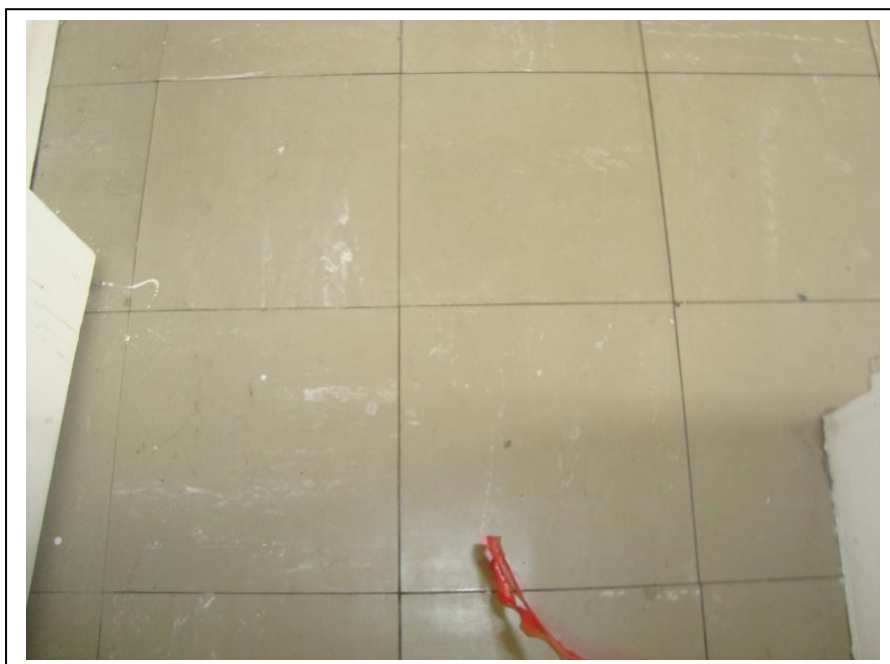
ID REF NO	SAMPLE/VISUAL REF.	FLOOR/LEVEL	LOCATION	DESCRIPTION	APPROX EXTENT	ANALYSIS RESULT	MATERIAL TYPE	NOTIFIABLE MATERIAL Y/N
Refer 3200/1	Refer 89354	1 <sup>st</sup> Floor	Kitchen	Floor Tile	6 m <sup>2</sup>	Chrysotile	Marley Vinyl	N

This material is considered to be the same as the Bathroom floor tile. If this material is going to be interfered with during works to this property it needs to be removed before demolition/refurbishment takes place. This requires removal by trained asbestos operatives following the latest ACOPS and HSE Guidance Notes and disposed of as asbestos waste.

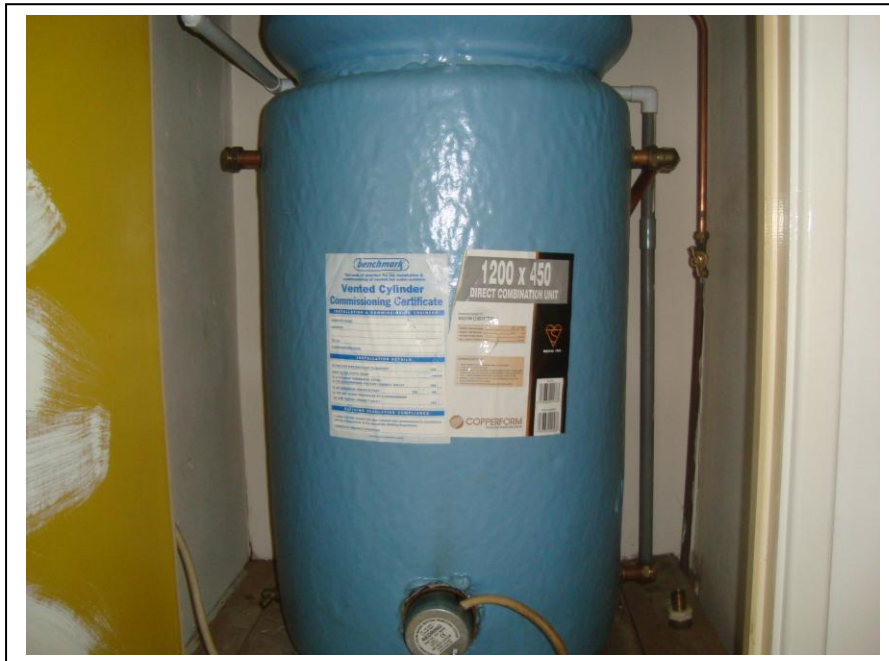
I D REF NO	SAMPLE/VISUAL REF.	FLOOR/LEVEL	LOCATION	DESCRIPTION	APPROX EXTENT	ANALYSIS RESULT	MATERIAL TYPE	NOTIFIABLE MATERIAL Y/N
Visual	Visual	1 <sup>st</sup> Floor	Airing Cupboard	All	1 no	No asbestos detected	N/A	N/A

No asbestos detected.

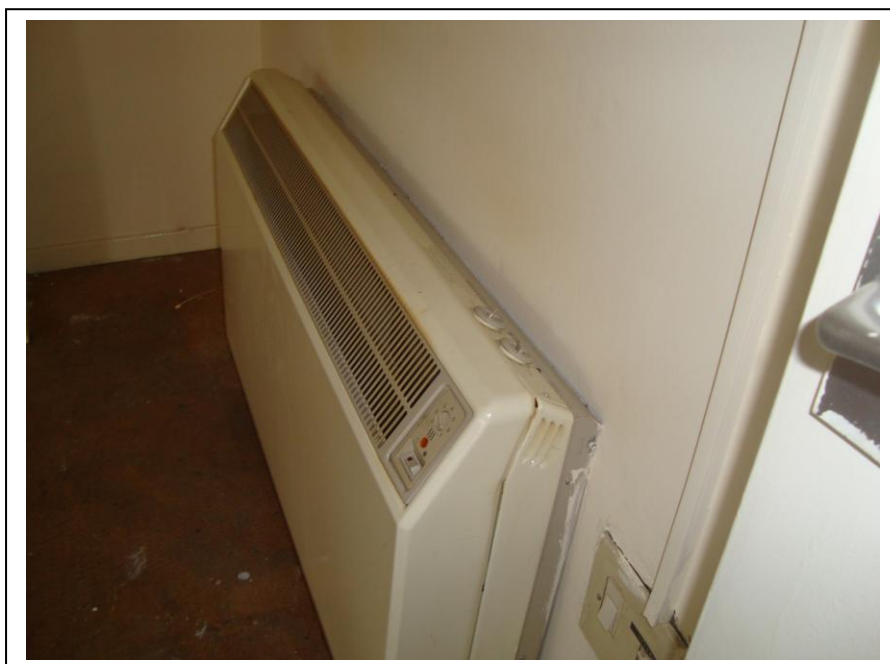
ID REF NO	SAMPLE/VISUAL REF.	FLOOR/LEVEL	LOCATION	DESCRIPTION	APPROX EXTENT	ANALYSIS RESULT	MATERIAL TYPE	NOTIFIABLE MATERIAL Y/N
Visual	Visual	1 <sup>st</sup> Floor	Lounge	Wall Heater (new technology)	1 no	No asbestos detected	N/A	N/A

Walls are block and plaster. Ceiling is plaster board. Floor and door are both wooden. Window and sill are wood. The storage heater is new technology no asbestos detected.

No asbestos detected.
