ASBESTOS SURVEY REPORT

SURVEY REFERENCE No. J079063

20 Bodnam Road, Cheltenham, Gloucestershire, GL51 0WE

CUSTOMER	SURVEY TYPE
Sovereign Housing Association Ltd 90 Bartholomew Street, Newbury, Berkshire RG14 5EE	Management Survey Standard sampling, identification and assessment survey including priority risk assessment plus part refurbishment to specified locations only

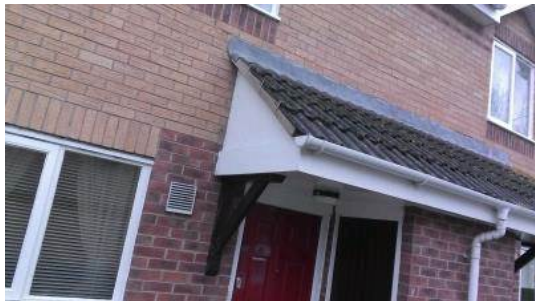
<u>Inspection Details:</u>	
Inspection Number	: 17
Inspection Date	: 27/01/2016
Inspection Type	: Visual Inspection
Level of Identification	: Asbestos Presumed
<u>Material Location:</u>	
Building Name / No	: 20 Bodnam Road
Floor Level	: External
Area / Room	: PORCH
Item Description	: Undercloaking
<u>Material Details:</u>	
Product Description	: Panel - Asbestos Cement
Estimated Quantity	: 2 Im
Likelihood of Disturbance	: Low disturbance
Sample Number	: N/A
Sample Location	: N/A
Sample Analysis	: N/A

<u>Material Assessment as per HSG264:</u>		
<u>Factors</u>	<u>Assessment Description</u>	<u>Score</u>
Product/Material Type	: Cement	1
Damage/Deterioration	: Good Condition	0
Surface Treatment	: Cement	1
Asbestos Type	: Crocidolite (or unknown)	3
Material Assessment Score:		5
Material assessment parameters and algorithm scoring factors are detailed in the Scope of Survey Agreement.		
<u>Priority Risk Assessment as per HSG264 & HSG227:</u>		
<u>Factors</u>		<u>Score</u>
Main/Secondary Activities Carried Out		1
Location		0
Accessibility		0
Extent/Amount		1
Frequency		0
Occupancy		0
Average Time area is in use		0
Maintenance activity		1
Maintenance frequency		0
Priority Risk Assessment Score:		3
The customer provided ACE with priority risk assessment information prior to the undertaking of this survey, therefore the risk assessment for this inspection is based on material and priority assessment.		
Total Assessment Score:		8

Material Risk Assessment Category as per HSG264 & HSG227: Very Low

Action : Inspect at Intervals & Update Register

Priority : Very Low

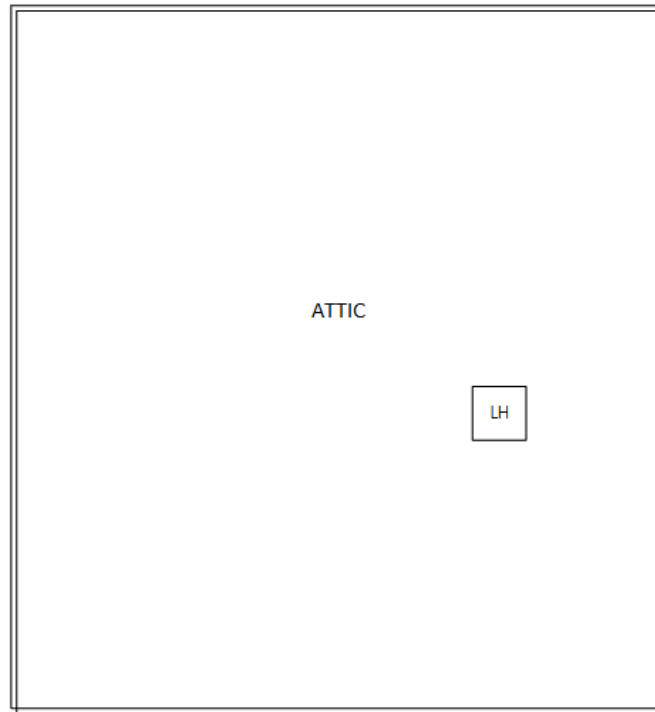
Floor Level: Roof Void

10	-	20 Bodnam Road	Roof Void	ATTIC	No suspect materials found		-	-	N.A.D
11	As inspection 1	20 Bodnam Road	Ground	HALL	Ceiling	Textured Coating	-	-	N.A.D.I.S
12	-	20 Bodnam Road	Ground	HALL	Floor		-	-	Asbestos presumed as not accessed
13	EO001879	20 Bodnam Road	Ground	KITCHEN	Ceiling	Textured Coating	-	-	N.A.D.I.S
14	-	20 Bodnam Road	Ground	KITCHEN	Window		-	-	Asbestos presumed as not accessed

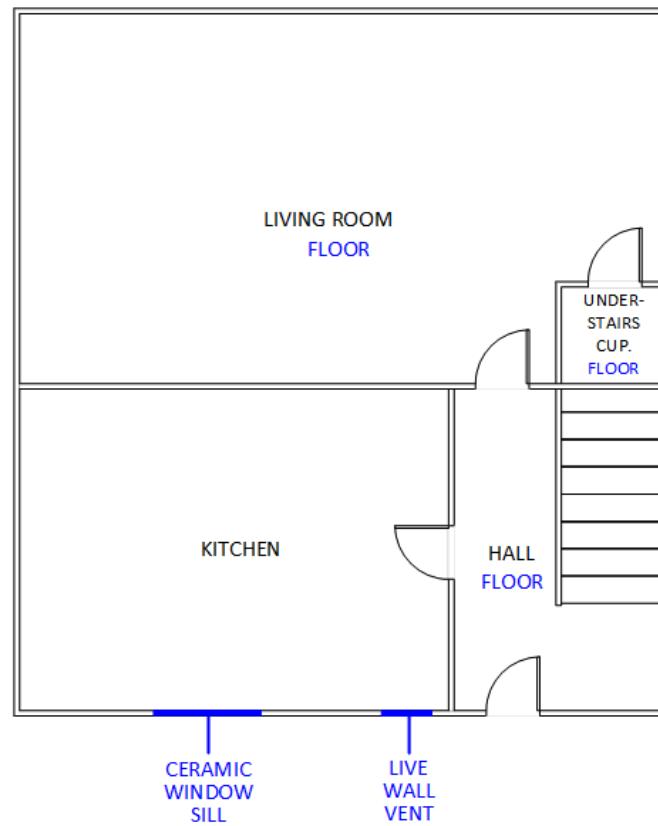
Floor Level: Ground Floor

Building Name	Building Level	Room / Area	Element / Location	Restriction Comments
20 Bodnam Road	Ground Floor	UNDERSTAIRS CUPBOARD	Floor	Fixed laminate flooring - would damage to access
20 Bodnam Road	Ground Floor	KITCHEN	Window	Ceramic sill - would damage to access
20 Bodnam Road	Ground Floor	KITCHEN	Wall	Wall vent - live and in use
20 Bodnam Road	Ground Floor	LIVING ROOM	Floor	Fixed laminate flooring - would damage to access
20 Bodnam Road	Ground Floor	HALL	Floor	Fixed laminate flooring - would damage to access

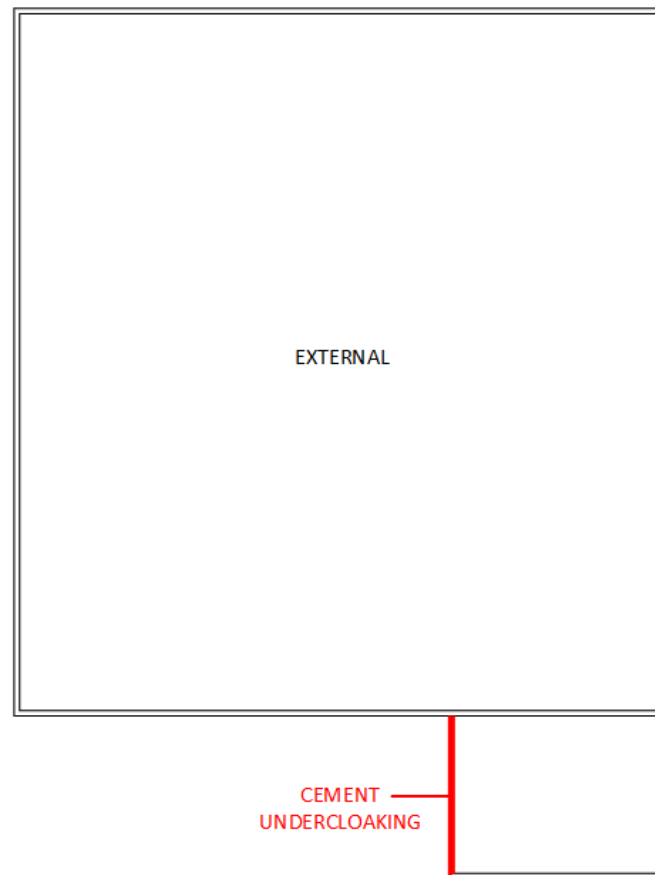
Floor Level: External

Inspection No	Sample Reference Number	Building Name/No	Floor/Level	Area/Room	Item Description	Product Description	Damage/Deterioration	Estimated Quantity	Level of Identification
15	-	20 Bodnam Road	Ground	KITCHEN	Wall		-	-	Asbestos presumed as not accessed
16	EO001880	20 Bodnam Road	External	EXTERNAL	Soffit	Non Asbestos Insulating Board	-	-	N.A.D.I.S
17	-	20 Bodnam Road	External	PORCH	Undercloaking	Panel - Asbestos Cement	Good Condition	2lm	Asbestos Presumed

Inspection No	Building Name/No	Floor/Level	Area/room	Element/Component	Material Description	Recommended Action
17	20 Bodnam Road	External	PORCH	Undercloaking	Panel - Asbestos Cement	Inspect at Intervals & Update Register
