An Asbestos Management with part Refurbishment Survey (MA & PA) at
75 Camford Close
Beggarwood
Basingstoke
Hampshire
RG22 4UJ

Survey Conducted:	13 December 2022	
Date of approval:	20 Feb 2023	
Our Reference:	J301119	
Surveyed By:	Fiona Williamson	
UPRN:	136150	
Scope of Works:	Refurbishment survey to tiles in property key area prior to replacements with a management survey to the remainder of the property.	
Requested By:

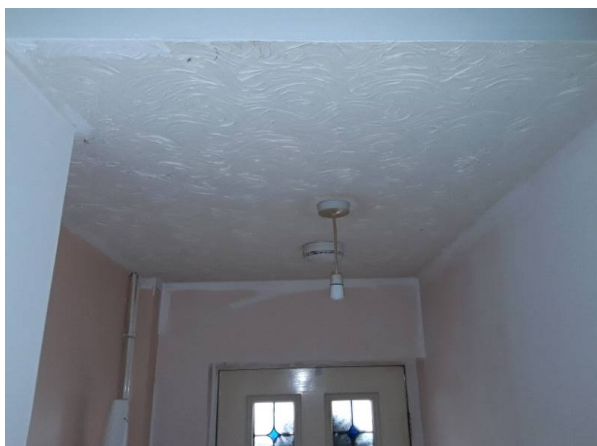
Building:	75 Camford Close	Floor Level:	Ground	Item Ref:	J301119-1
Room Name:	(001) Entrance				
Sample Ref:	FW008372				
Component:	Textured coating to plasterboard ceiling				
Extent:	2m ²

Material Assessment		
Product Type	Extent of damage	Surface Treatment Score
Asbestos Type	Material Assessment Score (MA)	
No Asbestos Detected

Conclusions and Actions	
Recommendation:	No further action required
Further Information:	None
General Notes: Textured coating to plasterboard ceiling. Plasterboard walls. Concrete floor. Modern linoleum to concrete stairs. Modern black vinyl stair treads. uPVC front door. Modern electrics on wall.

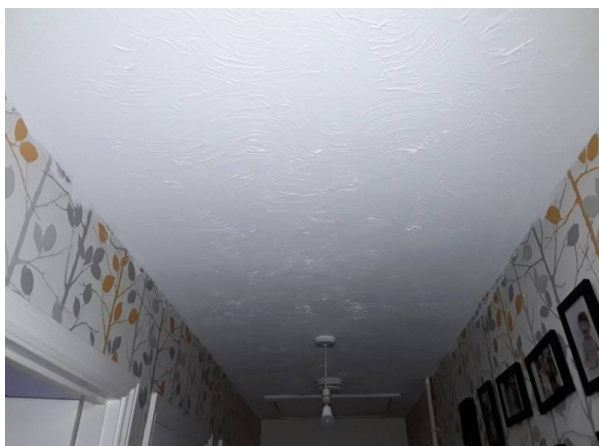
Building:	75 Camford Close	Floor Level:	First	Item Ref:	J301119-2
Room Name:	(002) Landing				
Sample Ref:	As FW008372				
Component:	Textured coating to plasterboard ceiling				
Extent:	8m ²

Material Assessment		
Product Type	Extent of damage	Surface Treatment Score
Asbestos Type	Material Assessment Score (MA)	
No asbestos detected in visually consistent material

Conclusions and Actions	
Recommendation:	No further action required
Further Information:	None
General Notes: Textured coating to plasterboard ceiling. Plasterboard walls. Modern linoleum to floor - no access under modern linoleum due to excessive damage. Modern linoleum to concrete stairs. Modern black vinyl stair treads. Plastic loft hatch access panel.

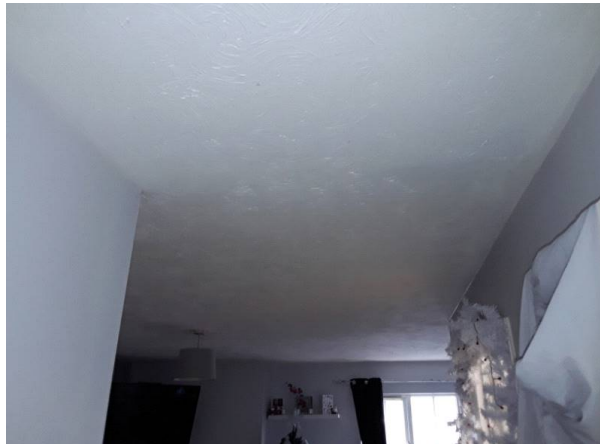
Building:	75 Camford Close	Floor Level:	First	Item Ref:	J301119-3
Room Name:	(003) Lounge				
Sample Ref:	As FW008372				
Component:	Textured coating to plasterboard ceiling				
Extent:	20lm

Material Assessment		
Product Type	Extent of damage	Surface Treatment Score
Asbestos Type	Material Assessment Score (MA)	
No asbestos detected in visually consistent material

Conclusions and Actions	
Recommendation:	No further action required
Further Information:	None
General Notes: Textured coating to plasterboard ceiling. Plasterboard walls. Beige floor tiles to concrete floor. uPVC window and wooden sill. Modern fireplace. Modern radiator.

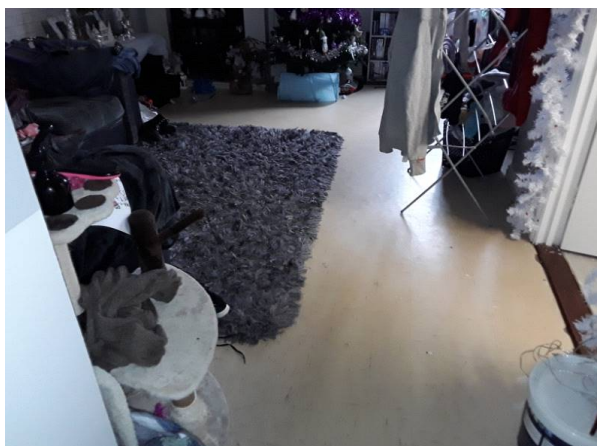
Building:	75 Camford Close	Floor Level:	First	Item Ref:	J301119-4
Room Name:	(003) Lounge				
Sample Ref:	FW008373				
Component:	Beige floor tiles to concrete floor				
Extent:	20m ²

Material Assessment		
Product Type	Extent of damage	Surface Treatment Score
Asbestos Type	Material Assessment Score (MA)	
No Asbestos Detected

Conclusions and Actions	
Recommendation:	No further action required
Further Information:	None
General Notes: Textured coating to plasterboard ceiling. Plasterboard walls. Beige floor tiles to concrete floor. uPVC window and wooden sill. Modern fireplace. Modern radiator.

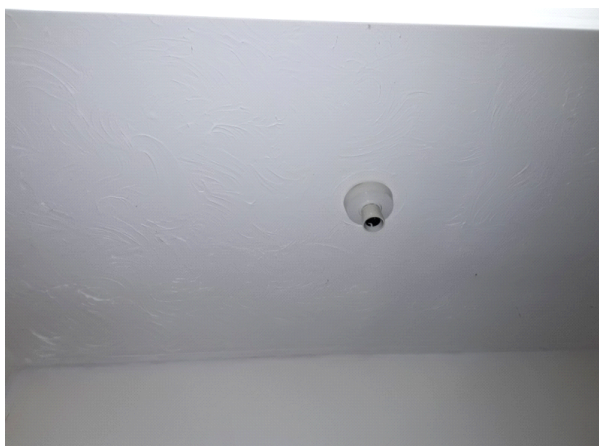
Building:	75 Camford Close	Floor Level:	First	Item Ref:	J301119-5
Room Name:	(004) Cupboard				
Sample Ref:	As FW008372				
Component:	Textured coating to plasterboard ceiling				
Extent:	3m ²

Material Assessment		
Product Type	Extent of damage	Surface Treatment Score
Asbestos Type	Material Assessment Score (MA)	
No asbestos detected in visually consistent material

Conclusions and Actions	
Recommendation:	No further action required
Further Information:	None
General Notes: Textured coating to plasterboard ceiling. Plasterboard walls. Beige floor tiles to concrete floor. uPVC window and wooden sill. Modern fireplace. Modern radiator.

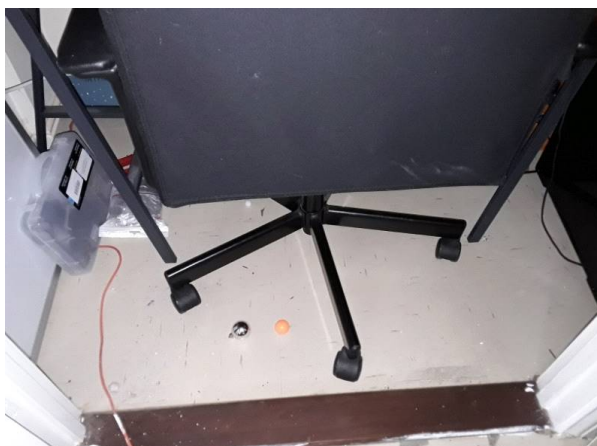
Building:	75 Camford Close	Floor Level:	First	Item Ref:	J301119-6
Room Name:	(004) Cupboard				
Sample Ref:	As FW008373				
Component:	Beige floor tiles to concrete floor				
Extent:	3m ²

Material Assessment		
Product Type	Extent of damage	Surface Treatment Score
Asbestos Type	Material Assessment Score (MA)	
No asbestos detected in visually consistent material

Conclusions and Actions	
Recommendation:	No further action required
Further Information:	None
General Notes: Textured coating to plasterboard ceiling. Plasterboard walls. Beige floor tiles to concrete floor. uPVC window and wooden sill. Modern fireplace. Modern radiator.

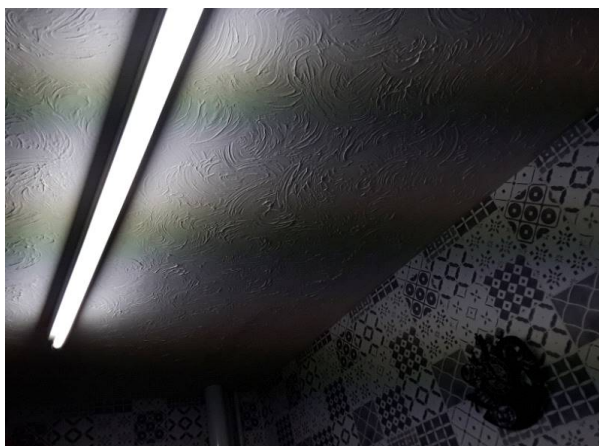
Building:	75 Camford Close	Floor Level:	First	Item Ref:	J301119-7
Room Name:	(005) Kitchen				
Sample Ref:	As FW008372				
Component:	Textured coating to plasterboard ceiling				
Extent:	8m ²

Material Assessment		
Product Type	Extent of damage	Surface Treatment Score
Asbestos Type	Material Assessment Score (MA)	
No asbestos detected in visually consistent material

Conclusions and Actions	
Recommendation:	No further action required
Further Information:	None
General Notes: Textured coating to plasterboard ceiling. Plasterboard walls. Laminate panelling to floor - no access under laminate panelling due to excessive damage. Plasterboard boxing adjacent to cabinet - no access within boxing due to excessive damage. Modern sink pad. Modern Worcester boiler with a metal flue. Modern extract fan in ceiling. Modern radiator.

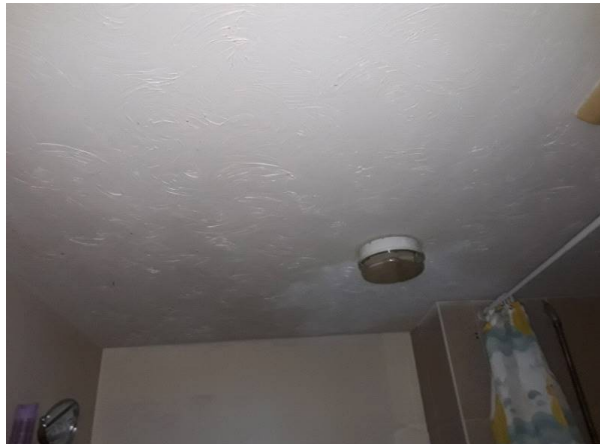
Building:	75 Camford Close	Floor Level:	First	Item Ref:	J301119-8
Room Name:	(006) Bathroom				
Sample Ref:	As FW008372				
Component:	Textured coating to plasterboard ceiling				
Extent:	8m ²

Material Assessment		
Product Type	Extent of damage	Surface Treatment Score
Asbestos Type	Material Assessment Score (MA)	
No asbestos detected in visually consistent material

Conclusions and Actions	
Recommendation:	No further action required
Further Information:	None
General Notes: Textured coating to plasterboard ceiling. Plasterboard walls. Ceramic tiles to floor - no access under ceramic tiles due excessive damage. Ceramic tiled boxing to bath - no access behind ceramic tiles due to excessive damage. Wooden boxing under toilet and sink - no access within boxing due to excessive damage. Wooden bath panel - no access behind bath panel due to excessive damage. Ceramic cistern. Modern extract fan in ceiling. Modern towel rail.

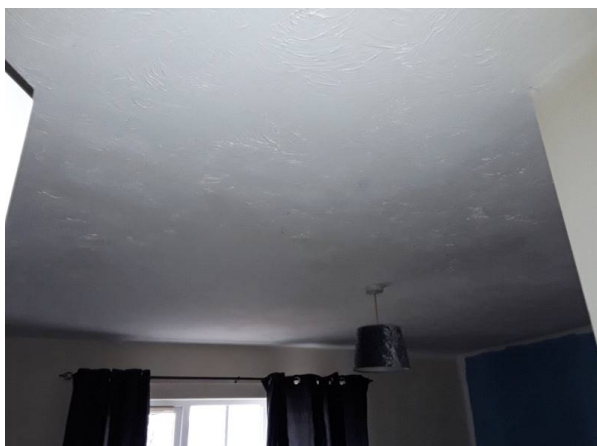
Building:	75 Camford Close	Floor Level:	First	Item Ref:	J301119-9
Room Name:	(007) Bedroom				
Sample Ref:	FW008374				
Component:	Textured coating to plasterboard ceiling				
Extent:	14m ²

Material Assessment		
Product Type	Extent of damage	Surface Treatment Score
Asbestos Type	Material Assessment Score (MA)	
No Asbestos Detected

Conclusions and Actions	
Recommendation:	No further action required
Further Information:	None
General Notes: Textured coating to plasterboard ceiling. Plasterboard walls. Beige floor tiles to concrete floor. uPVC window and wooden sill. Modern fireplace. Modern radiator.

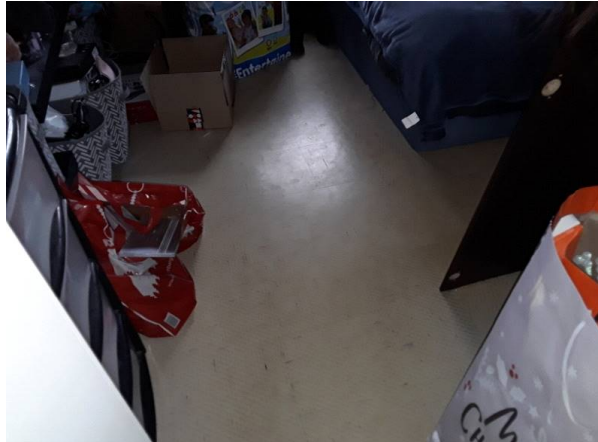
Building:	75 Camford Close	Floor Level:	First	Item Ref:	J301119-10
Room Name:	(007) Bedroom				
Sample Ref:	As FW008373				
Component:	Beige floor tiles to concrete floor				
Extent:	14m ²

Material Assessment		
Product Type	Extent of damage	Surface Treatment Score
Asbestos Type	Material Assessment Score (MA)	
No asbestos detected in visually consistent material

Conclusions and Actions	
Recommendation:	No further action required
Further Information:	None
General Notes: Textured coating to plasterboard ceiling. Plasterboard walls. Beige floor tiles to concrete floor. uPVC window and wooden sill. Modern fireplace. Modern radiator.

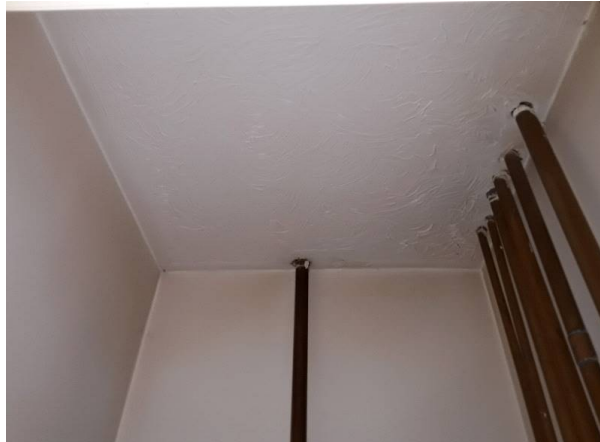
Building:	75 Camford Close	Floor Level:	First	Item Ref:	J301119-11
Room Name:	(008) Cupboard				
Sample Ref:	As FW008374				
Component:	Textured coating to plasterboard ceiling				
Extent:	1.5m ²

Material Assessment		
Product Type	Extent of damage	Surface Treatment Score
Asbestos Type	Material Assessment Score (MA)	
No asbestos detected in visually consistent material

Conclusions and Actions	
Recommendation:	No further action required
Further Information:	None
General Notes: Textured coating to plasterboard ceiling. Plasterboard walls. Concrete floor. Modern immersion heater.

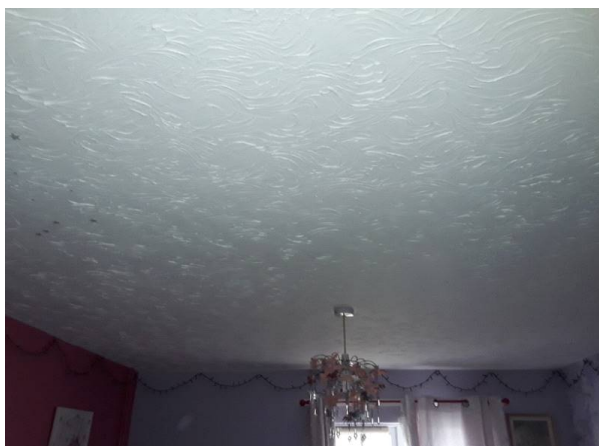
Building:	75 Camford Close	Floor Level:	First	Item Ref:	J301119-12
Room Name:	(009) Bedroom				
Sample Ref:	As FW008374				
Component:	Textured coating to plasterboard ceiling				
Extent:	12m ²

Material Assessment		
Product Type	Extent of damage	Surface Treatment Score
Asbestos Type	Material Assessment Score (MA)	
No asbestos detected in visually consistent material

Conclusions and Actions	
Recommendation:	No further action required
Further Information:	None
General Notes: Textured coating to plasterboard ceiling. Plasterboard walls. Beige floor tiles to concrete floor. uPVC window and wooden sill. Modern fireplace. Modern radiator.

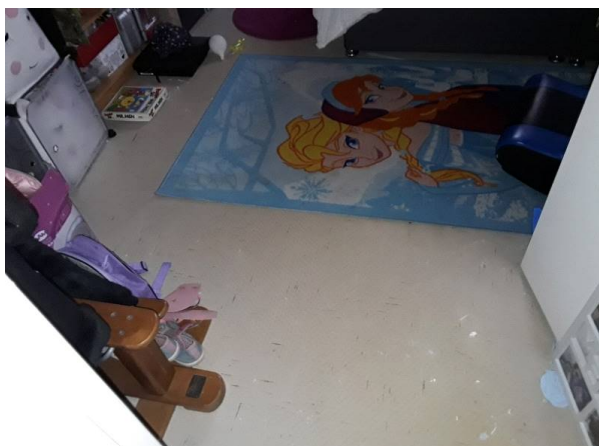
Building:	75 Camford Close	Floor Level:	First	Item Ref:	J301119-13
Room Name:	(009) Bedroom				
Sample Ref:	As FW008373				
Component:	Beige floor tiles to concrete floor				
Extent:	12m ²

Material Assessment		
Product Type	Extent of damage	Surface Treatment Score
Asbestos Type	Material Assessment Score (MA)	
No asbestos detected in visually consistent material

Conclusions and Actions	
Recommendation:	No further action required
Further Information:	None
General Notes: Textured coating to plasterboard ceiling. Plasterboard walls. Beige floor tiles to concrete floor. uPVC window and wooden sill. Modern fireplace. Modern radiator.

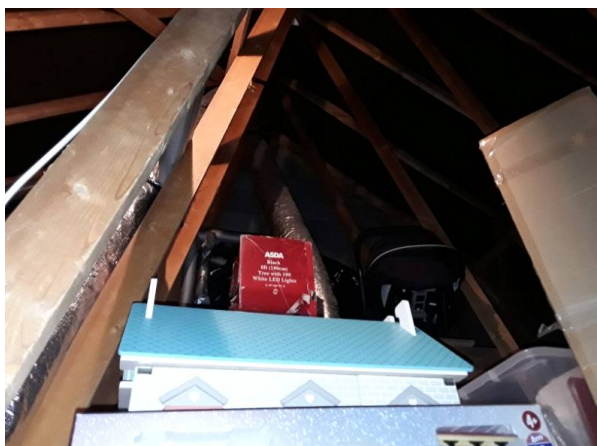
Building:	75 Camford Close	Floor Level:	Roof Void	Item Ref:	J301119-14
Room Name:	(010) Loft				
Sample Ref:					
Component:	No suspect materials found				
Extent:

Material Assessment		
Product Type	Extent of damage	Surface Treatment Score
Asbestos Type	Material Assessment Score (MA)	
No suspect materials

Conclusions and Actions	
Recommendation:	No further action required
Further Information:	None
General Notes: Limited access due to Tenant's belongings. Modern sarking felt. Breeze block walls. Plasterboard floor panels. MMMF insulation. Foam lagging to metal pipework. MMMF insulation to wired Aluminium ducting to extract fan in bathroom. Plastic loft hatch access panel.
