**An Asbestos Management with part Refurbishment Survey (MA & PA) at**  
**18 Brickham Road**  
**Devizes**  
**Wiltshire**  
**SN10 2SS**

<b>Survey Conducted:</b>	9 February 2023	
<b>Date of approval:</b>	13 Feb 2023	
<b>Our Reference:</b>	J309168	
<b>Surveyed By:</b>	Fiona Williamson	
<b>UPRN:</b>	11502	
<b>Scope of Works:</b>	Refurbishment survey to the kitchen ceiling prior to leak repairs with a management survey to the remainder of the property.	
<b>Requested By:</b>

## 1.0 Executive Summary

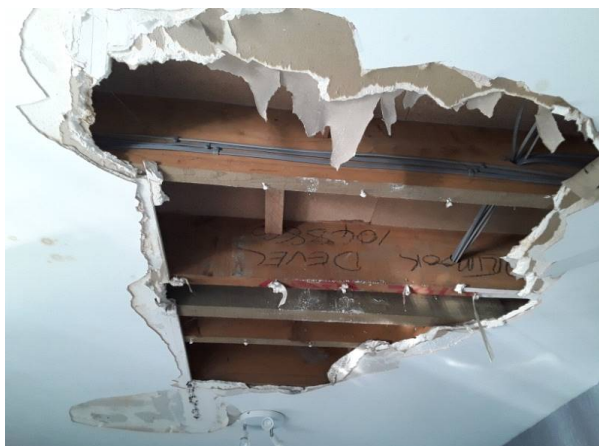
<b>Building:</b>	18 Brickham Road	<b>Floor Level:</b>	Ground	<b>Item Ref:</b>	<b>J309168-1</b>
<b>Room Name:</b>	(001) Kitchen				
<b>Sample Ref:</b>	FW008627				
<b>Component:</b>	Textured coating to plasterboard ceiling				
<b>Extent:</b>	18m <sup>2</sup>

Material Assessment		
<b>Product Type</b>	<b>Extent of damage</b>	<b>Surface Treatment Score</b>
<b>Asbestos Type</b>	<b>Material Assessment Score (MA)</b>	
No Asbestos Detected

Conclusions and Actions	
<b>Recommendation:</b>	No further action required
<b>Further Information:</b>	None
<b>General Notes:</b> Textured coating to plasterboard ceiling (behind layer of plaster). Hardboard ceiling above plasterboard ceiling. Metal pipes running in void area above plasterboard ceiling. Plaster to brick and plasterboard walls. Laminate panelling to floor - no access under laminate panelling (excessive damage). Wooden and plasterboard boxing adjacent to radiator - no access within boxing (excessive damage). No sink pad. uPVC windows and ceramic tile and uPVC over wooden sills. Wooden door to garden. Modern Vaillant boiler with plastic flue. Wooden panelling over metal pipework below and to the side of the boiler. Modern extract fan in wall. Modern radiator.

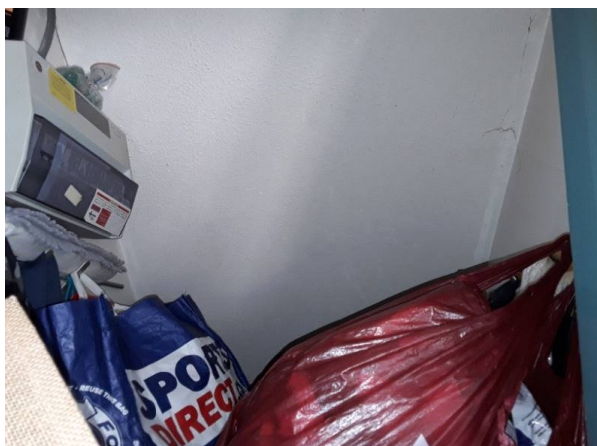
<b>Building:</b>	18 Brickham Road	<b>Floor Level:</b>	Ground	<b>Item Ref:</b>	<b>J309168-2</b>
<b>Room Name:</b>	(002) Cupboard				
<b>Sample Ref:</b>	As FW008628				
<b>Component:</b>	Textured coating to plasterboard underside to stairs				
<b>Extent:</b>	3m <sup>2</sup>

Material Assessment		
<b>Product Type</b>	<b>Extent of damage</b>	<b>Surface Treatment Score</b>
<b>Asbestos Type</b>	<b>Material Assessment Score (MA)</b>	
No asbestos detected in visually consistent material

Conclusions and Actions	
<b>Recommendation:</b>	No further action required
<b>Further Information:</b>	None
<b>General Notes:</b> Textured coating to plasterboard underside to stairs. Plaster to brick and plasterboard walls. Carpet to concrete floor. Modern electrics on wall.

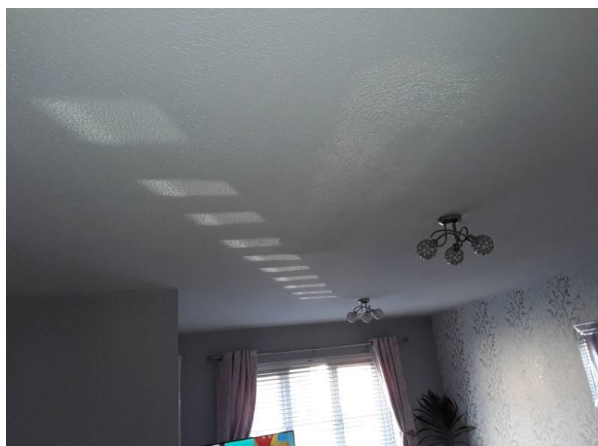
<b>Building:</b>	18 Brickham Road	<b>Floor Level:</b>	Ground	<b>Item Ref:</b>	<b>J309168-3</b>
<b>Room Name:</b>	(003) Lounge				
<b>Sample Ref:</b>	As FW008628				
<b>Component:</b>	Textured coating to plasterboard ceiling				
<b>Extent:</b>	20m <sup>2</sup>

Material Assessment		
<b>Product Type</b>	<b>Extent of damage</b>	<b>Surface Treatment Score</b>
<b>Asbestos Type</b>	<b>Material Assessment Score (MA)</b>	
No asbestos detected in visually consistent material

Conclusions and Actions	
<b>Recommendation:</b>	No further action required
<b>Further Information:</b>	None
<b>General Notes:</b> Textured coating to plasterboard ceiling. Plaster to brick and plasterboard walls. Laminate panelling to floor - no access under laminate panelling (excessive damage). uPVC window and uPVC over wooden sill. Modern radiator. Modern electric heater.

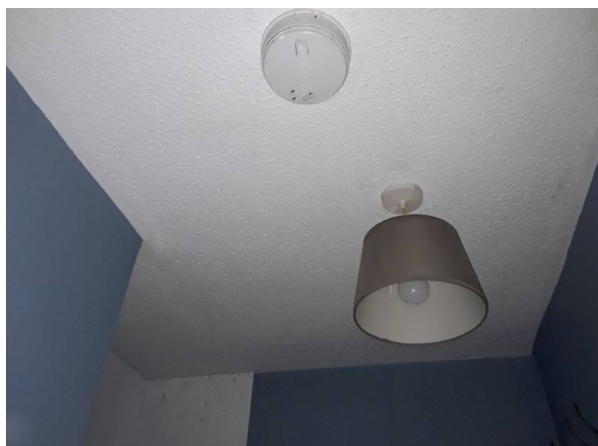
<b>Building:</b>	18 Brickham Road	<b>Floor Level:</b>	Ground	<b>Item Ref:</b>	<b>J309168-4</b>
<b>Room Name:</b>	(004) Hall				
<b>Sample Ref:</b>	FW008628				
<b>Component:</b>	Textured coating to plasterboard ceiling				
<b>Extent:</b>	3m <sup>2</sup>

Material Assessment		
<b>Product Type</b>	<b>Extent of damage</b>	<b>Surface Treatment Score</b>
<b>Asbestos Type</b>	<b>Material Assessment Score (MA)</b>	
No Asbestos Detected

Conclusions and Actions	
<b>Recommendation:</b>	No further action required
<b>Further Information:</b>	None
<b>General Notes:</b> Textured coating to plasterboard ceiling. Plaster to brick and plasterboard walls. Laminate panelling to floor - no access under laminate panelling (excessive damage). Carpet to wooden stairs. Wooden front door. Modern radiator.

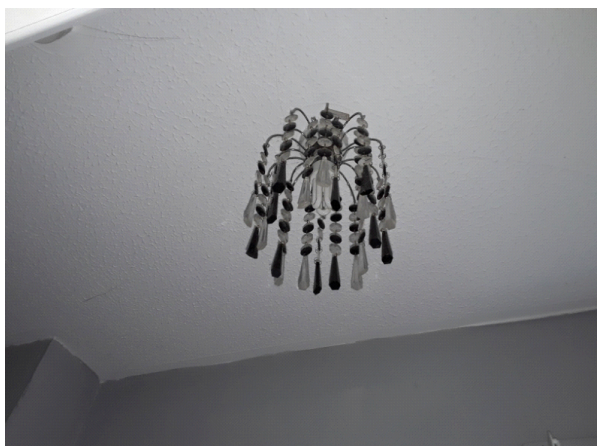
<b>Building:</b>	18 Brickham Road	<b>Floor Level:</b>	Ground	<b>Item Ref:</b>	<b>J309168-5</b>
<b>Room Name:</b>	(005) WC				
<b>Sample Ref:</b>	As FW008628				
<b>Component:</b>	Textured coating to plasterboard ceiling				
<b>Extent:</b>	2.5m <sup>2</sup>

Material Assessment		
<b>Product Type</b>	<b>Extent of damage</b>	<b>Surface Treatment Score</b>
<b>Asbestos Type</b>	<b>Material Assessment Score (MA)</b>	
No asbestos detected in visually consistent material

Conclusions and Actions	
<b>Recommendation:</b>	No further action required
<b>Further Information:</b>	None
<b>General Notes:</b> Textured coating to plasterboard ceiling. Plaster to brick and plasterboard walls. Laminate panelling to floor - no access under laminate panelling (excessive damage). Plasterboard boxing adjacent to toilet - no access within boxing (excessive damage). Wooden boxing under sink - no access within boxing (excessive damage). Ceramic cistern. uPVC window and wooden sill. Modern extract fan in wall. Modern radiator.

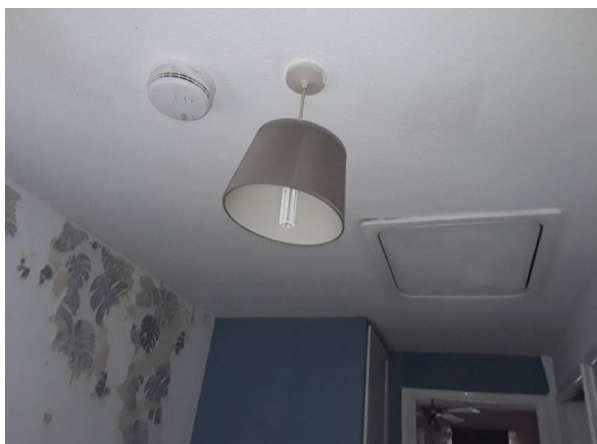
<b>Building:</b>	18 Brickham Road	<b>Floor Level:</b>	First	<b>Item Ref:</b>	<b>J309168-6</b>
<b>Room Name:</b>	(006) Landing				
<b>Sample Ref:</b>	FW008629				
<b>Component:</b>	Textured coating to plasterboard ceiling				
<b>Extent:</b>	7m <sup>2</sup>

Material Assessment		
<b>Product Type</b>	<b>Extent of damage</b>	<b>Surface Treatment Score</b>
<b>Asbestos Type</b>	<b>Material Assessment Score (MA)</b>	
No Asbestos Detected

Conclusions and Actions	
<b>Recommendation:</b>	No further action required
<b>Further Information:</b>	None
<b>General Notes:</b> Textured coating to plasterboard ceiling. Plaster to brick and plasterboard walls. Carpet to hardboard floor and wooden stairs. uPVC window and wooden sill. Plastic loft hatch access panel.

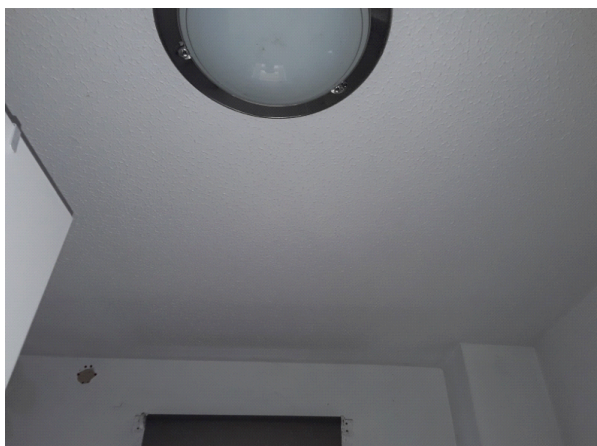
<b>Building:</b>	18 Brickham Road	<b>Floor Level:</b>	First	<b>Item Ref:</b>	<b>J309168-7</b>
<b>Room Name:</b>	(007) Bathroom				
<b>Sample Ref:</b>	As FW008629				
<b>Component:</b>	Textured coating to plasterboard ceiling				
<b>Extent:</b>	6m <sup>2</sup>

Material Assessment		
<b>Product Type</b>	<b>Extent of damage</b>	<b>Surface Treatment Score</b>
<b>Asbestos Type</b>	<b>Material Assessment Score (MA)</b>	
No asbestos detected in visually consistent material

Conclusions and Actions	
<b>Recommendation:</b>	No further action required
<b>Further Information:</b>	None
<b>General Notes:</b> Textured coating to plasterboard ceiling. Plaster to brick and plasterboard walls. Modern linoleum to hardboard floor. Plasterboard boxing adjacent to toilet - no access within boxing (excessive damage). No bath panel. Plastic and metal pipes in void area under bath. Ceramic cistern. uPVC window and ceramic tile sill. Modern extract fan in wall. Modern radiator.

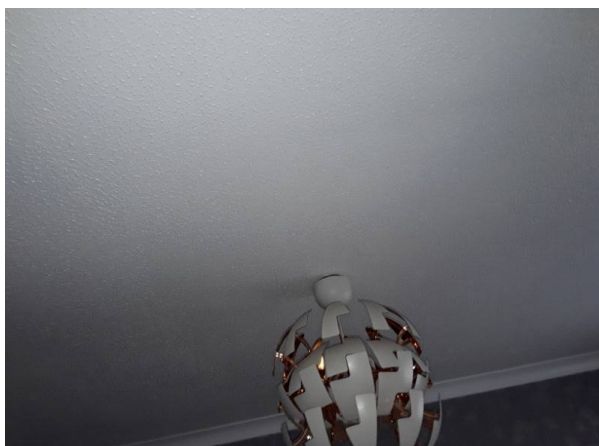
<b>Building:</b>	18 Brickham Road	<b>Floor Level:</b>	First	<b>Item Ref:</b>	<b>J309168-8</b>
<b>Room Name:</b>	(008) Bedroom				
<b>Sample Ref:</b>	As FW008629				
<b>Component:</b>	Textured coating to plasterboard ceiling				
<b>Extent:</b>	12m <sup>2</sup>

Material Assessment		
<b>Product Type</b>	<b>Extent of damage</b>	<b>Surface Treatment Score</b>
<b>Asbestos Type</b>	<b>Material Assessment Score (MA)</b>	
No asbestos detected in visually consistent material

Conclusions and Actions	
<b>Recommendation:</b>	No further action required
<b>Further Information:</b>	None
<b>General Notes:</b> Textured coating to plasterboard ceiling. Plaster to brick and plasterboard walls. Laminate panelling to hardboard floor. uPVC window and wooden sill. Modern radiator.

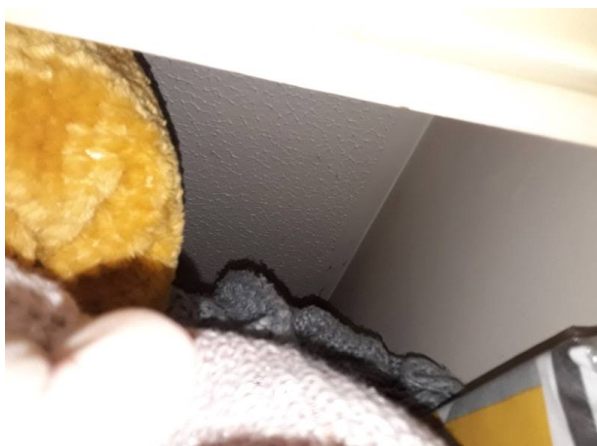
<b>Building:</b>	18 Brickham Road	<b>Floor Level:</b>	First	<b>Item Ref:</b>	<b>J309168-9</b>
<b>Room Name:</b>	(009) Cupboard				
<b>Sample Ref:</b>	As FW008629				
<b>Component:</b>	Textured coating to plasterboard ceiling				
<b>Extent:</b>	1.5m <sup>2</sup>

Material Assessment		
<b>Product Type</b>	<b>Extent of damage</b>	<b>Surface Treatment Score</b>
<b>Asbestos Type</b>	<b>Material Assessment Score (MA)</b>	
No asbestos detected in visually consistent material

Conclusions and Actions	
<b>Recommendation:</b>	No further action required
<b>Further Information:</b>	None
<b>General Notes:</b> Textured coating to plasterboard ceiling. Plasterboard walls. Hardboard floor. Modern immersion heater.

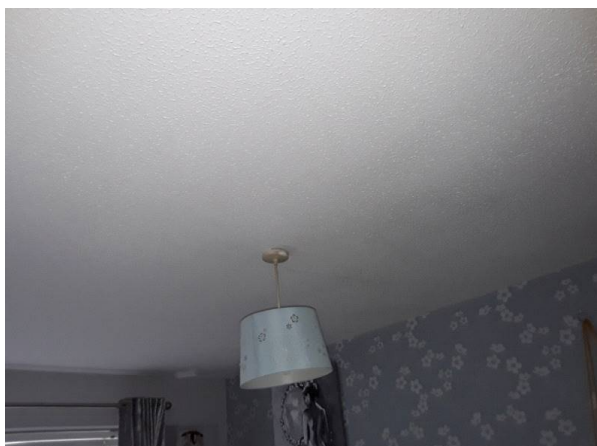
<b>Building:</b>	18 Brickham Road	<b>Floor Level:</b>	First	<b>Item Ref:</b>	<b>J309168-10</b>
<b>Room Name:</b>	(010) Bedroom				
<b>Sample Ref:</b>	FW008630				
<b>Component:</b>	Textured coating to plasterboard ceiling				
<b>Extent:</b>	12m <sup>2</sup>

Material Assessment		
<b>Product Type</b>	<b>Extent of damage</b>	<b>Surface Treatment Score</b>
<b>Asbestos Type</b>	<b>Material Assessment Score (MA)</b>	
No Asbestos Detected

Conclusions and Actions	
<b>Recommendation:</b>	No further action required
<b>Further Information:</b>	None
<b>General Notes:</b> Textured coating to plasterboard ceiling. Plaster to brick and plasterboard walls. Laminate panelling to hardboard floor. uPVC window and wooden sill. Modern radiator.

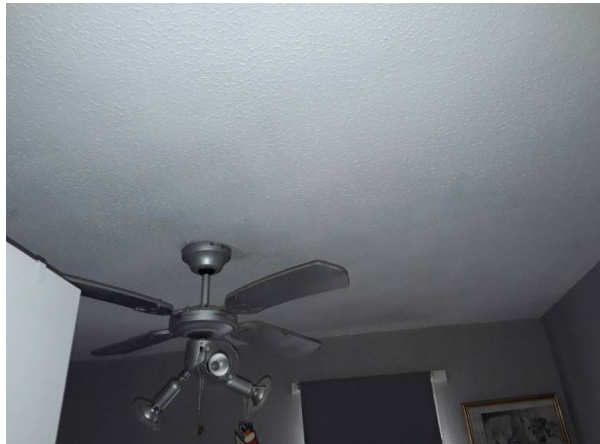
<b>Building:</b>	18 Brickham Road	<b>Floor Level:</b>	First	<b>Item Ref:</b>	<b>J309168-11</b>
<b>Room Name:</b>	(011) Bedroom				
<b>Sample Ref:</b>	As FW008630				
<b>Component:</b>	Textured coating to plasterboard ceiling				
<b>Extent:</b>	8m <sup>2</sup>

Material Assessment		
<b>Product Type</b>	<b>Extent of damage</b>	<b>Surface Treatment Score</b>
<b>Asbestos Type</b>	<b>Material Assessment Score (MA)</b>	
No asbestos detected in visually consistent material

Conclusions and Actions	
<b>Recommendation:</b>	No further action required
<b>Further Information:</b>	None
<b>General Notes:</b> Textured coating to plasterboard ceiling. Plaster to brick and plasterboard walls. Carpet to hardboard floor. uPVC window and wooden sill. Modern radiator.

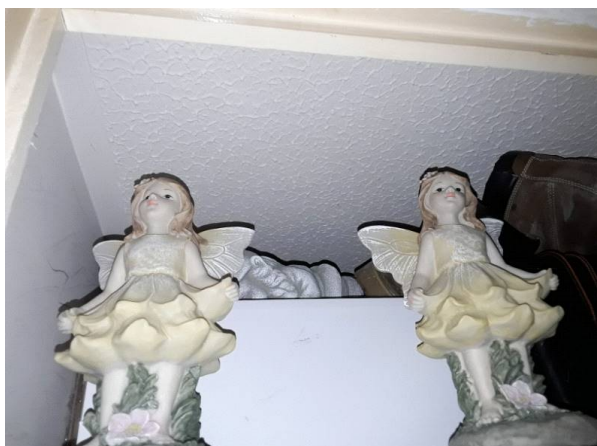
<b>Building:</b>	18 Brickham Road	<b>Floor Level:</b>	First	<b>Item Ref:</b>	<b>J309168-12</b>
<b>Room Name:</b>	(012) Cupboard				
<b>Sample Ref:</b>	As FW008630				
<b>Component:</b>	Textured coating to plasterboard ceiling				
<b>Extent:</b>	2m <sup>2</sup>

Material Assessment		
<b>Product Type</b>	<b>Extent of damage</b>	<b>Surface Treatment Score</b>
<b>Asbestos Type</b>	<b>Material Assessment Score (MA)</b>	
No asbestos detected in visually consistent material

Conclusions and Actions	
<b>Recommendation:</b>	No further action required
<b>Further Information:</b>	None
<b>General Notes:</b> Textured coating to plasterboard ceiling. Plaster to brick and plasterboard walls. Hardboard floor

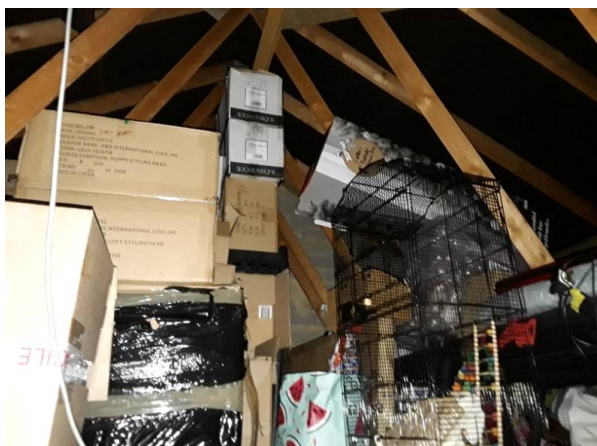
<b>Building:</b>	18 Brickham Road	<b>Floor Level:</b>	Roof Void	<b>Item Ref:</b>	J309168-15
<b>Room Name:</b>	(013) Loft				
<b>Sample Ref:</b>					
<b>Component:</b>	No asbestos containing materials found				
<b>Extent:</b>

Material Assessment		
<b>Product Type</b>	<b>Extent of damage</b>	<b>Surface Treatment Score</b>
<b>Asbestos Type</b>	<b>Material Assessment Score (MA)</b>	
No suspect materials

Conclusions and Actions	
<b>Recommendation:</b>	No further action required
<b>Further Information:</b>	None
<b>General Notes:</b> Limited access due to tenants belongings. Modern sarking felt. Breeze block walls. Plasterboard floor panels. MMMF insulation. Plastic loft hatch access panel.

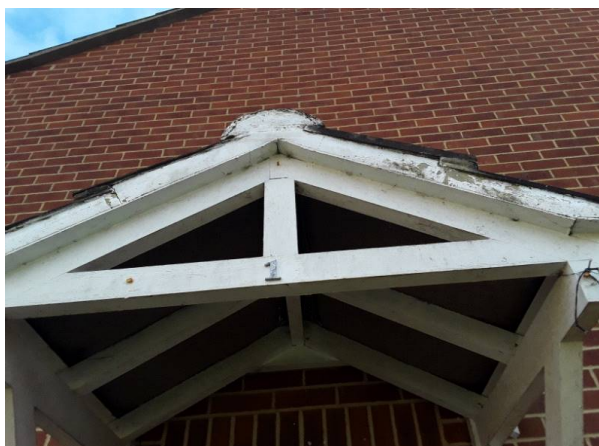
Site Address: 18 Brickham Road, Devizes, Wiltshire	Ref No. J309168	Date Of Issue 13/02/2023
	Page 14 of 15

Material Assessment		
<b>Product Type</b>	<b>Extent of damage</b>	<b>Surface Treatment Score</b>
Cement (1)	Low Damage (1)	1
<b>Asbestos Type</b>	<b>Material Assessment Score (MA)</b>	<b>Very Low (4)</b>
Chrysotile (1)

Priority Assessment		
<b>Occupant Activity</b>	<b>Location Score</b>	<b>Accessibility Score</b>
0 (Rare disturbance)	0	0
<b>Extent Score</b>	<b>No. of occupants</b>	<b>Frequency of Use</b>
2 (10m^2 - 50m^2 or 10m - 50m pipe run)	2 (4 to 10)	3 (Daily)
<b>Avg. time area is in use</b>	<b>Type of Maintenance</b>	<b>Freq. of Maintenance</b>
0 (<1 hour)	0 (Minor disturbance)	1 (<1 per year)
<b>Priority Assessment Score (PA)</b>		<b>4</b>

Conclusions and Actions	
<b>Recommendation:</b>	Manage and Inspect
<b>Further Information:</b>	None
<b>General Notes:</b> Modern roof tiles. Wooden soffits and fascia. Plastic drainpipes and guttering. Cement board undercloak to roof and entrance canopy. uPVC windows. Wooden front and rear doors. Modern roof tiles and sarking felt to entrance canopy. Modern damp proof course.
