An Asbestos Management with part Refurbishment Survey (MA & PA) at
2 Gainsborough Way
Freshbrook
Swindon
Wiltshire
SN5 8PZ

| Survey Conducted: | 19 August 2019 | |
| Our Reference: | J173384 | |
| Scope of Works: | Refurbishment survey to the bathroom with management to the remainder of the property. | |

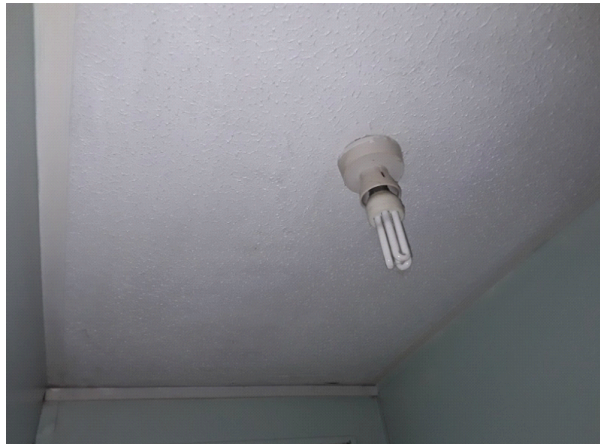
| Sample Ref: | FW001131 (Sample 3) | | | | |

| Component: | Textured coating to plasterboard ceiling | | | | |

| Material Assessment | | |
|---|---|---|
| Textured Coating (1) | Low Damage (1) | 1 |

| Conclusions and Actions | |
|--|---|
| Recommendation: | Manage and Inspect |

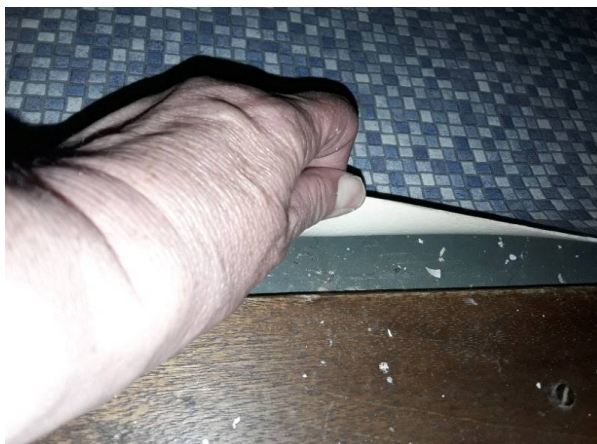
| Sample Ref: | FW001132 (Sample 4) | | | | |

| Component: | Bitumen backed green floor tiles to concrete floor (under modern linoleum) | | | | |

| Conclusions and Actions | |
|--|---|
| Recommendation: | No further action required |

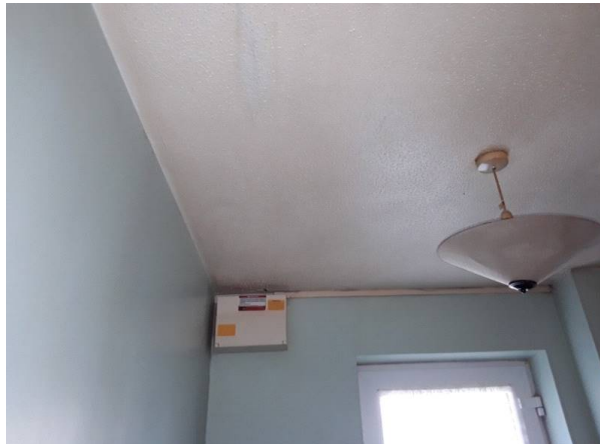
| Sample Ref: | As FW001131 (Ref Sample 3) | | | | |

| Component: | Textured coating to plasterboard ceiling | | | | |

| Material Assessment | | |
|---|---|---|
| Textured Coating (1) | Low Damage (1) | 1 |

| Conclusions and Actions | |
|---|---|
| Recommendation: | Manage and Inspect |

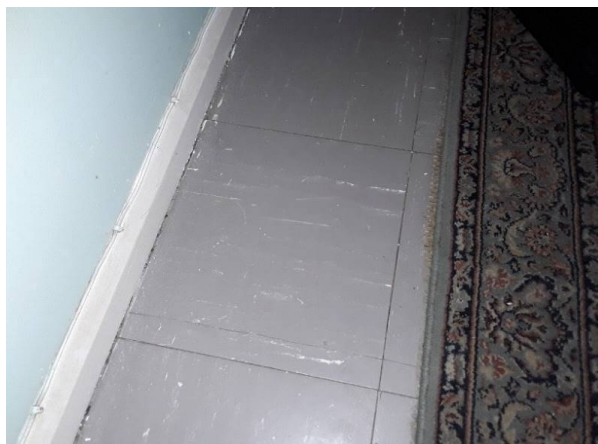
| Sample Ref: | FW001133 (Sample 5) | | | | |

| Component: | Bitumen backed grey floor tiles to concrete floor | | | | |

| Conclusions and Actions | |
|---|---|
| Recommendation: | No further action required |

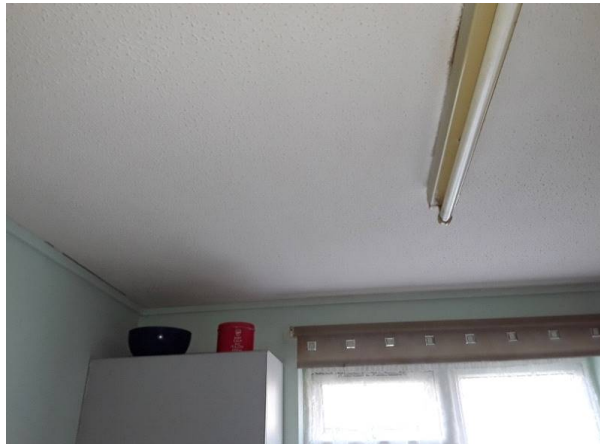
| Sample Ref: | As FW001131 (Ref Sample 3) | | | | |

| Component: | Textured coating to plasterboard ceiling | | | | |

| Material Assessment | | |
|---|---|---|
| Textured Coating (1) | Low Damage (1) | 1 |

| Conclusions and Actions | |
|--|---|
| Recommendation: | Manage and Inspect |

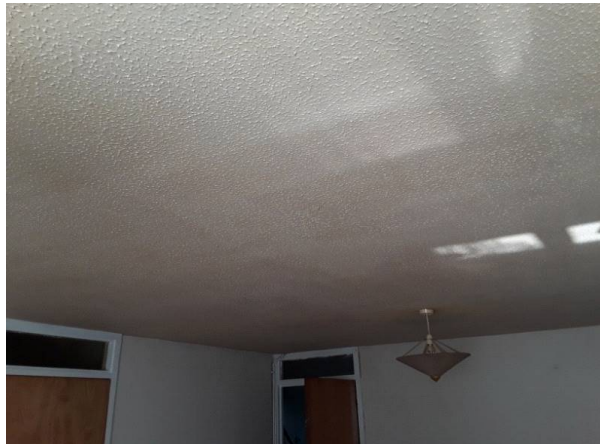
| Sample Ref: | As FW001131 (Ref Sample 3) | | | | |

| Component: | Textured coating to plasterboard ceiling | | | | |

| Material Assessment | | |
|---|---|---|
| Textured Coating (1) | Low Damage (1) | 1 |

| Conclusions and Actions | |
|---|---|
| Recommendation: | Manage and Inspect |

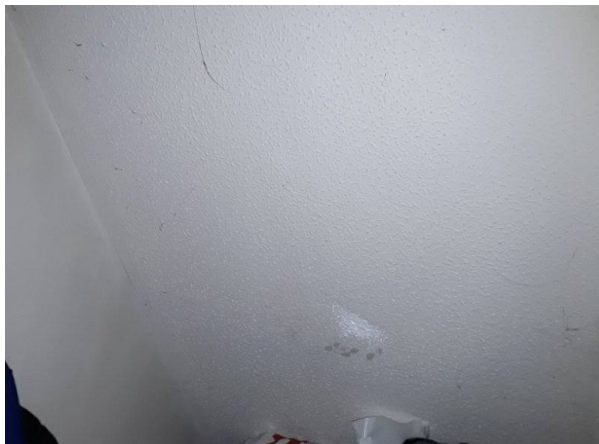
| Sample Ref: | FW001134 (Sample 6) | | | | |

| Component: | Textured coating to plasterboard ceiling | | | | |

| Material Assessment | | |
|---|---|---|
| Textured Coating (1) | Low Damage (1) | 1 |

| Conclusions and Actions | |
|---|---|
| Recommendation: | Manage and Inspect |

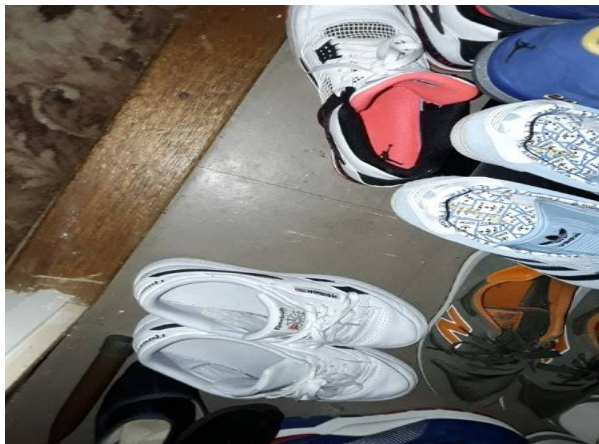
| Sample Ref: | As FW001133 (Ref Sample 5) | | | | |

| Component: | Bitumen backed grey floor tiles to concrete floor | | | | |

| Conclusions and Actions | |
|---|---|
| Recommendation: | No further action required |

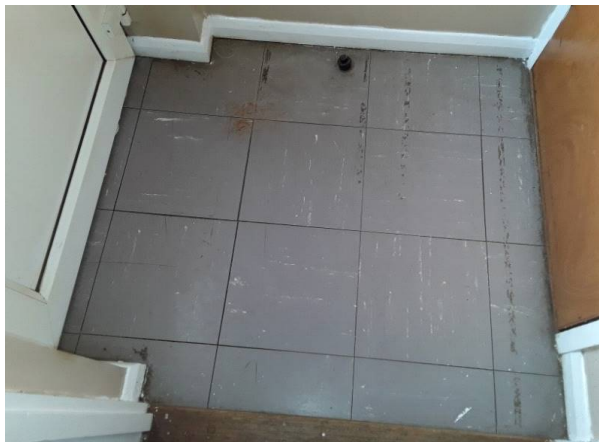
| Sample Ref: | As FW001133 (Ref Sample 5) | | | | |

| Component: | Bitumen backed grey floor tiles to concrete floor | | | | |

| Conclusions and Actions | |
|---|---|
| Recommendation: | No further action required |

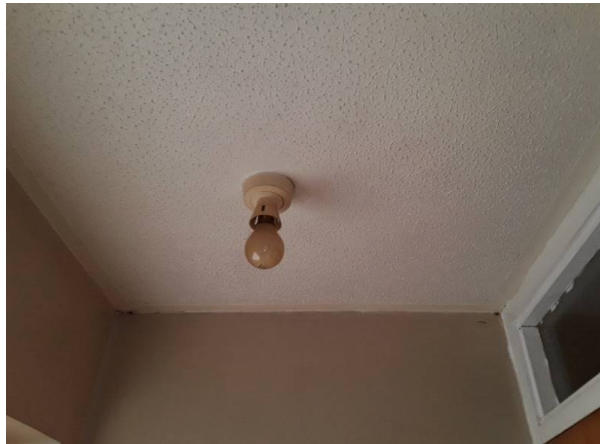
| Sample Ref: | As FW001134 (Ref Sample 6) | | | | |

| Component: | Textured coating to plasterboard ceiling | | | | |

| Material Assessment | | |
|---|---|---|
| Textured Coating (1) | Low Damage (1) | 1 |

| Conclusions and Actions | |
|---|---|
| Recommendation: | Manage and Inspect |

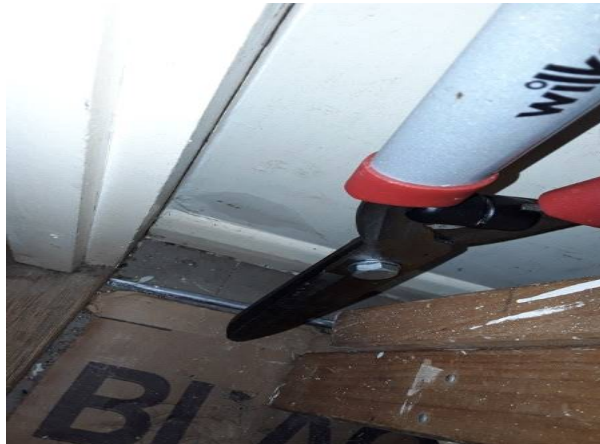
| Sample Ref: | As FW001133 (Ref Sample 5) | | | | |

| Component: | Bitumen backed grey floor tiles to concrete floor | | | | |

| Conclusions and Actions | |
|--|---|
| Recommendation: | No further action required |

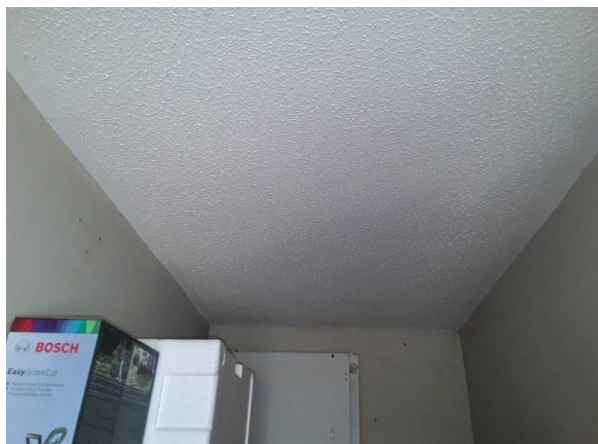
| Sample Ref: | As FW001134 (Ref Sample 6) | | | | |

| Component: | Textured coating to plasterboard ceiling | | | | |

| Material Assessment | | |
|---|---|---|
| Textured Coating (1) | Low Damage (1) | 1 |

| Conclusions and Actions | |
|--|---|
| Recommendation: | Manage and Inspect |

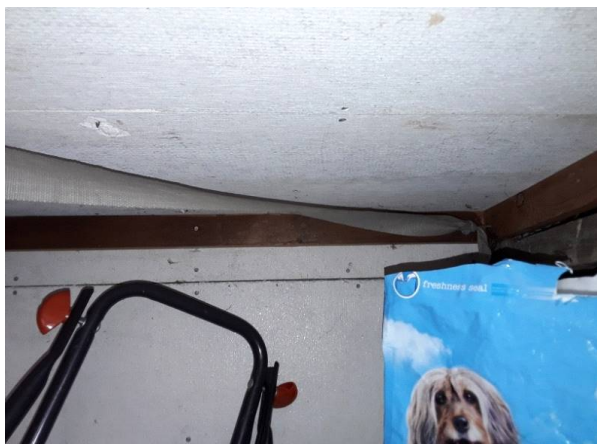
| Sample Ref: | FW001135 (Sample 7) | | | | |

| Component: | Insulation board wall and ceiling panels | | | | |

| Conclusions and Actions | |
|--|---|
| Recommendation: | No further action required |

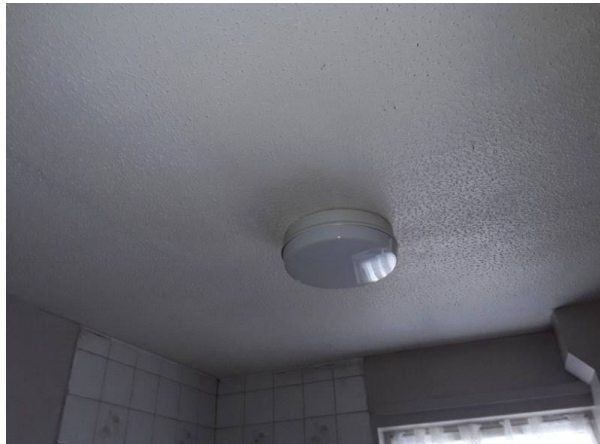
| Sample Ref: | FW001129 (Sample 1) | | | | |

| Component: | Textured coating to plasterboard ceiling | | | | |

| Material Assessment | | |
|---|---|---|
| Textured Coating (1) | Low Damage (1) | 1 |

| Conclusions and Actions | |
|--|---|
| Recommendation: | Remediate in-line with refurb scope |

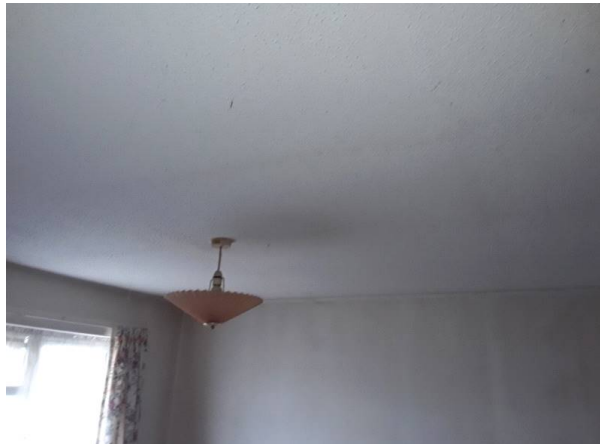
| Sample Ref: | As FW001129 (Ref Sample 1) | | | | |

| Component: | Textured coating to plasterboard ceiling | | | | |

| Material Assessment | | |
|---|---|---|
| Textured Coating (1) | Low Damage (1) | 1 |

| Conclusions and Actions | |
|---|---|
| Recommendation: | Manage and Inspect |

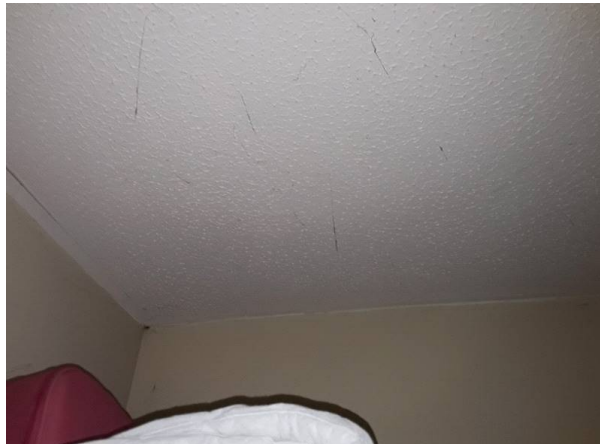
| Sample Ref: | As FW001129 (Ref Sample 1) | | | | |

| Component: | Textured coating to plasterboard ceiling | | | | |

| Material Assessment | | |
|---|---|---|
| Textured Coating (1) | Low Damage (1) | 1 |

| Conclusions and Actions | |
|---|---|
| Recommendation: | Manage and Inspect |

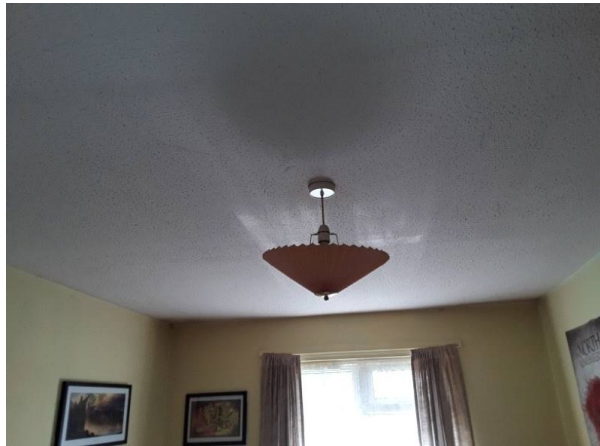
| Sample Ref: | As FW001129 (Ref Sample 1) | | | | |

| Component: | Textured coating to plasterboard ceiling | | | | |

| Material Assessment | | |
|---|---|---|
| Textured Coating (1) | Low Damage (1) | 1 |

| Conclusions and Actions | |
|---|---|
| Recommendation: | Manage and Inspect |

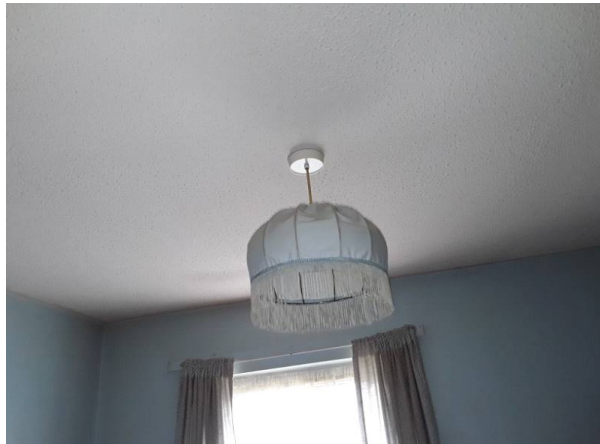
| Sample Ref: | As FW001130 (Ref Sample 2) | | | | |

| Component: | Textured coating to plasterboard ceiling | | | | |

| Material Assessment | | |
|---|---|---|
| Textured Coating (1) | Low Damage (1) | 1 |

| Conclusions and Actions | |
|---|---|
| Recommendation: | Manage and Inspect |

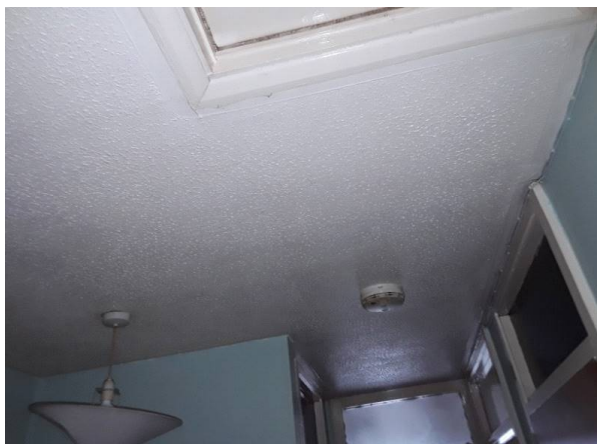
| Sample Ref: | FW001130 (Sample 2) | | | | |

| Component: | Textured coating to plasterboard ceiling | | | | |

| Material Assessment | | |
|---|---|---|
| Textured Coating (1) | Low Damage (1) | 1 |

| Conclusions and Actions | |
|--|---|
| Recommendation: | Manage and Inspect |

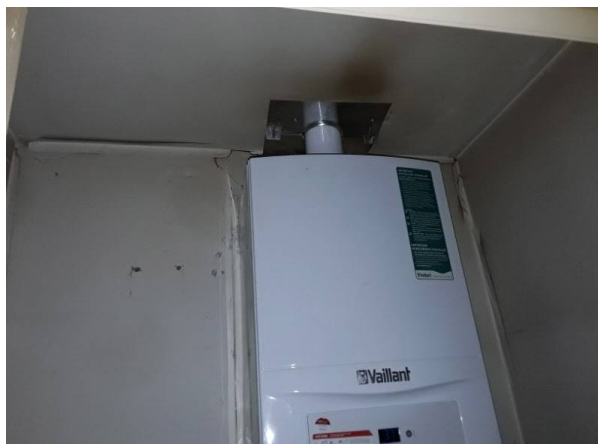
| Component: | No asbestos containing materials found | | | | |

| Conclusions and Actions | |
|---|---|
| Recommendation: | No further action required |

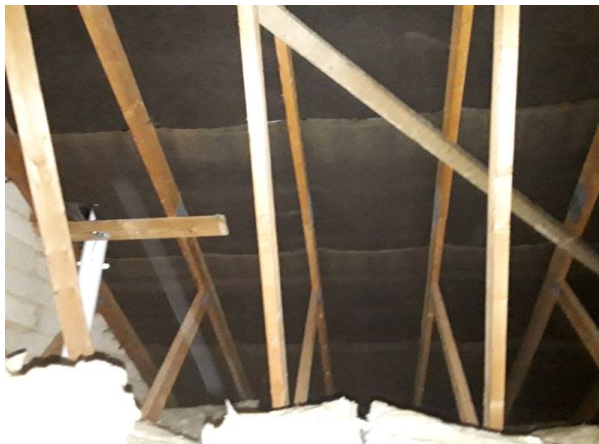
| Component: | No asbestos containing materials found | | | | |

| Conclusions and Actions | |
|---|---|
| Recommendation: | No further action required |

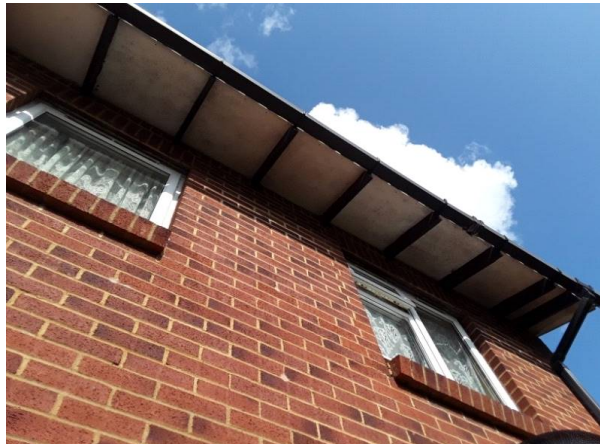
| Sample Ref: | Presumed (Visual 1) | | | | |

| Location (Plan room references in brackets) | Result (asbestos type) | Action | Sample Ref |
|---|---|---|---|
| 2 Gainsborough Way External (017) External Insulation board soffits | Crocidolite | Manage and Inspect | Presumed (Visual 1) |

| Component: | Insulation board soffits | | | | |

| Material Assessment | | |
|---|---|---|
| Board (2) | Low Damage (1) | 1 |

| Conclusions and Actions | |
|---|---|
| Recommendation: | Manage and Inspect |

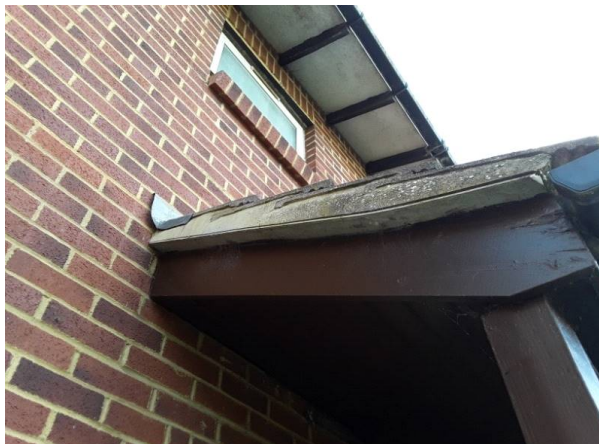
| Sample Ref: | FW001136 (Sample 8) | | | | |

| Component: | Cement board undercloak to roof and entrance canopy | | | | |

| Conclusions and Actions | |
|---|---|
| Recommendation: | No further action required |
