**An Asbestos Management with part Refurbishment Survey (MA & PA) at
4 Wilmot Close, The Prinnels, Swindon, Wiltshire
SN5 6NN**

Survey Conducted:	28 January 2021	
Date of approval:	1 Feb 2021	
Our Reference:	J224341	
Surveyed By:	Fiona Williamson	
UPRN:	217875	
Scope of Works:	Refurbishment survey to the living room ceiling with a management survey to the remainder of the property.	
Requested By:

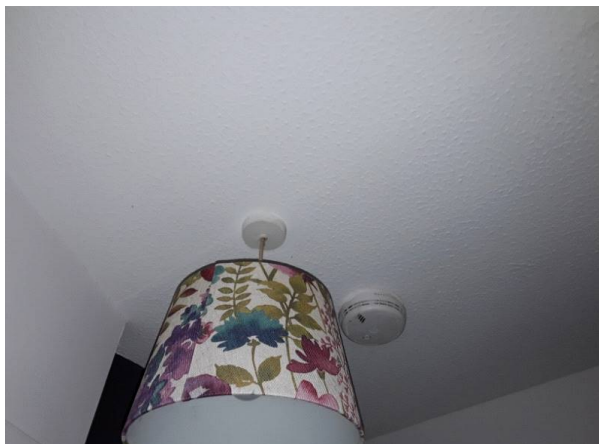
Building:	4 Wilmot Close	Floor Level:	Ground	Item Ref:	J224341-1
Room Name:	(001) Hall				
Sample Ref:	FW004262 (Sample 1)				
Component:	Textured coating to plasterboard ceiling

Material Assessment		
Product Type	Extent of damage	Surface Treatment Score
Asbestos Type	Material Assessment Score (MA)	
No Asbestos Detected

Conclusions and Actions	
Recommendation:	No further action required
Further Information:	None
General Notes: Textured coating to plasterboard ceiling. Plaster to brick and plasterboard walls. Carpet to concrete floor and wooden stairs. uPVC front door. Modern electrics. Wooden panelling over metal pipework adjacent to radiator. Modern radiator.

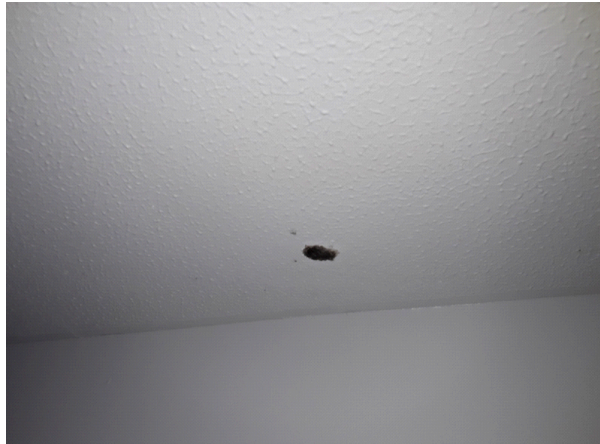
Building:	4 Wilmot Close	Floor Level:	Ground	Item Ref:	J224341-2
Room Name:	(002) Lounge				
Sample Ref:	As FW004262 (Ref Sample 1)				
Component:	Textured coating to plasterboard ceiling

Material Assessment		
Product Type	Extent of damage	Surface Treatment Score
Asbestos Type	Material Assessment Score (MA)	
No asbestos detected in visually consistent material

Conclusions and Actions	
Recommendation:	No further action required
Further Information:	None
General Notes: Textured coating to plasterboard ceiling. Plaster to brick and plasterboard walls. Carpet to concrete floor. uPVC window and wooden sill. Modern radiator.

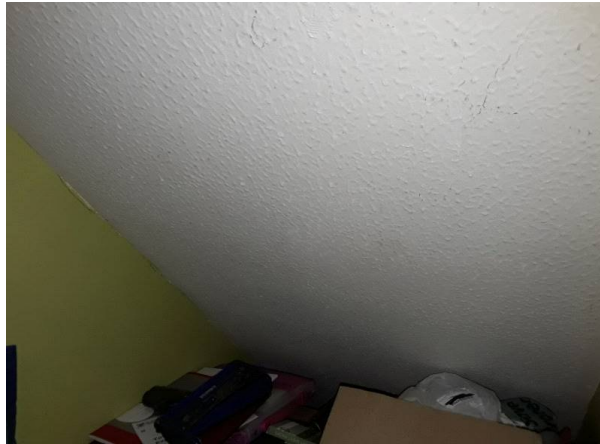
Building:	4 Wilmot Close	Floor Level:	Ground	Item Ref:	J224341-3
Room Name:	(003) Understairs Cupboard				
Sample Ref:	As FW004262 (Ref Sample 1)				
Component:	Textured coating to plasterboard underside to stairs

Material Assessment		
Product Type	Extent of damage	Surface Treatment Score
Asbestos Type	Material Assessment Score (MA)	
No asbestos detected in visually consistent material

Conclusions and Actions	
Recommendation:	No further action required
Further Information:	None
General Notes: Textured coating to plasterboard underside to stairs. Plasterboard walls. Carpet to concrete floor.

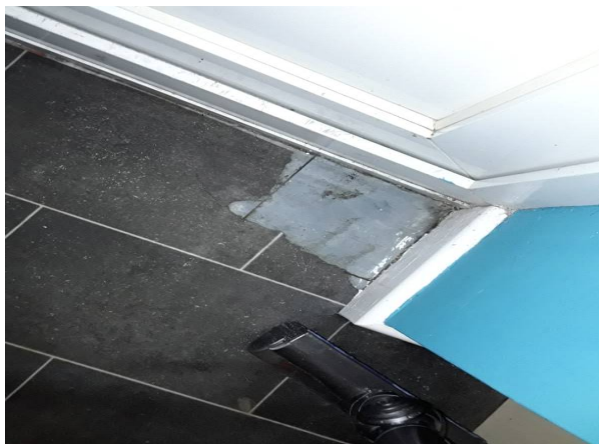
Building:	4 Wilmot Close	Floor Level:	Ground	Item Ref:	J224341-4
Room Name:	(004) Kitchen				
Sample Ref:	FW004263 (Sample 2)				
Component:	Blue found tiles to concrete floor (under modern linoleum)

Material Assessment		
Product Type	Extent of damage	Surface Treatment Score
Asbestos Type	Material Assessment Score (MA)	
No Asbestos Detected

Conclusions and Actions	
Recommendation:	No further action required
Further Information:	None
General Notes: Textured coating to plasterboard ceiling. Plaster to brick and plasterboard walls. Blue floor tiles to concrete floor (under modern linoleum). Plasterboard boxing adjacent to window - no access within boxing (excessive damage). Modern sink pad. uPVC window and sill. uPVC door to garden. Modern radiator.

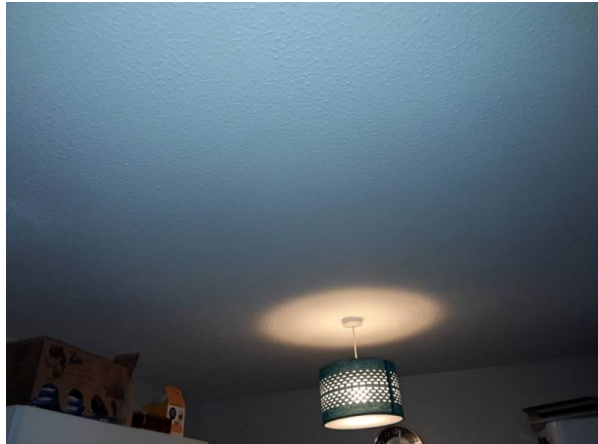
Building:	4 Wilmot Close	Floor Level:	Ground	Item Ref:	J224341-5
Room Name:	(004) Kitchen				
Sample Ref:	As FW004262 (Ref Sample 1)				
Component:	Textured coating to plasterboard ceiling

Material Assessment		
Product Type	Extent of damage	Surface Treatment Score
Asbestos Type	Material Assessment Score (MA)	
No asbestos detected in visually consistent material

Conclusions and Actions	
Recommendation:	No further action required
Further Information:	None
General Notes: Textured coating to plasterboard ceiling. Plaster to brick and plasterboard walls. Blue floor tiles to concrete floor (under modern linoleum). Plasterboard boxing adjacent to window - no access within boxing (excessive damage). Modern sink pad. uPVC window and sill. uPVC door to garden. Modern radiator.

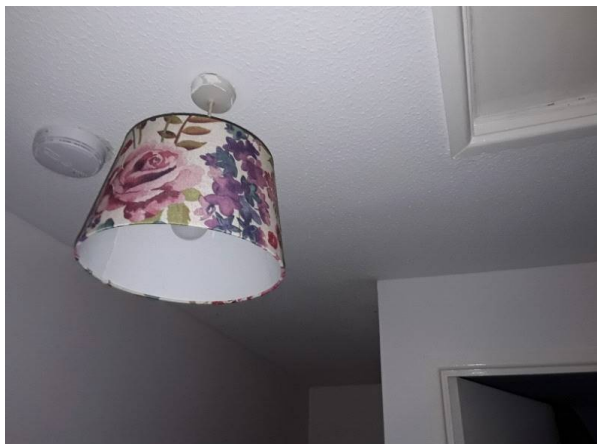
Building:	4 Wilmot Close	Floor Level:	First	Item Ref:	J224341-6
Room Name:	(005) Landing				
Sample Ref:	FW004264 (Sample 3)				
Component:	Textured coating to plasterboard ceiling

Material Assessment		
Product Type	Extent of damage	Surface Treatment Score
Asbestos Type	Material Assessment Score (MA)	
No Asbestos Detected

Conclusions and Actions	
Recommendation:	No further action required
Further Information:	None
General Notes: Textured coating to plasterboard ceiling. Plaster to brick and plasterboard walls. Carpet to hardboard floor and wooden stairs. Wooden loft hatch access panel.

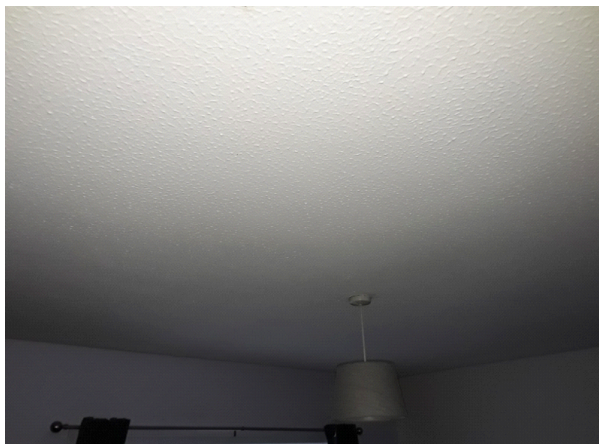
Building:	4 Wilmot Close	Floor Level:	First	Item Ref:	J224341-7
Room Name:	(006) Bedroom				
Sample Ref:	As FW004264 (Ref Sample 3)				
Component:	Textured coating to plasterboard ceiling

Material Assessment		
Product Type	Extent of damage	Surface Treatment Score
Asbestos Type	Material Assessment Score (MA)	
No asbestos detected in visually consistent material

Conclusions and Actions	
Recommendation:	No further action required
Further Information:	None
General Notes: Textured coating to plasterboard ceiling. Plaster to brick and plasterboard walls. Carpet to hardboard floor. uPVC window and wooden sill. Modern radiator.

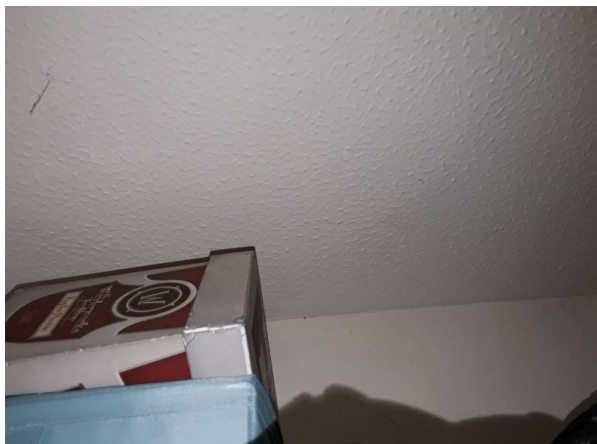
Building:	4 Wilmot Close	Floor Level:	First	Item Ref:	J224341-8
Room Name:	(007) Cupboard				
Sample Ref:	As FW004264 (Ref Sample 3)				
Component:	Textured coating to plasterboard ceiling

Material Assessment		
Product Type	Extent of damage	Surface Treatment Score
Asbestos Type	Material Assessment Score (MA)	
No asbestos detected in visually consistent material

Conclusions and Actions	
Recommendation:	No further action required
Further Information:	None
General Notes: Textured coating to plasterboard ceiling. Plaster to brick and plasterboard walls. Carpet to hardboard floor.

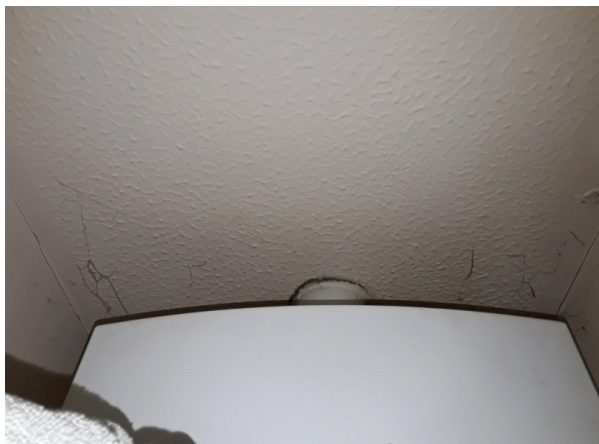
Building:	4 Wilmot Close	Floor Level:	First	Item Ref:	J224341-9
Room Name:	(008) Cupboard				
Sample Ref:	As FW004264 (Ref Sample 3)				
Component:	Textured coating to plasterboard ceiling

Material Assessment		
Product Type	Extent of damage	Surface Treatment Score
Asbestos Type	Material Assessment Score (MA)	
No asbestos detected in visually consistent material

Conclusions and Actions	
Recommendation:	No further action required
Further Information:	None
General Notes: Textured coating to plasterboard ceiling. Plaster to brick and plasterboard walls. Hardboard floor. Modern Worcester boiler with metal flue. Modern immersion heater.

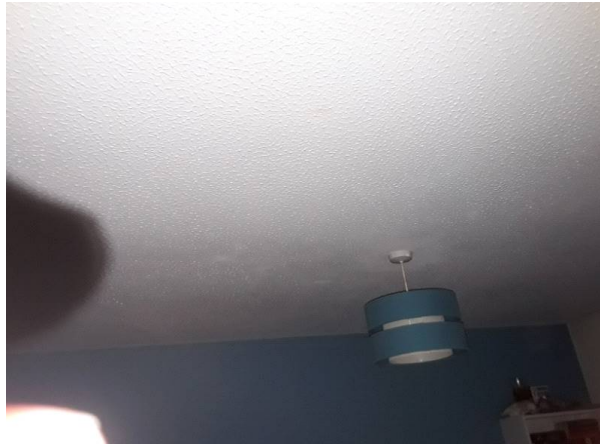
Building:	4 Wilmot Close	Floor Level:	First	Item Ref:	J224341-10
Room Name:	(009) Bedroom				
Sample Ref:	As FW004264 (Ref Sample 3)				
Component:	Textured coating to plasterboard ceiling

Material Assessment		
Product Type	Extent of damage	Surface Treatment Score
Asbestos Type	Material Assessment Score (MA)	
No asbestos detected in visually consistent material

Conclusions and Actions	
Recommendation:	No further action required
Further Information:	None
General Notes: Textured coating to plasterboard ceiling. Plaster to brick and plasterboard walls. Carpet to hardboard floor. uPVC window and wooden sill.

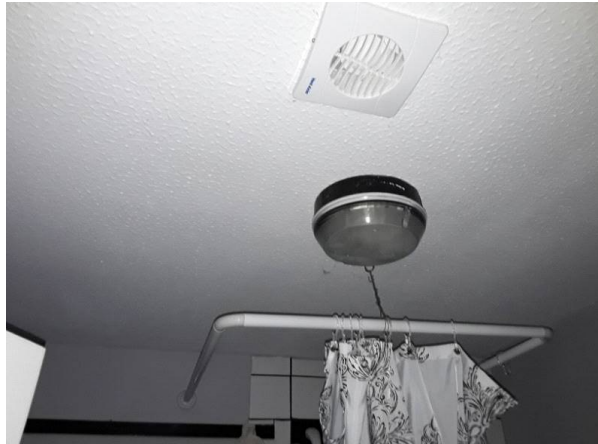
Building:	4 Wilmot Close	Floor Level:	First	Item Ref:	J224341-11
Room Name:	(010) Bathroom				
Sample Ref:	FW004265 (Sample 4)				
Component:	Textured coating to plasterboard ceiling

Material Assessment		
Product Type	Extent of damage	Surface Treatment Score
Asbestos Type	Material Assessment Score (MA)	
No Asbestos Detected

Conclusions and Actions	
Recommendation:	No further action required
Further Information:	None
General Notes: Textured coating to plasterboard ceiling. Plaster to brick and plasterboard walls. Modern linoleum to hardboard floor. Ceramic tiled boxing to bath - no access behind ceramic tiles (excessive damage). Plastic bath panel - no access behind bath panel (excessive damage). uPVC window and wooden sill. Modern extract fan in ceiling. Modern radiator.

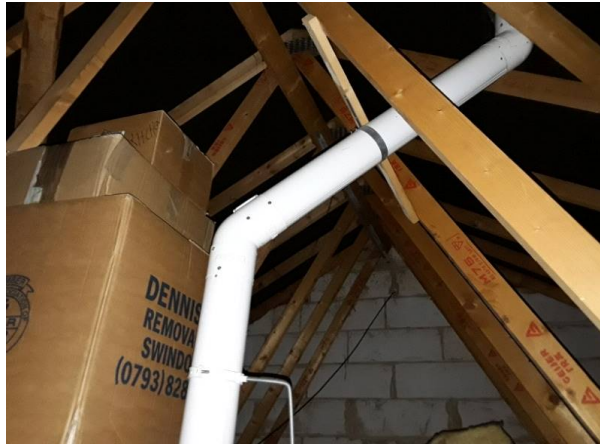
Building:	4 Wilmot Close	Floor Level:	Roof Void	Item Ref:	J224341-12
Room Name:	(011) Loft				
Sample Ref:					
Component:	No asbestos containing materials found

Material Assessment		
Product Type	Extent of damage	Surface Treatment Score
Asbestos Type	Material Assessment Score (MA)	
No suspect materials

Conclusions and Actions	
Recommendation:	No further action required
Further Information:	None
General Notes: Modern sarking felt. Breeze block walls. Plasterboard floor panels. MMMF insulation. Metal flue from boiler. Plastic soil pipe. Wooden loft doors access panel.

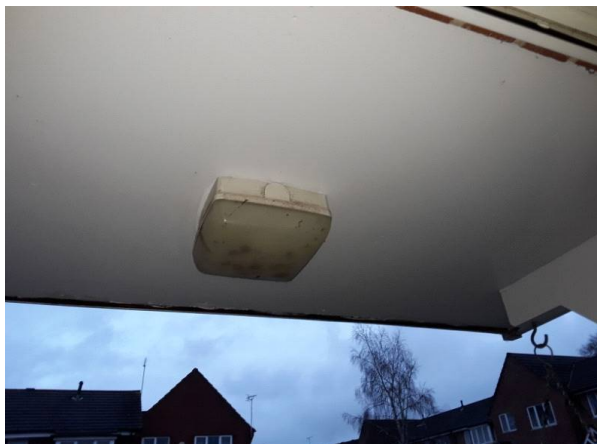
Building:	4 Wilmot Close	Floor Level:	External	Item Ref:	J224341-13
Room Name:	(012) External				
Sample Ref:	FW004266 (Sample 5)				
Component:	Insulation board ceiling panel to entrance canopy

Material Assessment		
Product Type	Extent of damage	Surface Treatment Score
Asbestos Type	Material Assessment Score (MA)	
No Asbestos Detected

Conclusions and Actions	
Recommendation:	No further action required
Further Information:	None
General Notes: Modern roof tiles. uPVC soffits. Plastic drainpipes and guttering. uPVC panelling to rear of guttering. Cement board undercloak to roof and entrance canopy. uPVC windows and sills. uPVC front and rear doors. Insulation board ceiling panel to entrance canopy. uPVC fascia in wooden frame to entrance canopy. Modern damp proof course.

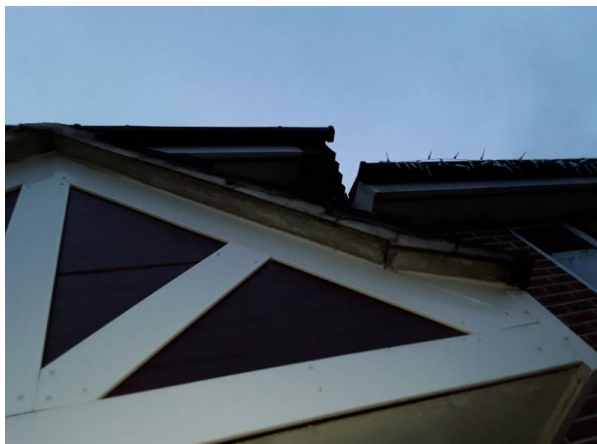
Building:	4 Wilmot Close	Floor Level:	External	Item Ref:	J224341-14
Room Name:	(012) External				
Sample Ref:	FW004267 (Sample 6)				
Component:	Cement board undercloak to roof and entrance canopy

Material Assessment		
Product Type	Extent of damage	Surface Treatment Score
Cement (1)	Low Damage (1)	1
Asbestos Type	Material Assessment Score (MA)	Very Low (4)
Chrysotile (1)

Priority Assessment		
Occupant Activity	Location Score	Accessibility Score
0 (Rare disturbance)	0	0
Extent / amount	No. of occupants	Frequency of Use
14lm (2)	1 (1 to 3)	3 (Daily)
Avg. time area is in use	Type of Maintenance	Freq. of Maintenance
0 (<1 hour)	0 (Minor disturbance)	1 (<1 per year)
Priority Assessment Score (PA)		4

Conclusions and Actions	
Recommendation:	Manage and Inspect
Further Information:	None
General Notes: Modern roof tiles. uPVC soffits. Plastic drainpipes and guttering. uPVC panelling to rear of guttering. Cement board undercloak to roof and entrance canopy. uPVC windows and sills. uPVC front and rear doors. Insulation board ceiling panel to entrance canopy. uPVC fascia in wooden frame to entrance canopy. Modern damp proof course.
