Management Survey with part Refurbishment/Demolition (MA only)

**At
26 St. Brides Close
Glastonbury
Somerset,
BA6 9JU**

Sanctuary Group

J277473

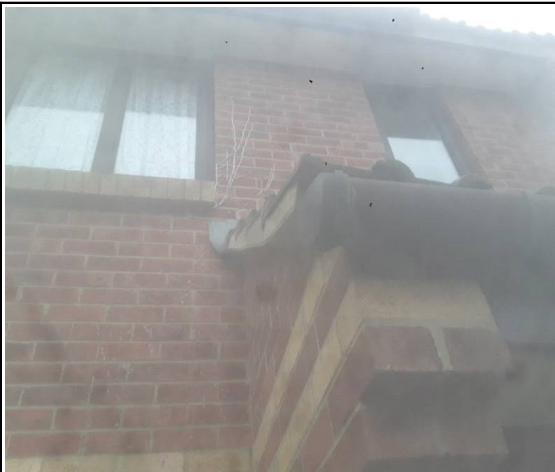
Room Comments:	Brick walls, concrete roof tiles, undercloaking, ib soffits, facias, gutters and down pipes

Sample Comments:	N/A	
Total Assessment Score:	0	
Risk Assessment Category:	N/A	
Recommendation:	Not applicable

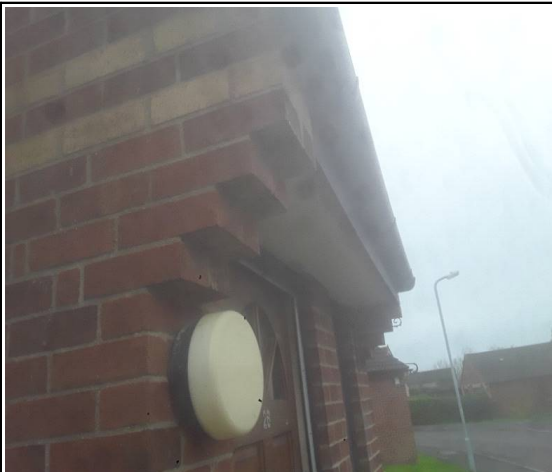
Room Comments:	Brick walls, concrete roof tiles, undercloaking, ib soffits, facias, gutters and down pipes

Sample Comments:	N/A	
Total Assessment Score:	0	
Risk Assessment Category:	N/A	
Recommendation:	Not applicable

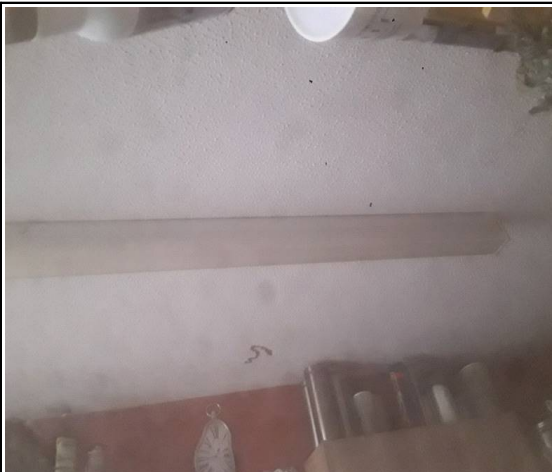
Room Comments:	Modern lino, timber floor, tiled plaster walls, textured coating to plaster ceiling, modern sink pad, timber boxing

Sample Comments:	N/A	
Total Assessment Score:	0	
Risk Assessment Category:	N/A	
Recommendation:	Not applicable

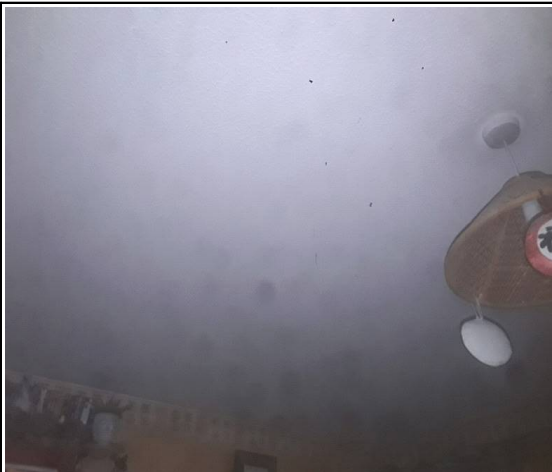
Room Comments:	Timber floor, plaster walls, textured coating to plaster ceiling

Sample Comments:	N/A	
Total Assessment Score:	0	
Risk Assessment Category:	N/A	
Recommendation:	Not applicable

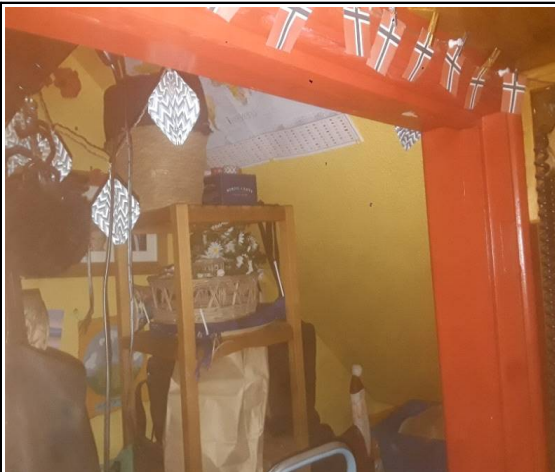
Room Comments:	Timber floor, plaster walls, textured coating to plaster ceiling

Sample Comments:	N/A	
Total Assessment Score:	0	
Risk Assessment Category:	N/A	
Recommendation:	Not applicable

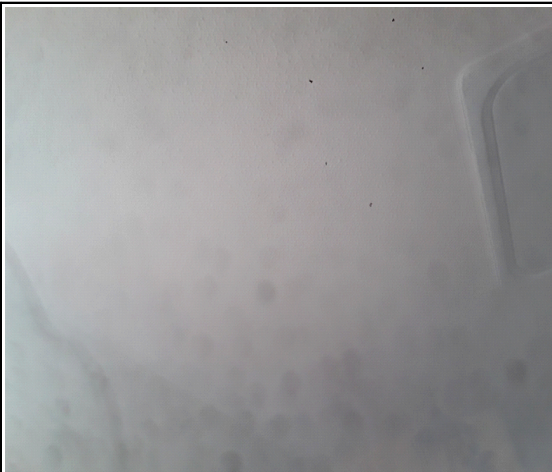
Room Comments:	Timber floor, plaster walls, textured coating to plaster ceiling

Sample Comments:	N/A	
Total Assessment Score:	0	
Risk Assessment Category:	N/A	
Recommendation:	Not applicable

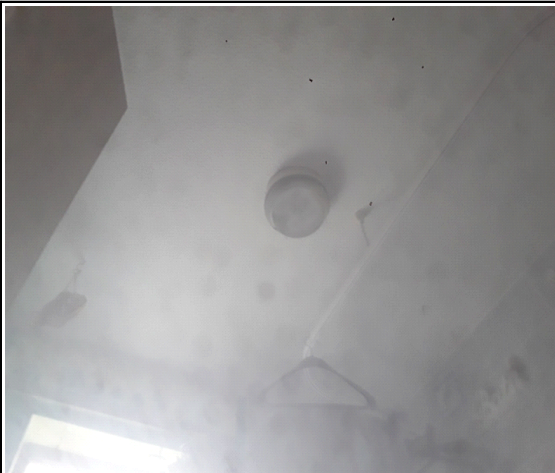
Room Comments:	Modern lino, timber floor, tiled plaster walls, textured coating to plaster ceiling, plastic bath panel

Sample Comments:	N/A	
Total Assessment Score:	0	
Risk Assessment Category:	N/A	
Recommendation:	Not applicable

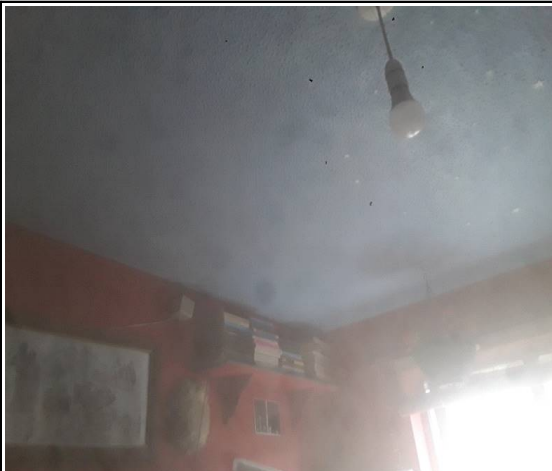
Room Comments:	Timber floor, plaster walls, textured coating to plaster ceiling

Sample Comments:	N/A	
Total Assessment Score:	0	
Risk Assessment Category:	N/A	
Recommendation:	Not applicable

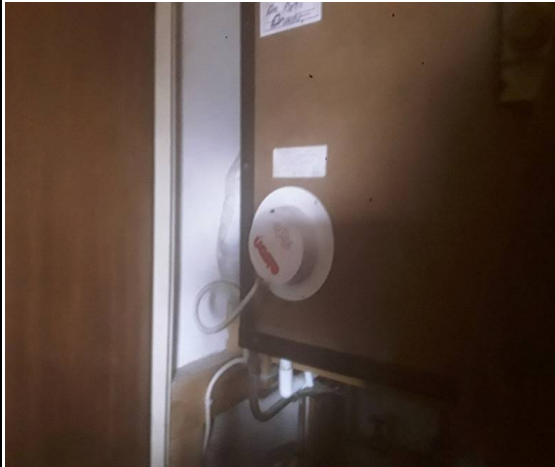
Room Comments:	Timber floor, plaster walls and ceiling

Sample Comments:	N/A	
Total Assessment Score:	0	
Risk Assessment Category:	N/A	
Recommendation:	Not applicable

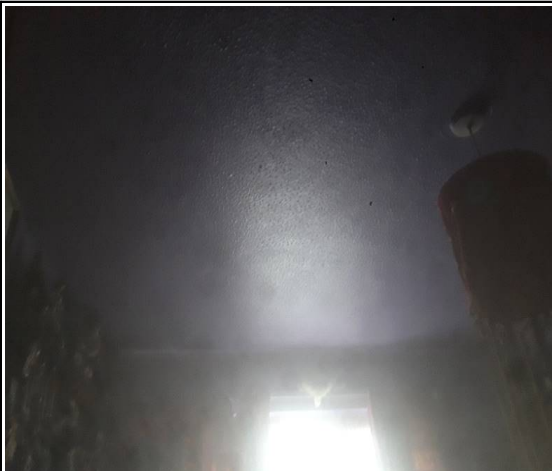
Room Comments:	Timber floor, plaster walls, textured coating to plaster ceiling

Sample Comments:	N/A	
Total Assessment Score:	0	
Risk Assessment Category:	N/A	
Recommendation:	Not applicable

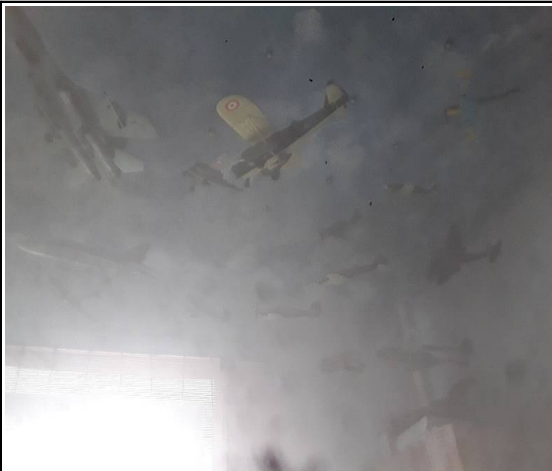
Room Comments:	Timber floor, plaster walls, textured coating to plaster ceiling

Sample Comments:	N/A	
Total Assessment Score:	0	
Risk Assessment Category:	N/A	
Recommendation:	Not applicable

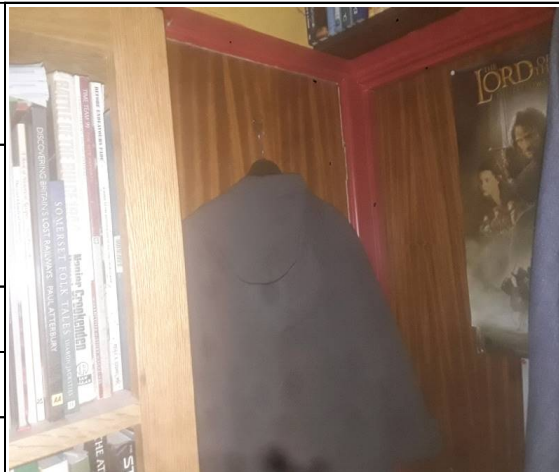
Inspection No	Building	Location:	Description:	Reason	Recommendation	Photo
14	Semi / 3 bed	First / Cupboard 107	Cupboard	No access, door blocked	Inspect Prior to Disturbance

Room Comments:	No access, door blocked

Sample Comments:	No access, door blocked	
Total Assessment Score:	12	
Risk Assessment Category:		
Recommendation:	Inspect prior to disturbance

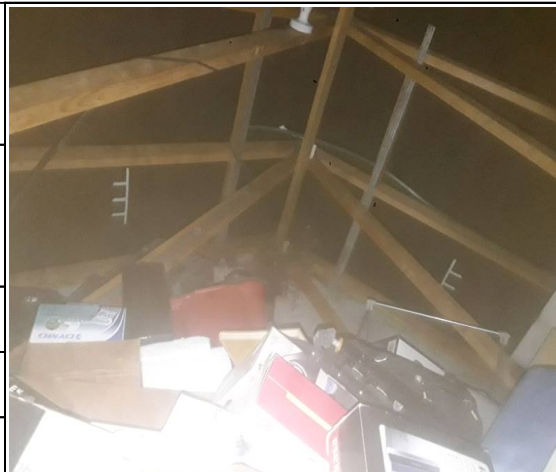
Room Comments:	Plasterboard floor, mmmf insulation, brick walls, felt, wood beams, limited access, full of belongings

Sample Comments:	N/A	
Total Assessment Score:	0	
Risk Assessment Category:	N/A	
Recommendation:	Not applicable
