Management Survey with part Refurbishment/Demolition (MA only)

**At
14 Jersey Close
Basingstoke
Hampshire,
RG24 9PR**

Sanctuary Group

Job Number	J276836
------------	---------

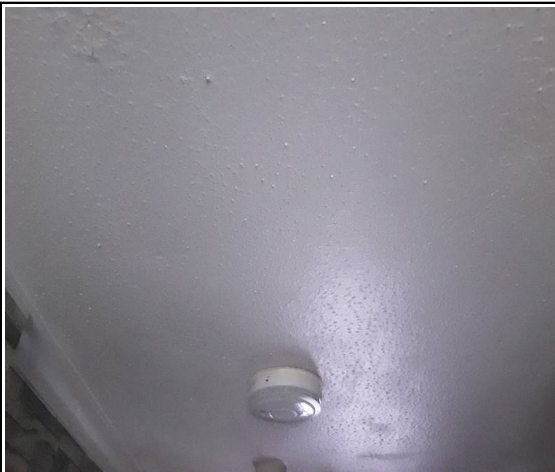
Inspection Number:	1	Intrusive Area – Yes or No:	No
Material Assessment			
Item:		Detail:	
Building:		1 / Three bedroom house	
Location:		Ground / Hall G01	
Sample Number:		GD011023	
Description:		Decorative Finishes	
Position:		to ceiling	
Extent:		6m ²	
Product Type:		Textured Coating	
Damage & Deterioration:		Low Damage	
Surface Treatment:		Enclosed sprays and lagging, Sealed AIB	
Asbestos Type:		No Asbestos Detected	
Material Score:		0

Room Comments:	plasterboard ceiling solid walls with plaster skim. Concrete floor with laminate flooring above. Timber doors and frames.

Sample Comments:	N/A	
Total Assessment Score:	0	
Risk Assessment Category:	N/A	
Recommendation:	Not applicable

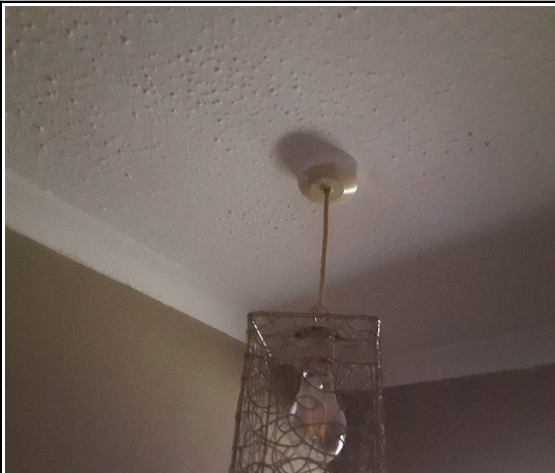
Inspection Number:	2	Intrusive Area – Yes or No:	No
Material Assessment			
Item:		Detail:	
Building:		1 / Three bedroom house	
Location:		Ground / Toilet G02	
Sample Number:		AS GD011023	
Description:		Decorative Finishes	
Position:		to ceiling	
Extent:		2m ²	
Product Type:		Textured Coating	
Damage & Deterioration:		Low Damage	
Surface Treatment:		Enclosed sprays and lagging, Sealed AIB	
Asbestos Type:		No Asbestos Detected	
Material Score:		0

Room Comments:	plasterboard ceiling solid walls with plaster skim. Concrete floor with laminate flooring above. Upvc windows. Ceramic toilet and cistern. Timber door and frame.

Sample Comments:	N/A	
Total Assessment Score:	0	
Risk Assessment Category:	N/A	
Recommendation:	Not applicable

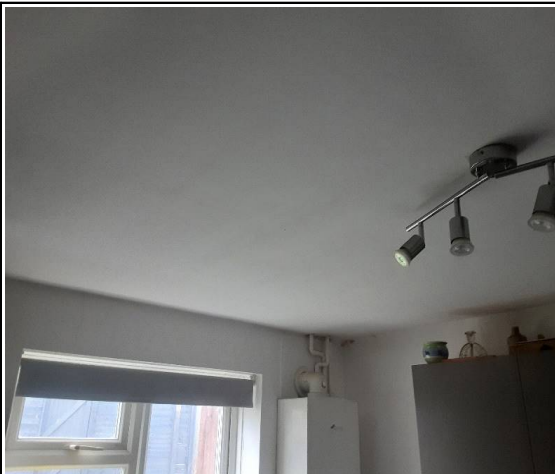
Inspection Number:	3	Intrusive Area – Yes or No:	No
Material Assessment			
Item:	Detail:		
Building:	1 / Three bedroom house		
Location:	Ground / Kitchen G03		
Sample Number:	Visual		
Description:	No suspect materials visually found		
Position:			
Extent:			
Product Type:	N/A		
Damage & Deterioration:	N/A		
Surface Treatment:	N/A		
Asbestos Type:	-		
Material Score:	0

Room Comments:	plasterboard ceiling solid walls with plaster skim. Concrete floor with modern plastic covering. Upvc windows. Boiler fixed to solid wall with metal flue passing through external wall. Timber door and frame.

Sample Comments:	N/A	
Total Assessment Score:	0	
Risk Assessment Category:	N/A	
Recommendation:	Not applicable

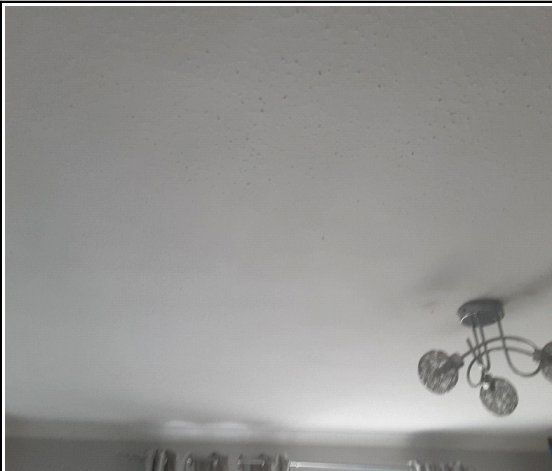
Inspection Number:	4	Intrusive Area – Yes or No:	No
Material Assessment			
Item:	Detail:		
Building:	1 / Three bedroom house		
Location:	Ground / Living Room G04		
Sample Number:	AS GD011023		
Description:	Decorative Finishes		
Position:	to ceiling		
Extent:	20m ²		
Product Type:	Textured Coating		
Damage & Deterioration:	Low Damage		
Surface Treatment:	Enclosed sprays and lagging, Sealed AIB		
Asbestos Type:	No Asbestos Detected		
Material Score:	0

Room Comments:	plasterboard ceiling solid walls with plaster skim. Concrete floor with laminate flooring above. Upvc windows. Timber door and frame.

Sample Comments:	N/A	
Total Assessment Score:	0	
Risk Assessment Category:	N/A	
Recommendation:	Not applicable

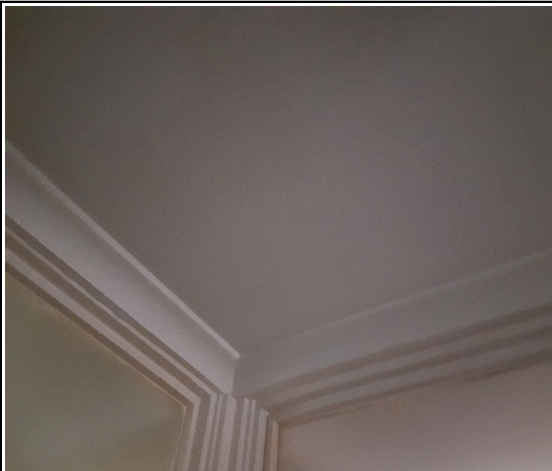
Inspection Number:	5	Intrusive Area – Yes or No:	No
Material Assessment			
Item:	Detail:		
Building:	1 / Three bedroom house		
Location:	First / Landing 101		
Sample Number:	GD011024		
Description:	Decorative Finishes		
Position:	to ceiling		
Extent:	8m ²		
Product Type:	Textured Coating		
Damage & Deterioration:	Low Damage		
Surface Treatment:	Enclosed sprays and lagging, Sealed AIB		
Asbestos Type:	No Asbestos Detected		
Material Score:	0

Room Comments:	plasterboard ceiling solid walls with plaster skim. Wooden floorboards and stairs with carpets covering. Timber doors and frames.

Sample Comments:	N/A	
Total Assessment Score:	0	
Risk Assessment Category:	N/A	
Recommendation:	Not applicable

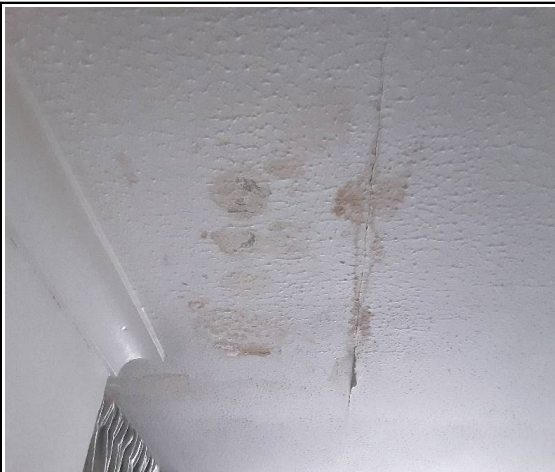
Inspection Number:	6	Intrusive Area – Yes or No:	No
Material Assessment			
Item:	Detail:		
Building:	1 / Three bedroom house		
Location:	First / Bedroom 102		
Sample Number:	AS GD011024		
Description:	Decorative Finishes		
Position:	to ceiling		
Extent:	12m ²		
Product Type:	Textured Coating		
Damage & Deterioration:	Low Damage		
Surface Treatment:	Enclosed sprays and lagging, Sealed AIB		
Asbestos Type:	No Asbestos Detected		
Material Score:	0

Room Comments:	plasterboard ceiling solid walls with plaster skim. Wooden floorboards with carpets covering. Upvc windows. Timber door and frame with glass above.

Sample Comments:	N/A	
Total Assessment Score:	0	
Risk Assessment Category:	N/A	
Recommendation:	Not applicable

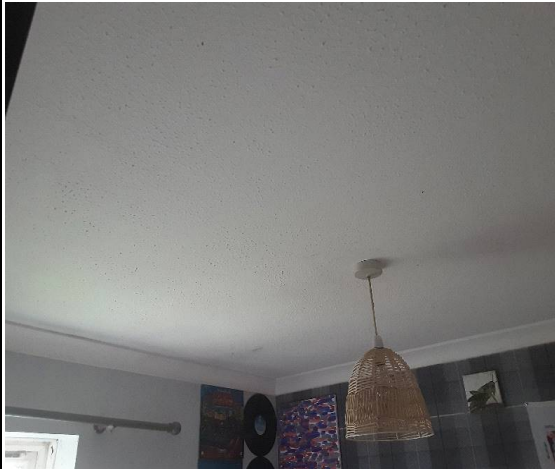
Inspection Number:	7	Intrusive Area – Yes or No:	No
Material Assessment			
Item:		Detail:	
Building:		1 / Three bedroom house	
Location:		First / Bedroom 103	
Sample Number:		AS GD011024	
Description:		Decorative Finishes	
Position:		to ceiling	
Extent:		10m ²	
Product Type:		Textured Coating	
Damage & Deterioration:		Low Damage	
Surface Treatment:		Enclosed sprays and lagging, Sealed AIB	
Asbestos Type:		No Asbestos Detected	
Material Score:		0

Room Comments:	plasterboard ceiling solid walls with plaster skim. Wooden floorboards with carpets covering. Upvc windows. Timber door and frame with glass above.

Sample Comments:	N/A	
Total Assessment Score:	0	
Risk Assessment Category:	N/A	
Recommendation:	Not applicable

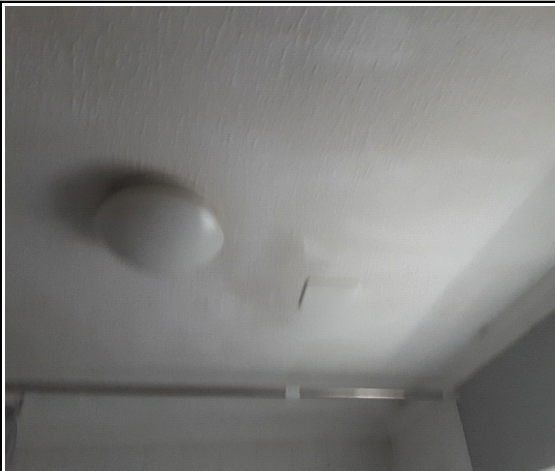
Inspection Number:	8	Intrusive Area – Yes or No:	No
Material Assessment			
Item:	Detail:		
Building:	1 / Three bedroom house		
Location:	First / Bathroom 104		
Sample Number:	GD011025		
Description:	Decorative Finishes		
Position:	to ceiling		
Extent:	8m ²		
Product Type:	Textured Coating		
Damage & Deterioration:	Low Damage		
Surface Treatment:	Enclosed sprays and lagging, Sealed AIB		
Asbestos Type:	No Asbestos Detected		
Material Score:	0

Room Comments:	plasterboard ceiling solid walls with plaster skim. Wooden floorboards with modern plastic covering. Metal bath with plastic panel. Ceramic toilet and cistern. Upvc windows. Timber door and frame with glass above.

Sample Comments:	N/A	
Total Assessment Score:	0	
Risk Assessment Category:	N/A	
Recommendation:	Not applicable

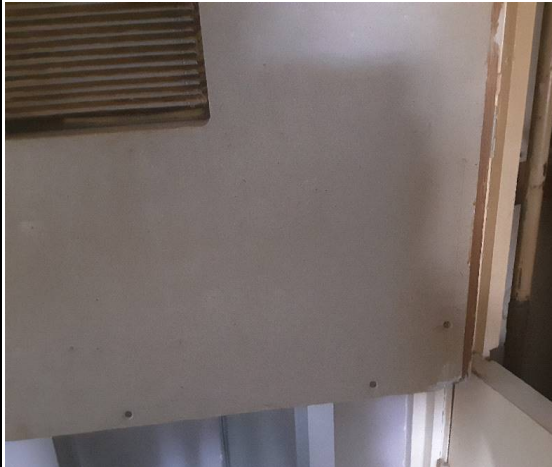
Inspection Number:	9	Intrusive Area – Yes or No:	No
Material Assessment			
Item:	Detail:		
Building:	1 / Three bedroom house		
Location:	First / Cupboard 105		
Sample Number:	GD011026		
Description:	Asbestos Insulating Board		
Position:	to door		
Extent:	2m ²		
Product Type:	Asbestos Insulating Board		
Damage & Deterioration:	Low Damage		
Surface Treatment:	Enclosed sprays and lagging, Sealed AIB		
Asbestos Type:	Chrysotile + Amosite		
Material Score:	6

Room Comments:	plasterboard ceiling solid walls with plaster skim. Wooden floorboards. Copper cylinder with foam lagging. Timber door and frame.

Sample Comments:	N/A	
Total Assessment Score:	6	
Risk Assessment Category:	Low	
Recommendation:	Remove

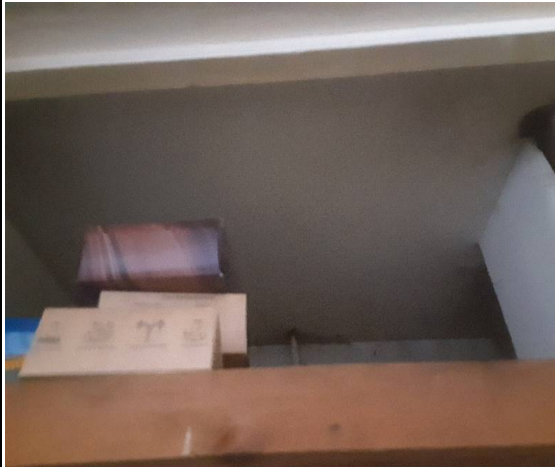
Inspection Number:	10	Intrusive Area – Yes or No:	No
Material Assessment			
Item:		Detail:	
Building:		1 / Three bedroom house	
Location:		First / Cupboard 105	
Sample Number:		AS GD011025	
Description:		Decorative Finishes	
Position:		to ceiling	
Extent:		1m ²	
Product Type:		Textured Coating	
Damage & Deterioration:		Low Damage	
Surface Treatment:		Enclosed sprays and lagging, Sealed AIB	
Asbestos Type:		No Asbestos Detected	
Material Score:		0

Room Comments:	plasterboard ceiling solid walls with plaster skim. Wooden floorboards. Copper cylinder with foam lagging. Timber door and frame.

Sample Comments:	N/A	
Total Assessment Score:	0	
Risk Assessment Category:	N/A	
Recommendation:	Not applicable

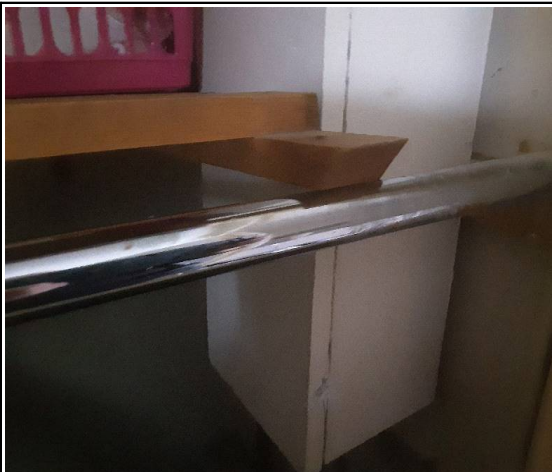
Inspection Number:	11	Intrusive Area – Yes or No:	No
Material Assessment			
Item:	Detail:		
Building:	1 / Three bedroom house		
Location:	First / Cupboard 105		
Sample Number:	GD011027		
Description:	Asbestos Insulating Board		
Position:	to boxing		
Extent:	1m ²		
Product Type:	Asbestos Insulating Board		
Damage & Deterioration:	Low Damage		
Surface Treatment:	Enclosed sprays and lagging, Sealed AIB		
Asbestos Type:	Chrysotile + Amosite		
Material Score:	6

Room Comments:	plasterboard ceiling solid walls with plaster skim. Wooden floorboards. Copper cylinder with foam lagging. Timber door and frame.

Sample Comments:	N/A	
Total Assessment Score:	6	
Risk Assessment Category:	Low	
Recommendation:	Remove

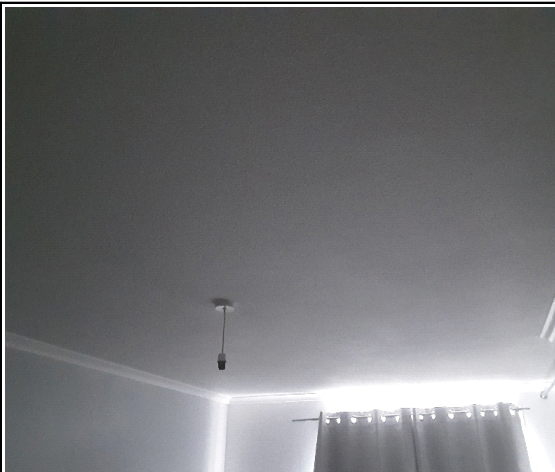
Inspection Number:	12	Intrusive Area – Yes or No:	No
Material Assessment			
Item:	Detail:		
Building:	1 / Three bedroom house		
Location:	First / Bedroom 106		
Sample Number:	AS GD011024		
Description:	Decorative Finishes		
Position:	to ceiling		
Extent:	12m ²		
Product Type:	Textured Coating		
Damage & Deterioration:	Low Damage		
Surface Treatment:	Enclosed sprays and lagging, Sealed AIB		
Asbestos Type:	No Asbestos Detected		
Material Score:	0

Room Comments:	plasterboard ceiling solid walls with plaster skim. Wooden floorboards with carpets covering. Upvc windows. Timber door and frame with glass above.

Sample Comments:	N/A	
Total Assessment Score:	0	
Risk Assessment Category:	N/A	
Recommendation:	Not applicable

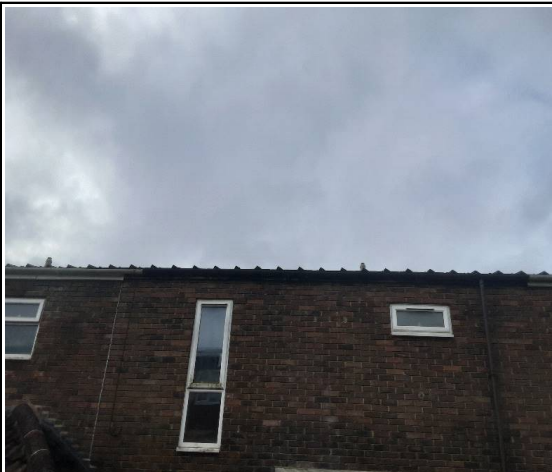
Inspection Number:	14	Intrusive Area – Yes or No:	No
Material Assessment			
Item:	Detail:		
Building:	1 / Three bedroom house		
Location:	External / External E01		
Sample Number:	Visual		
Description:	No suspect materials visually found		
Position:			
Extent:			
Product Type:	N/A		
Damage & Deterioration:	N/A		
Surface Treatment:	N/A		
Asbestos Type:	-		
Material Score:	0

Room Comments:	Two storey building with pitched stone tiled roof. Wooden fascia boards plastic gutters and downpipe.

Sample Comments:	N/A	
Total Assessment Score:	0	
Risk Assessment Category:	N/A	
Recommendation:	Not applicable

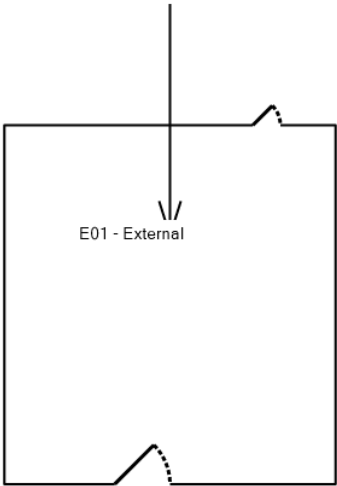
Inspection 14 - No suspect materials visually found
