## ***Management Survey with part Refurbishment/Demolition (MA only)***

**At  
20 St. Clements Way  
Bishopdown  
Salisbury  
Wiltshire,  
SP1 3FF**

***Sanctuary Group***

***Management survey to whole property, refurbishment survey to targeted areas.***

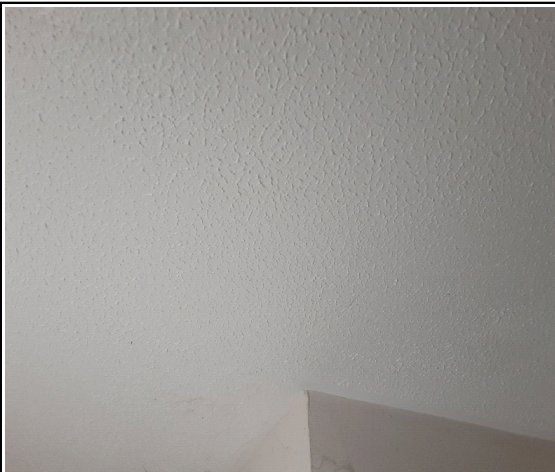
Inspection Number:	1	Intrusive Area – Yes or No:	No
<b>Material Assessment</b>			
<b>Item:</b>		<b>Detail:</b>	
Building:		1 / Two bedroom house	
Location:		First / Landing 101	
Sample Number:		GD011165	
Description:		Decorative Finishes	
Position:		to ceiling	
Extent:		8m <sup>2</sup>	
Product Type:		Textured Coating	
Damage & Deterioration:		Low Damage	
Surface Treatment:		Enclosed sprays and lagging, Sealed AIB	
Asbestos Type:		No Asbestos Detected	
Material Score:		0

Room Comments:	plasterboard ceiling solid walls with plaster skim. Wooden floorboards and stairs with carpets covering.

Sample Comments:	N/A	
Total Assessment Score:	0	
Risk Assessment Category:	N/A	
Recommendation:	Not applicable

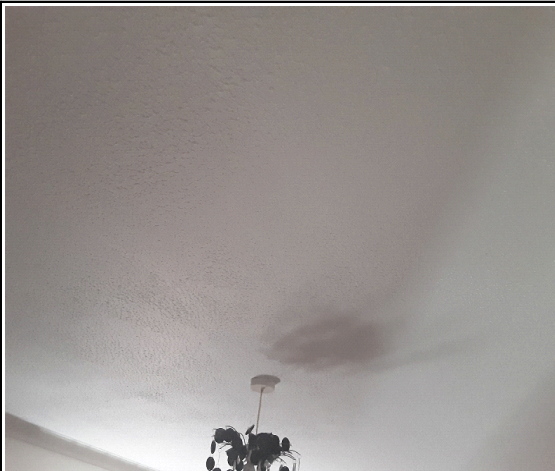
Inspection Number:	2	Intrusive Area – Yes or No:	No
<b>Material Assessment</b>			
<b>Item:</b>		<b>Detail:</b>	
Building:		1 / Two bedroom house	
Location:		First / Bedroom 102	
Sample Number:		AS GD011165	
Description:		Decorative Finishes	
Position:		to ceiling	
Extent:		12m <sup>2</sup>	
Product Type:		Textured Coating	
Damage & Deterioration:		Low Damage	
Surface Treatment:		Enclosed sprays and lagging, Sealed AIB	
Asbestos Type:		No Asbestos Detected	
Material Score:		0

Room Comments:	Plasterboard ceiling solid walls with plaster skim. Wooden floorboards with carpets covering. Upvc windows. Timber door and frame.

Sample Comments:	N/A	
Total Assessment Score:	0	
Risk Assessment Category:	N/A	
Recommendation:	Not applicable

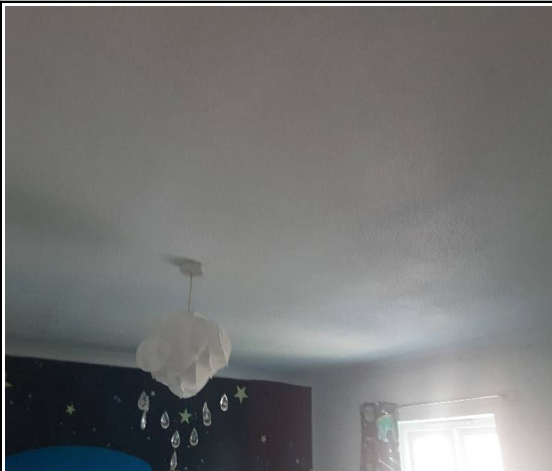
Inspection Number:	3	Intrusive Area – Yes or No:	No
<b>Material Assessment</b>			
Item:	Detail:		
Building:	1 / Two bedroom house		
Location:	First / Bedroom 103		
Sample Number:	AS GD011165		
Description:	Decorative Finishes		
Position:	to ceiling		
Extent:	10m <sup>2</sup>		
Product Type:	Textured Coating		
Damage & Deterioration:	Low Damage		
Surface Treatment:	Enclosed sprays and lagging, Sealed AIB		
Asbestos Type:	No Asbestos Detected		
Material Score:	0

Room Comments:	Plasterboard ceiling solid walls with plaster skim. Wooden floorboards with carpets covering. Upvc windows. Timber door and frame.

Sample Comments:	N/A	
Total Assessment Score:	0	
Risk Assessment Category:	N/A	
Recommendation:	Not applicable

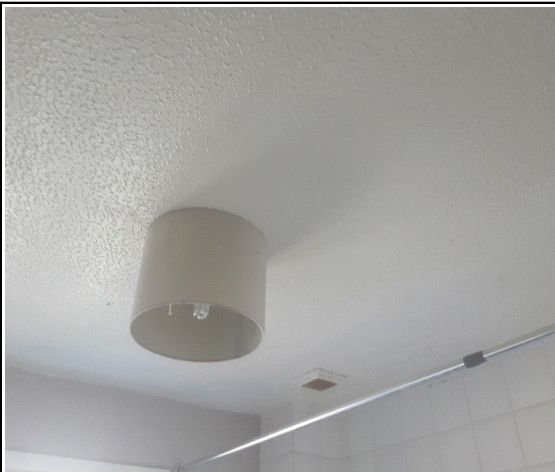
Inspection Number:	5	Intrusive Area – Yes or No:	No
<b>Material Assessment</b>			
<b>Item:</b>		<b>Detail:</b>	
Building:		1 / Two bedroom house	
Location:		First / Bathroom 105	
Sample Number:		AS GD011165	
Description:		Decorative Finishes	
Position:		to ceiling	
Extent:		6m <sup>2</sup>	
Product Type:		Textured Coating	
Damage & Deterioration:		Low Damage	
Surface Treatment:		Enclosed sprays and lagging, Sealed AIB	
Asbestos Type:		No Asbestos Detected	
Material Score:		0

Room Comments:	plasterboard ceiling solid walls with plaster skim. Wooden floorboards with modern plastic covering. Upvc windows. Ceramic toilet and cistern. Plastic bath and panel. Timber door and frame.

Sample Comments:	N/A	
Total Assessment Score:	0	
Risk Assessment Category:	N/A	
Recommendation:	Not applicable

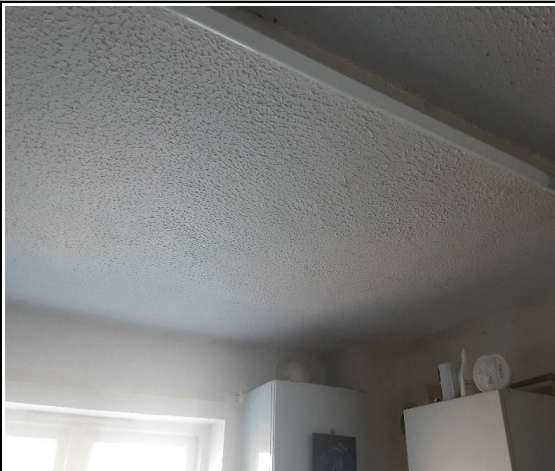
Inspection Number:	6	Intrusive Area – Yes or No:	No
<b>Material Assessment</b>			
Item:	Detail:		
Building:	1 / Two bedroom house		
Location:	Ground / Kitchen G01		
Sample Number:	GD011166		
Description:	Decorative Finishes		
Position:	to ceiling		
Extent:	8m <sup>2</sup>		
Product Type:	Textured Coating		
Damage & Deterioration:	Low Damage		
Surface Treatment:	Enclosed sprays and lagging, Sealed AIB		
Asbestos Type:	No Asbestos Detected		
Material Score:	0

Room Comments:	plasterboard ceiling solid walls with plaster skim. Concrete floor with modern plastic covering. Upvc windows. Boiler fixed to solid wall with metal flue passing through external wall. Timber door and frame.

Sample Comments:	N/A	
Total Assessment Score:	0	
Risk Assessment Category:	N/A	
Recommendation:	Not applicable

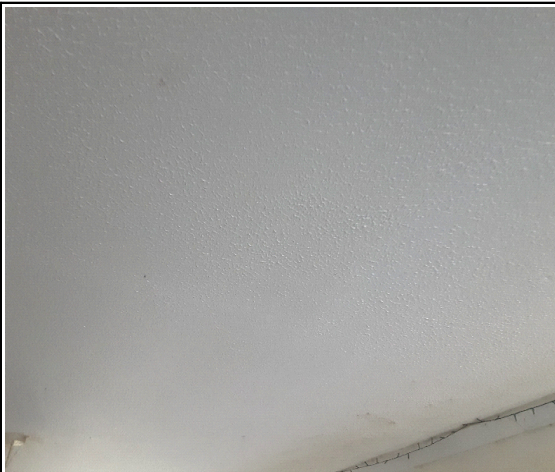
Inspection Number:	7	Intrusive Area – Yes or No:	No
<b>Material Assessment</b>			
<b>Item:</b>		<b>Detail:</b>	
Building:		1 / Two bedroom house	
Location:		Ground / Living Room G02	
Sample Number:		GD011167	
Description:		Decorative Finishes	
Position:		to ceiling	
Extent:		20m <sup>2</sup>	
Product Type:		Textured Coating	
Damage & Deterioration:		Low Damage	
Surface Treatment:		Enclosed sprays and lagging, Sealed AIB	
Asbestos Type:		No Asbestos Detected	
Material Score:		0

Room Comments:	plasterboard ceiling solid walls with plaster skim. Concrete floor with carpets covering. Upvc windows. Timber door and frame.

Sample Comments:	N/A	
Total Assessment Score:	0	
Risk Assessment Category:	N/A	
Recommendation:	Not applicable

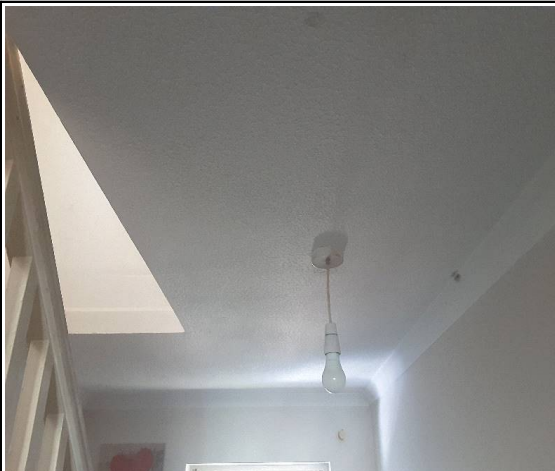
Inspection Number:	8	Intrusive Area – Yes or No:	No
<b>Material Assessment</b>			
<b>Item:</b>		<b>Detail:</b>	
Building:		1 / Two bedroom house	
Location:		Ground / Hall G03	
Sample Number:		AS GD011166	
Description:		Decorative Finishes	
Position:		to ceiling	
Extent:		8m <sup>2</sup>	
Product Type:		Textured Coating	
Damage & Deterioration:		Low Damage	
Surface Treatment:		Enclosed sprays and lagging, Sealed AIB	
Asbestos Type:		No Asbestos Detected	
Material Score:		0

Room Comments:	plasterboard ceiling solid walls with plaster skim. Concrete floor with carpets covering. Timber doors and frames.

Sample Comments:	N/A	
Total Assessment Score:	0	
Risk Assessment Category:	N/A	
Recommendation:	Not applicable

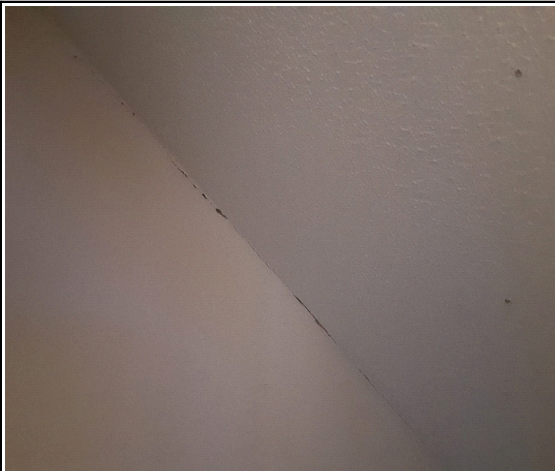
Inspection Number:	9	Intrusive Area – Yes or No:	No
<b>Material Assessment</b>			
<b>Item:</b>		<b>Detail:</b>	
Building:		1 / Two bedroom house	
Location:		Ground / Cupboard G04	
Sample Number:		AS GD011166	
Description:		Decorative Finishes	
Position:		to ceiling	
Extent:		3m <sup>2</sup>	
Product Type:		Textured Coating	
Damage & Deterioration:		Low Damage	
Surface Treatment:		Enclosed sprays and lagging, Sealed AIB	
Asbestos Type:		No Asbestos Detected	
Material Score:		0

Room Comments:	plasterboard ceiling solid walls with plaster skim. Concrete floor with carpets covering. Modern rcd fuse box. Timber door and frame

Sample Comments:	N/A	
Total Assessment Score:	0	
Risk Assessment Category:	N/A	
Recommendation:	Not applicable

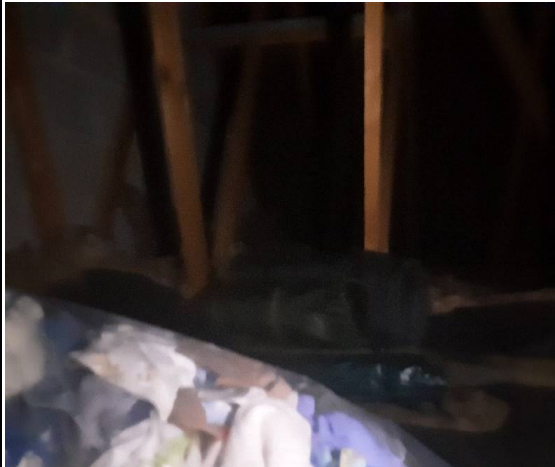
Inspection Number:	10	Intrusive Area – Yes or No:	No
<b>Material Assessment</b>			
<b>Item:</b>		<b>Detail:</b>	
Building:		1 / Two bedroom house	
Location:		Roof / Loft Space R01	
Sample Number:		Visual	
Description:		No suspect materials visually found	
Position:			
Extent:			
Product Type:		N/A	
Damage & Deterioration:		N/A	
Surface Treatment:		N/A	
Asbestos Type:		-	
Material Score:		0

Room Comments:	plasterboard floor forming ceiling below timber joists with mmmf lagging above. Modern felt to underside of roof. wooden hatch.

Sample Comments:	N/A	
Total Assessment Score:	0	
Risk Assessment Category:	N/A	
Recommendation:	Not applicable

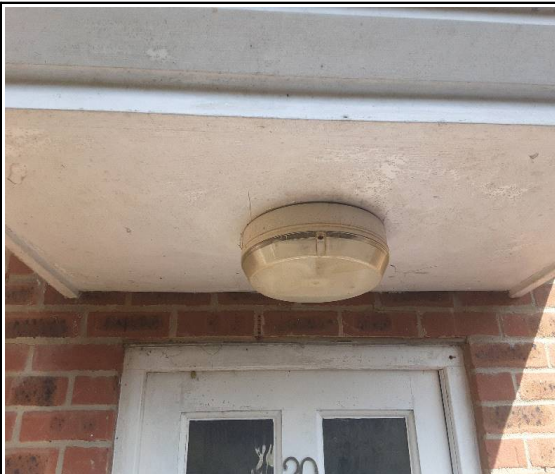
Inspection Number:	11	Intrusive Area – Yes or No:	No
<b>Material Assessment</b>			
<b>Item:</b>	<b>Detail:</b>		
Building:	1 / Two bedroom house		
Location:	External / Porch E01		
Sample Number:	GD011168		
Description:	Asbestos Insulating Board		
Position:	to ceiling		
Extent:	2m <sup>2</sup>		
Product Type:	Asbestos Insulating Board		
Damage & Deterioration:	Low Damage		
Surface Treatment:	Enclosed sprays and lagging, Sealed AIB		
Asbestos Type:	No Asbestos Detected		
Material Score:	0

Room Comments:	timber frame with lead roof.

Sample Comments:	N/A	
Total Assessment Score:	0	
Risk Assessment Category:	N/A	
Recommendation:	Not applicable

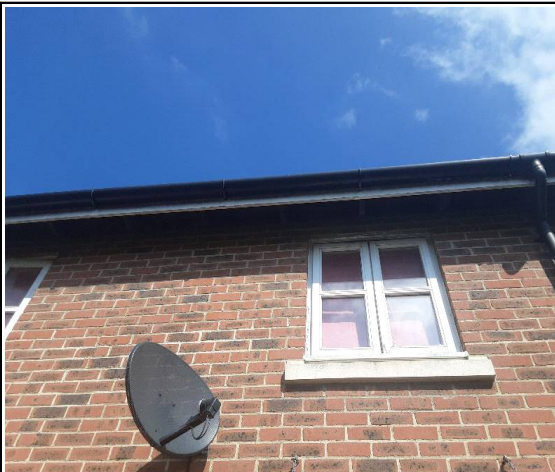
Inspection Number:	12	Intrusive Area – Yes or No:	No
<b>Material Assessment</b>			
<b>Item:</b>		<b>Detail:</b>	
Building:		1 / Two bedroom house	
Location:		External / External E02	
Sample Number:		Visual	
Description:		No suspect materials visually found	
Position:			
Extent:			
Product Type:		N/A	
Damage & Deterioration:		N/A	
Surface Treatment:		N/A	
Asbestos Type:		-	
Material Score:		0

Room Comments:	Two storey building with pitched stone tiled roof. Plastic gutters and downpipe.

Sample Comments:	N/A	
Total Assessment Score:	0	
Risk Assessment Category:	N/A	
Recommendation:	Not applicable

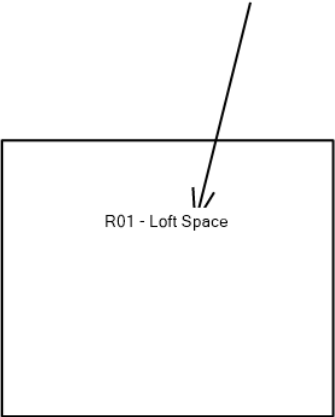
R01 - Loft Space

Inspection 10 - No suspect materials visually found
