MANAGEMENT SURVEY

Client: Sanctuary Group
Site ID: Y0090BLK1

**The Ferns
Ipswich Street
Swindon
Wiltshire
SN2 1HP**

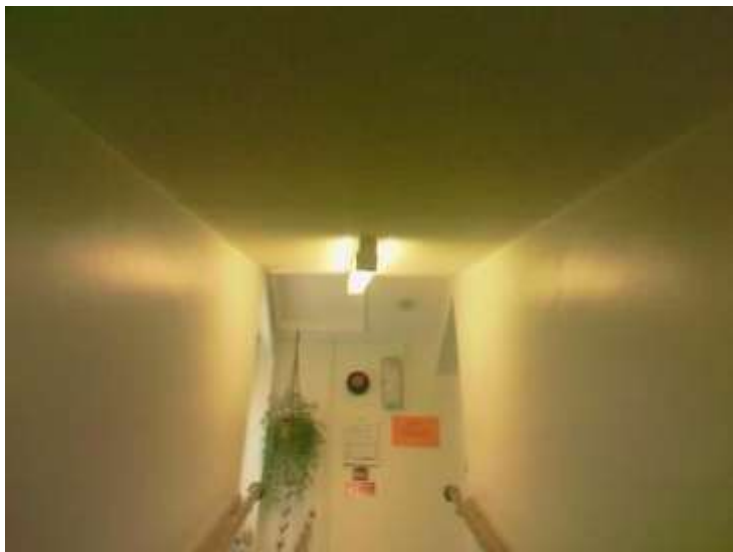
Asbestos Type	Product Type	Amount	Extent of Damage	Surface Treatment	Action Assessment	Material Assessment
Chrysotile (White)	Textured Coating - Ceiling	< 6 Sq M	Good condition: No visible damage	Sealed Composite Materials	Manage	2

Comments: The material was seen to be in good condition at the time of the initial inspection.

Recommendations: The condition of the material should be monitored by a competent person/company and its presence made aware to those at risk, as part of a Control of Asbestos Regulations (CAR) 2006 compliant management strategy.

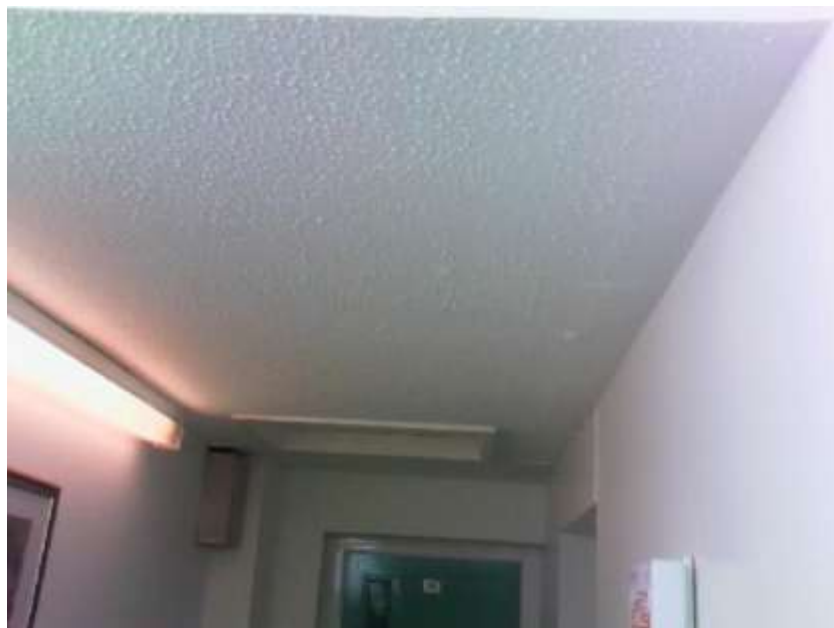
Asbestos Type	Product Type	Amount	Extent of Damage	Surface Treatment	Action Assessment	Material Assessment
Chrysotile (White)	Textured Coating - Ceiling	< 8 Sq M	Good condition: No visible damage	Sealed Composite Materials	Manage	2

Comments: The material was seen to be in good condition at the time of the initial inspection.

Recommendations: The condition of the material should be monitored by a competent person/company and its presence made aware to those at risk, as part of a Control of Asbestos Regulations (CAR) 2006 compliant management strategy.

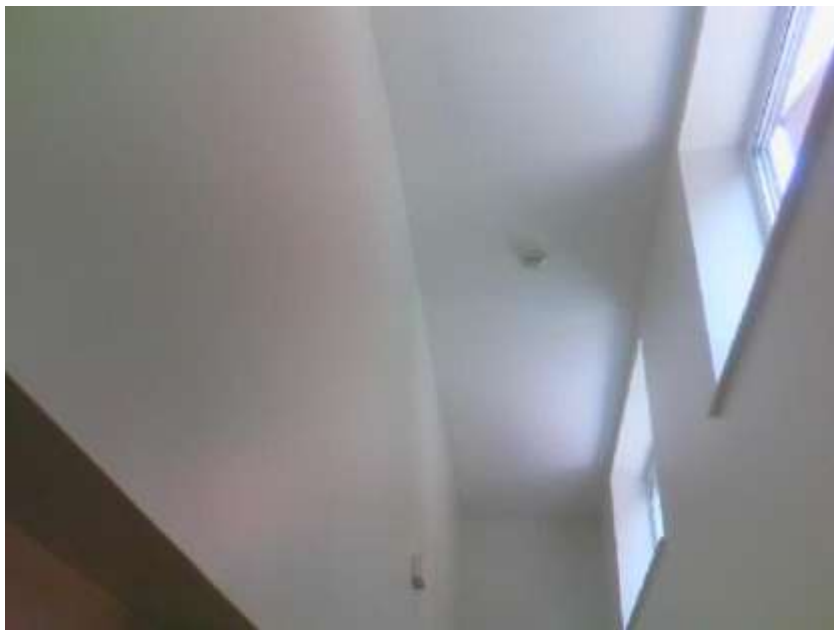
Asbestos Type	Product Type	Amount	Extent of Damage	Surface Treatment	Action Assessment	Material Assessment
Chrysotile (White)	Textured Coating - Ceiling	< 8 Sq M	Good condition: No visible damage	Sealed Composite Materials	Manage	2

Comments: The material was seen to be in good condition at the time of the initial inspection.

Recommendations: The condition of the material should be monitored by a competent person/company and its presence made aware to those at risk, as part of a Control of Asbestos Regulations (CAR) 2006 compliant management strategy.

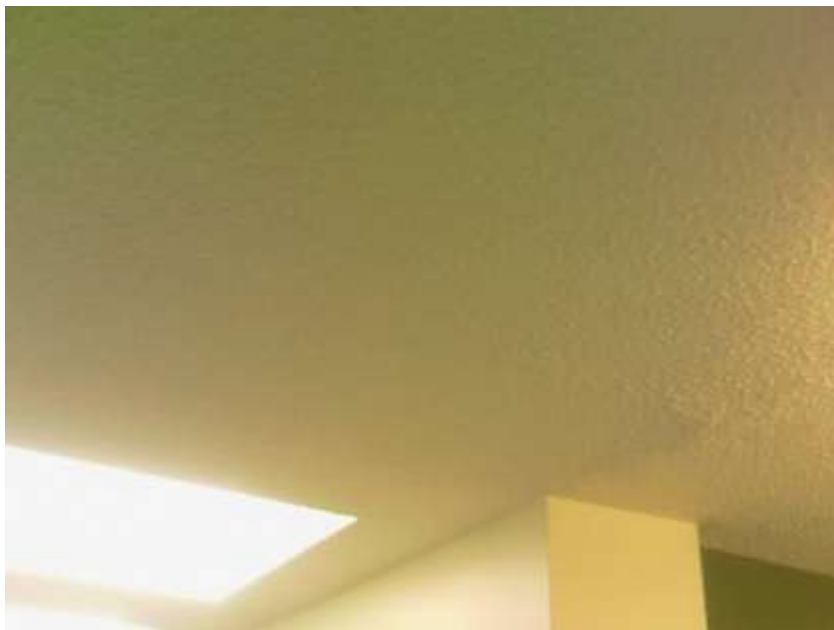
Asbestos Type	Product Type	Amount	Extent of Damage	Surface Treatment	Action Assessment	Material Assessment
Chrysotile (White)	Textured Coating - Ceiling	< 6 Sq M	Good condition: No visible damage	Sealed Composite Materials	Manage	2

Comments: The material was seen to be in good condition at the time of the initial inspection.

Recommendations: The condition of the material should be monitored by a competent person/company and its presence made aware to those at risk, as part of a Control of Asbestos Regulations (CAR) 2006 compliant management strategy.

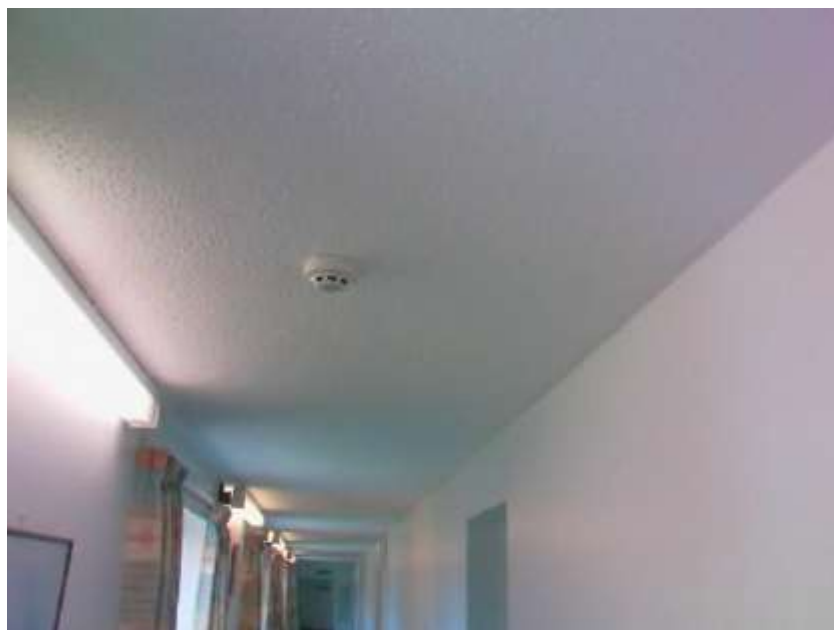
Asbestos Type	Product Type	Amount	Extent of Damage	Surface Treatment	Action Assessment	Material Assessment
Chrysotile (White)	Textured Coating - Ceiling	< 20 Sq M	Good condition: No visible damage	Sealed Composite Materials	Manage	2

Comments: The material was seen to be in good condition at the time of the initial inspection.

Recommendations: The condition of the material should be monitored by a competent person/company and its presence made aware to those at risk, as part of a Control of Asbestos Regulations (CAR) 2006 compliant management strategy.

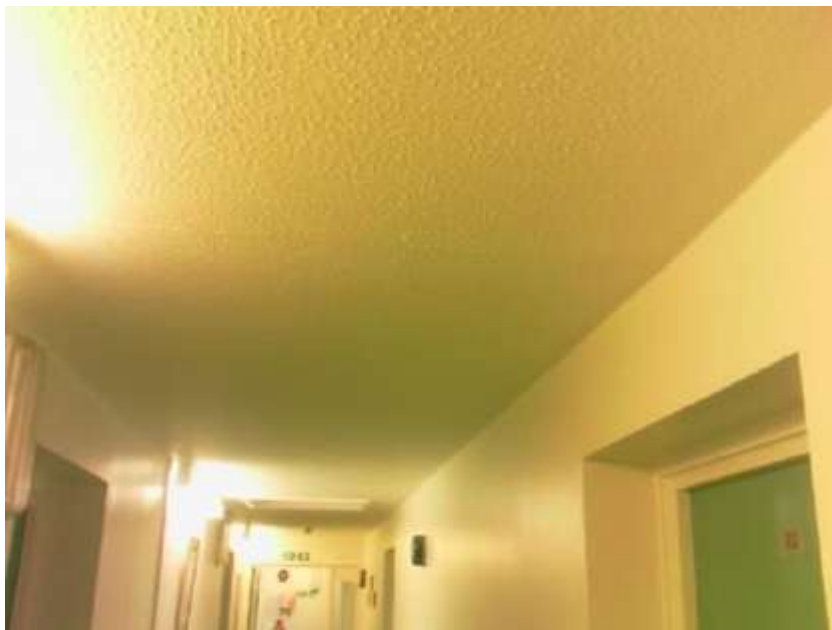
Asbestos Type	Product Type	Amount	Extent of Damage	Surface Treatment	Action Assessment	Material Assessment
Chrysotile (White)	Textured Coating - Ceiling	< 18 Sq M	Good condition: No visible damage	Sealed Composite Materials	Manage	2

Comments: The material was seen to be in good condition at the time of the initial inspection.

Recommendations: The condition of the material should be monitored by a competent person/company and its presence made aware to those at risk, as part of a Control of Asbestos Regulations (CAR) 2006 compliant management strategy.

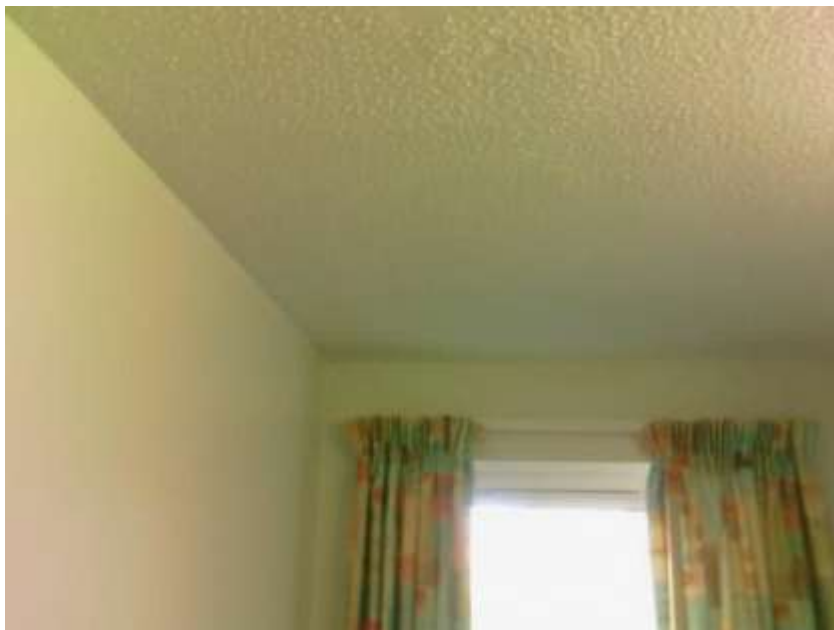
Asbestos Type	Product Type	Amount	Extent of Damage	Surface Treatment	Action Assessment	Material Assessment
Chrysotile (White)	Textured Coating - Ceiling	< 8 Sq M	Good condition: No visible damage	Sealed Composite Materials	Manage	2

Comments: The material was seen to be in good condition at the time of the initial inspection.

Recommendations: The condition of the material should be monitored by a competent person/company and its presence made aware to those at risk, as part of a Control of Asbestos Regulations (CAR) 2006 compliant management strategy.

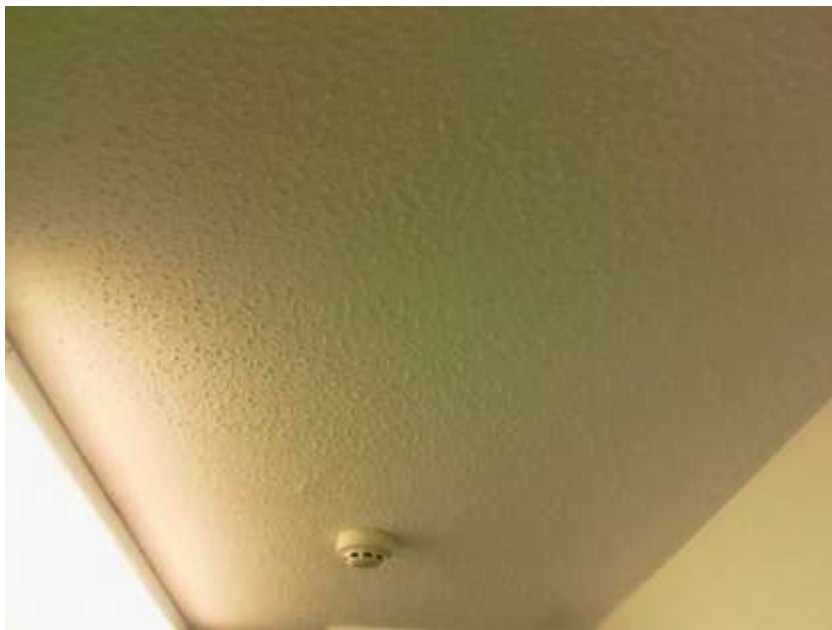
Asbestos Type	Product Type	Amount	Extent of Damage	Surface Treatment	Action Assessment	Material Assessment
Chrysotile (White)	Textured Coating - Ceiling	< 4 Sq M	Good condition: No visible damage	Sealed Composite Materials	Manage	2

Comments: The material was seen to be in good condition at the time of the initial inspection.

Recommendations: The condition of the material should be monitored by a competent person/company and its presence made aware to those at risk, as part of a Control of Asbestos Regulations (CAR) 2006 compliant management strategy.

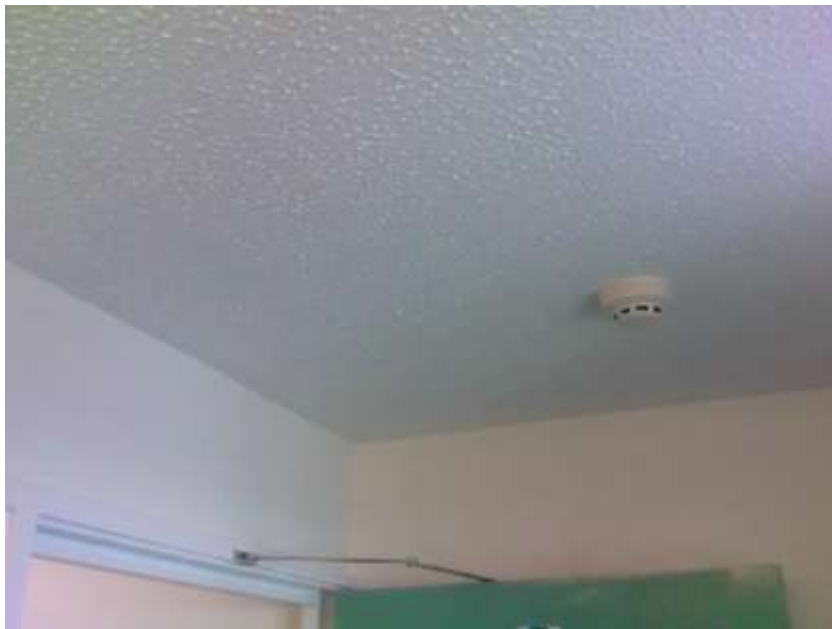
Asbestos Type	Product Type	Amount	Extent of Damage	Surface Treatment	Action Assessment	Material Assessment
Chrysotile (White)	Textured Coating - Ceiling	< 6 Sq M	Good condition: No visible damage	Sealed Composite Materials	Manage	2

Comments: The material was seen to be in good condition at the time of the initial inspection.

Recommendations: The condition of the material should be monitored by a competent person/company and its presence made aware to those at risk, as part of a Control of Asbestos Regulations (CAR) 2006 compliant management strategy.

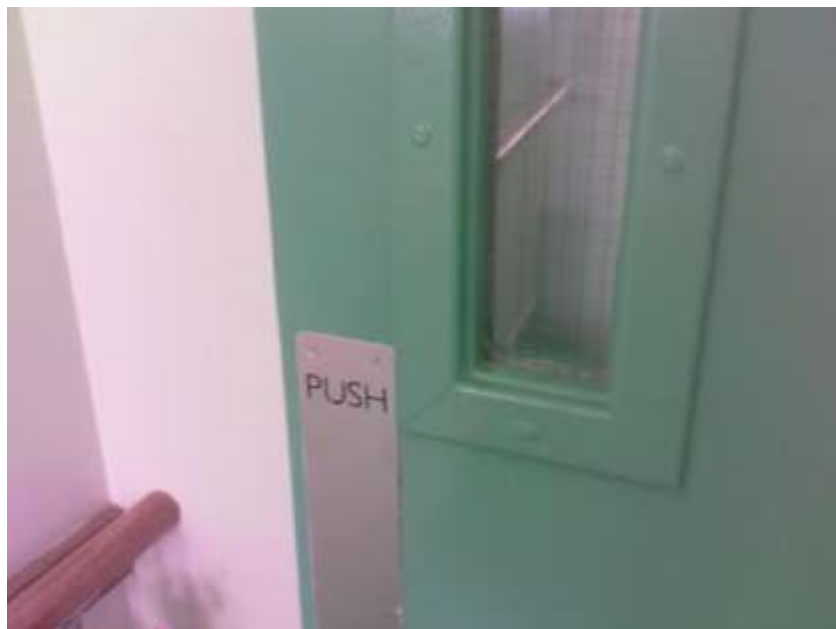
Asbestos Type	Product Type	Amount	Extent of Damage	Surface Treatment	Action Assessment	Material Assessment
Non Asbestos	Insulating Board	N/A	N/A	N/A	N/A	0

Comments: No asbestos was detected in the sample taken from the material.

Recommendations: No further action is required.

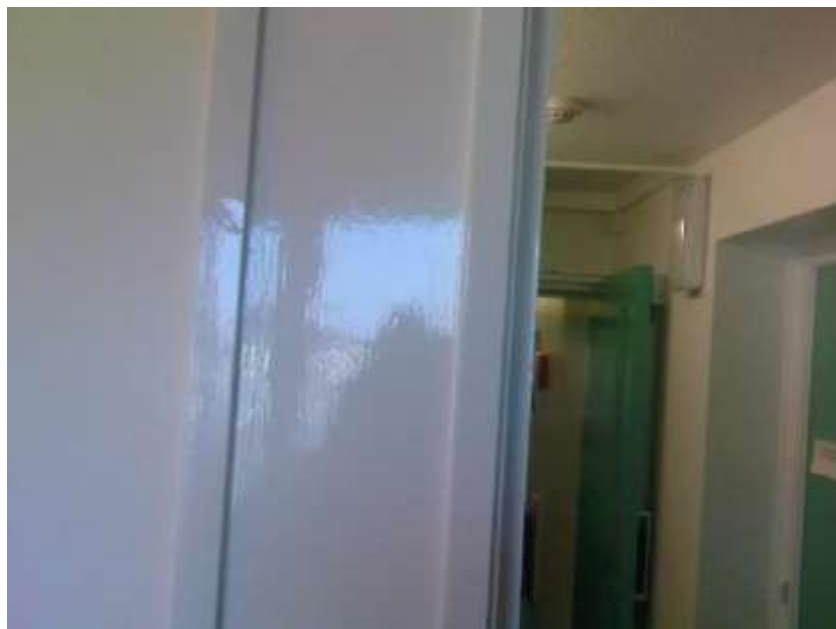
Asbestos Type	Product Type	Amount	Extent of Damage	Surface Treatment	Action Assessment	Material Assessment
Non Asbestos	Insulating Board	N/A	N/A	N/A	N/A	0

Comments: No asbestos was detected in the sample taken from the material.

Recommendations: No further action is required.

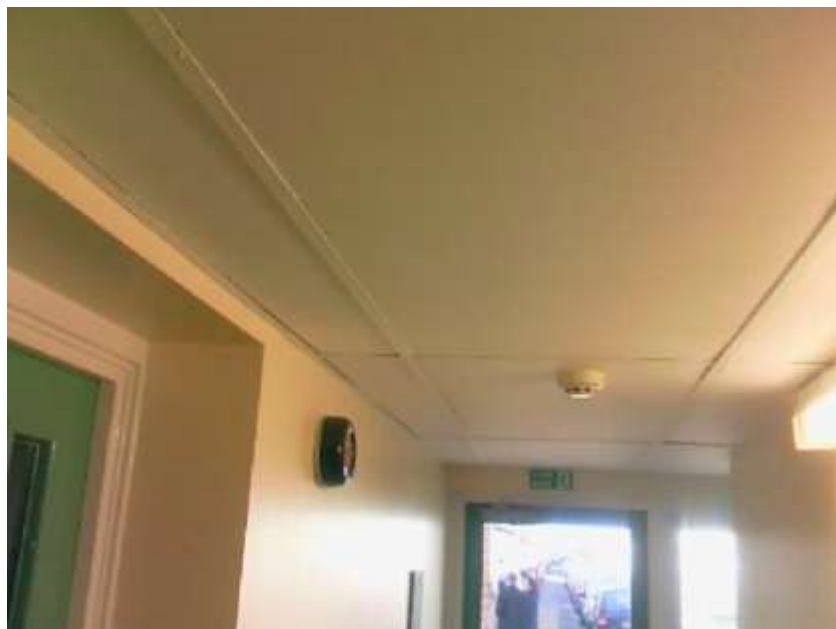
Asbestos Type	Product Type	Amount	Extent of Damage	Surface Treatment	Action Assessment	Material Assessment
Non Asbestos	Insulating Board	N/A	N/A	N/A	N/A	0

Comments: No asbestos was detected in the sample taken from the material.

Recommendations: No further action is required.

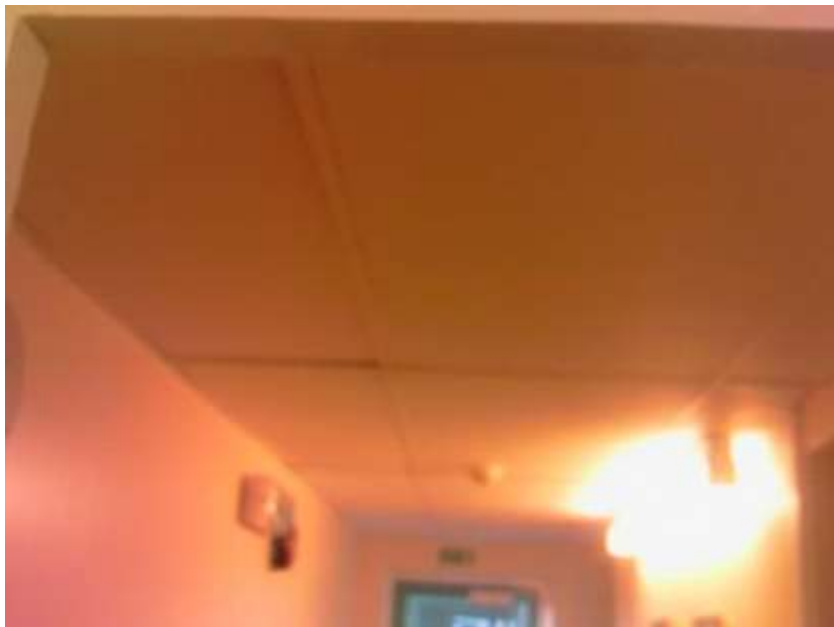
Asbestos Type	Product Type	Amount	Extent of Damage	Surface Treatment	Action Assessment	Material Assessment
Non Asbestos	Insulating Board	N/A	N/A	N/A	N/A	0

Comments: No asbestos was detected in the sample taken from the material.

Recommendations: No further action is required.

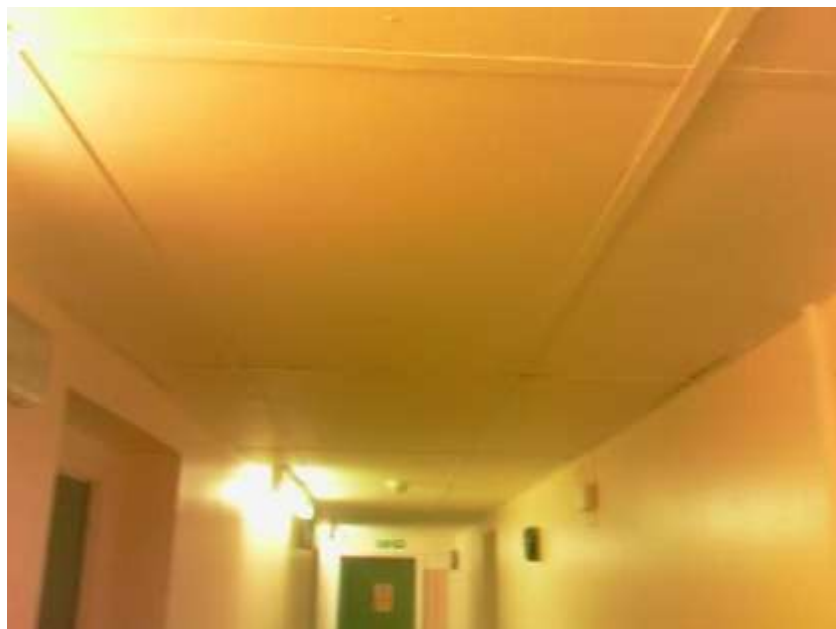
Asbestos Type	Product Type	Amount	Extent of Damage	Surface Treatment	Action Assessment	Material Assessment
Non Asbestos	Insulating Board	N/A	N/A	N/A	N/A	0

Comments: No asbestos was detected in the sample taken from the material.

Recommendations: No further action is required.

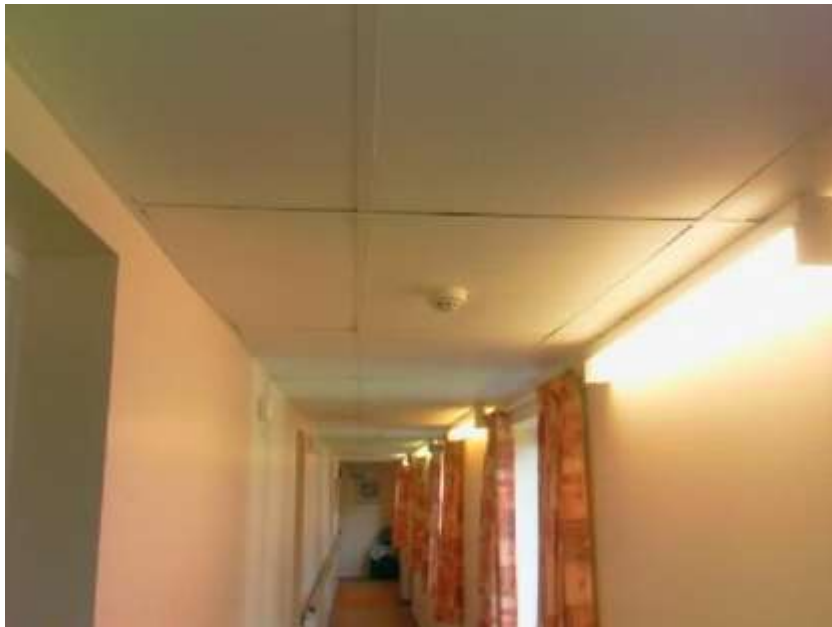
Asbestos Type	Product Type	Amount	Extent of Damage	Surface Treatment	Action Assessment	Material Assessment
Non Asbestos	Insulating Board	N/A	N/A	N/A	N/A	0

Comments: No asbestos was detected in the sample taken from the material.

Recommendations: No further action is required.

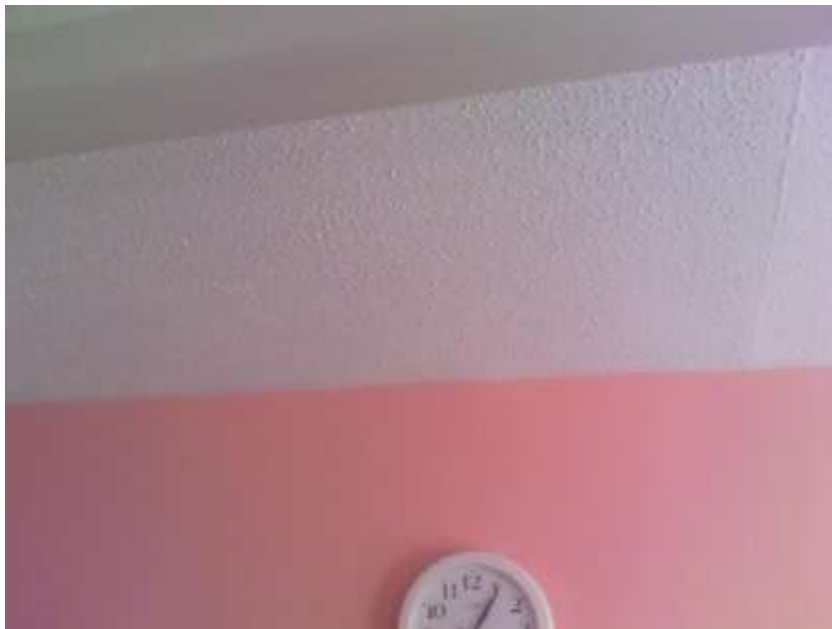
Asbestos Type	Product Type	Amount	Extent of Damage	Surface Treatment	Action Assessment	Material Assessment
Chrysotile (White)	Textured Coating - Ceiling	< 12 Sq M	Good condition: No visible damage	Sealed Composite Materials	Manage	2

Comments: The material was seen to be in good condition at the time of the initial inspection.

Recommendations: The condition of the material should be monitored by a competent person/company and its presence made aware to those at risk, as part of a Control of Asbestos Regulations (CAR) 2006 compliant management strategy.

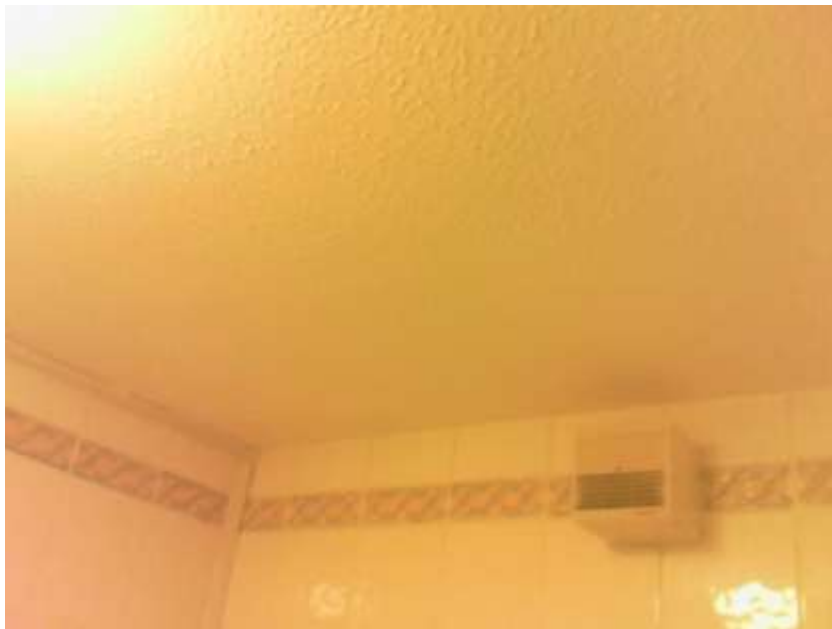
Asbestos Type	Product Type	Amount	Extent of Damage	Surface Treatment	Action Assessment	Material Assessment
Chrysotile (White)	Textured Coating - Ceiling	< 6 Sq M	Good condition: No visible damage	Sealed Composite Materials	Manage	2

Comments: The material was seen to be in good condition at the time of the initial inspection.

Recommendations: The condition of the material should be monitored by a competent person/company and its presence made aware to those at risk, as part of a Control of Asbestos Regulations (CAR) 2006 compliant management strategy.

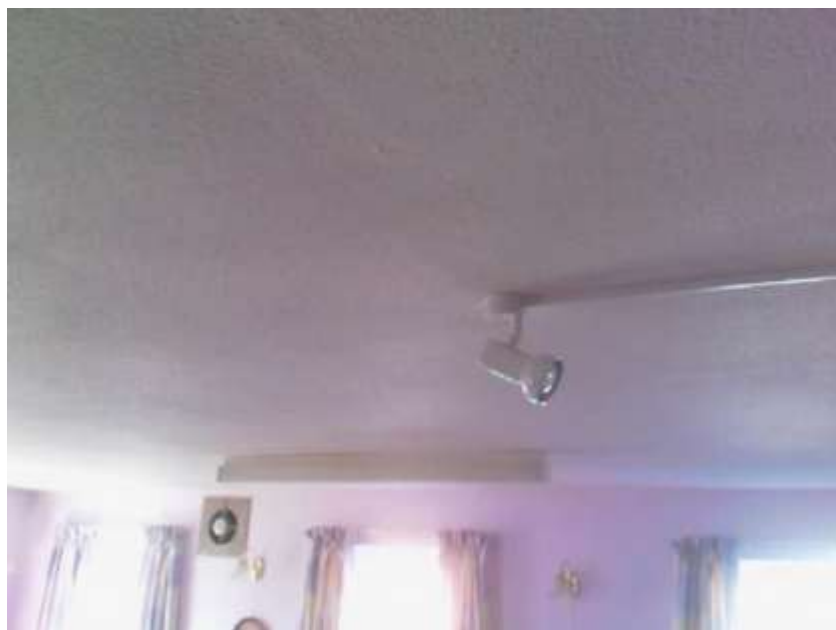
Asbestos Type	Product Type	Amount	Extent of Damage	Surface Treatment	Action Assessment	Material Assessment
Chrysotile (White)	Textured Coating - Ceiling	< 30 Sq M	Good condition: No visible damage	Sealed Composite Materials	Manage	2

Comments: The material was seen to be in good condition at the time of the initial inspection.

Recommendations: The condition of the material should be monitored by a competent person/company and its presence made aware to those at risk, as part of a Control of Asbestos Regulations (CAR) 2006 compliant management strategy.

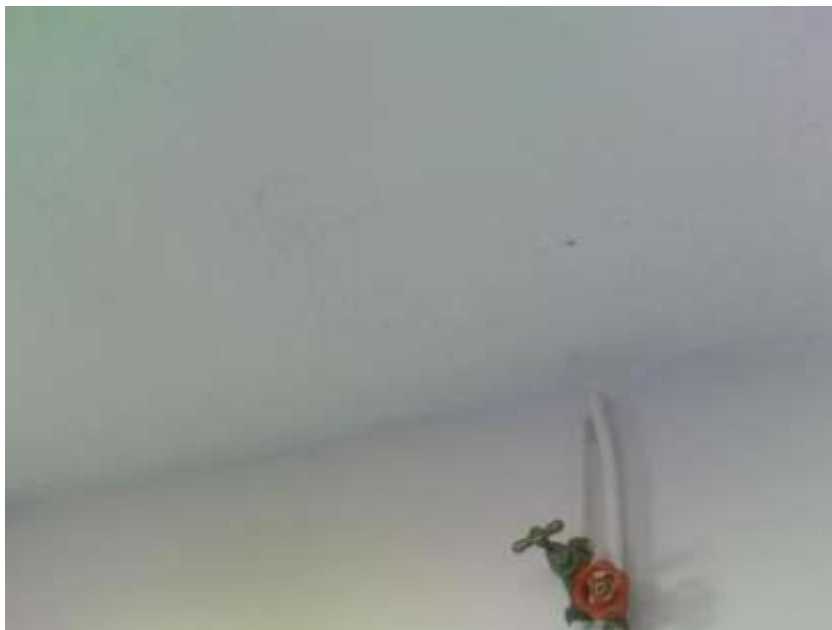
Asbestos Type	Product Type	Amount	Extent of Damage	Surface Treatment	Action Assessment	Material Assessment
Chrysotile (White)	Textured Coating - Ceiling	< 10 Sq M	Good condition: No visible damage	Sealed Composite Materials	Manage	2

Comments: The material was seen to be in good condition at the time of the initial inspection.

Recommendations: The condition of the material should be monitored by a competent person/company and its presence made aware to those at risk, as part of a Control of Asbestos Regulations (CAR) 2006 compliant management strategy.

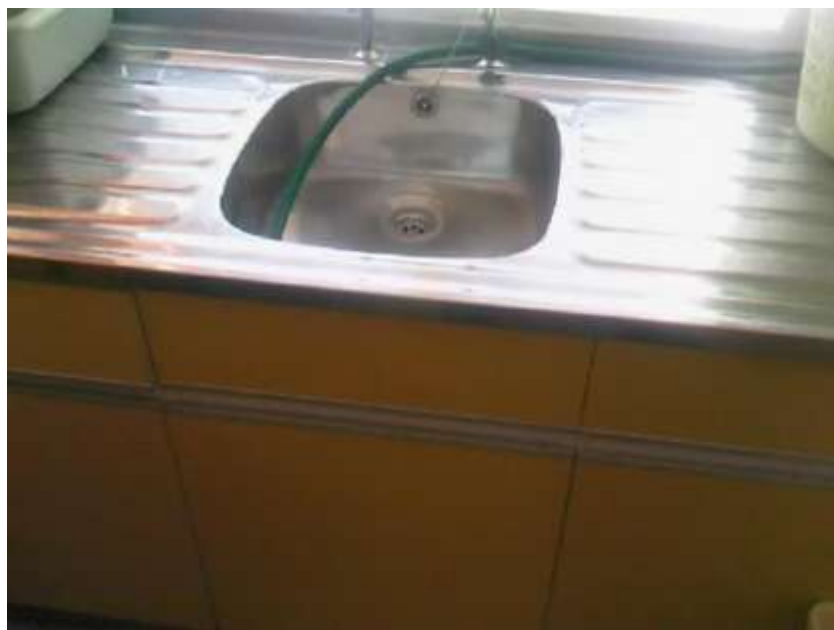
Asbestos Type	Product Type	Amount	Extent of Damage	Surface Treatment	Action Assessment	Material Assessment
Chrysotile (White)	Bitumen	< 1 Sq M	Good condition: No visible damage	Sealed Composite Materials	Manage	2

Comments: The material was seen to be in good condition at the time of the initial inspection.

Recommendations: The condition of the material should be monitored by a competent person/company and its presence made aware to those at risk, as part of a Control of Asbestos Regulations (CAR) 2006 compliant management strategy.

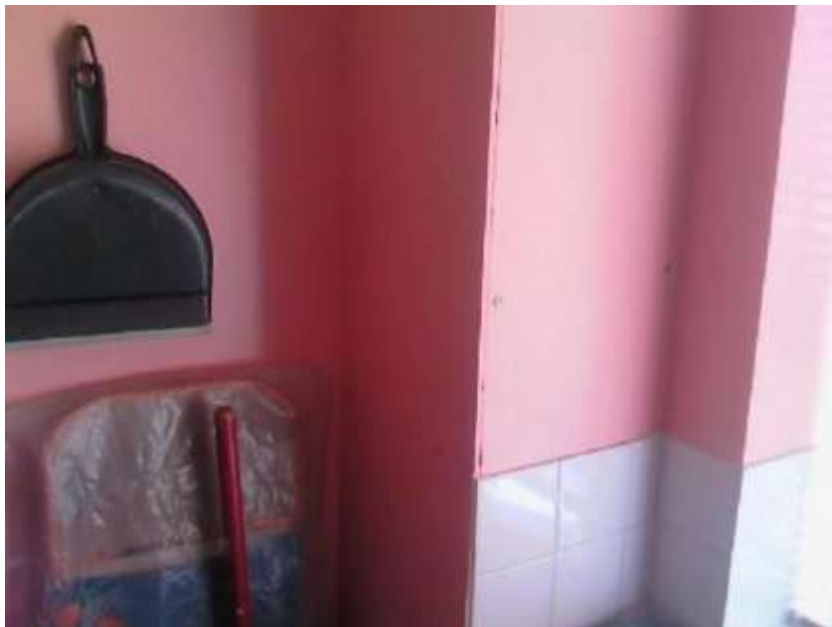
Asbestos Type	Product Type	Amount	Extent of Damage	Surface Treatment	Action Assessment	Material Assessment
Non Asbestos	Insulating Board	N/A	N/A	N/A	N/A	0

Comments: No asbestos was detected in the sample taken from the material.

Recommendations: No further action is required.

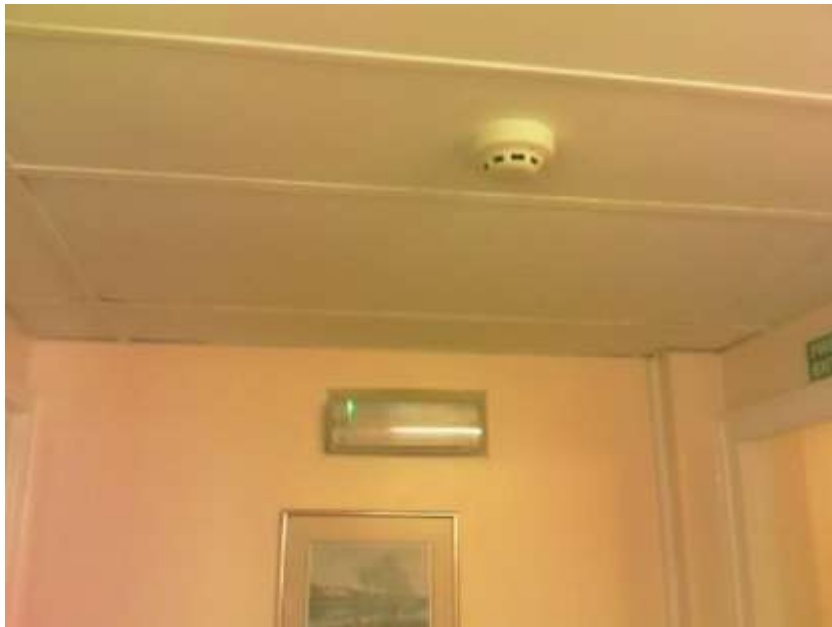
Asbestos Type	Product Type	Amount	Extent of Damage	Surface Treatment	Action Assessment	Material Assessment
Non Asbestos	Insulating Board	N/A	N/A	N/A	N/A	0

Comments: No asbestos was detected in the sample taken from the material.

Recommendations: No further action is required.

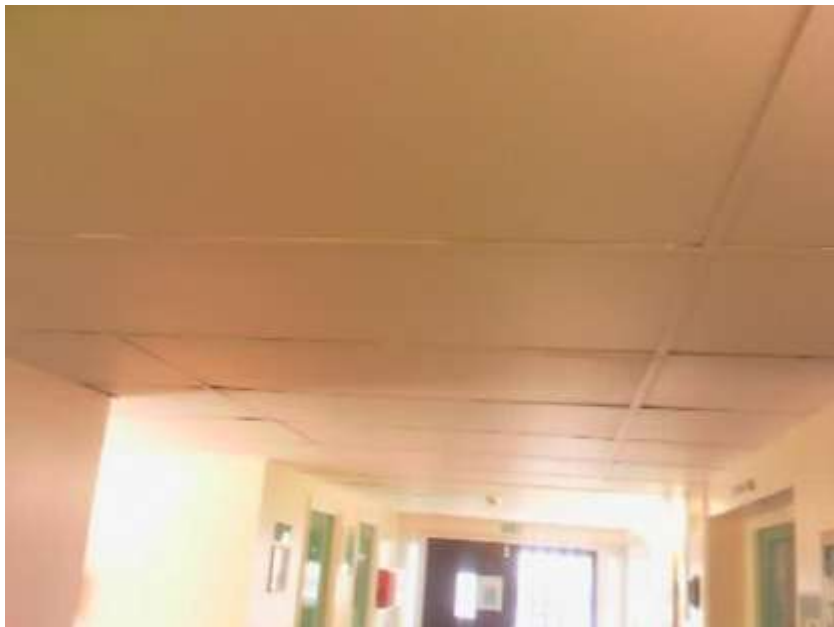
Asbestos Type	Product Type	Amount	Extent of Damage	Surface Treatment	Action Assessment	Material Assessment
Non Asbestos	Insulating Board	N/A	N/A	N/A	N/A	0

Comments: No asbestos was detected in the sample taken from the material.

Recommendations: No further action is required.

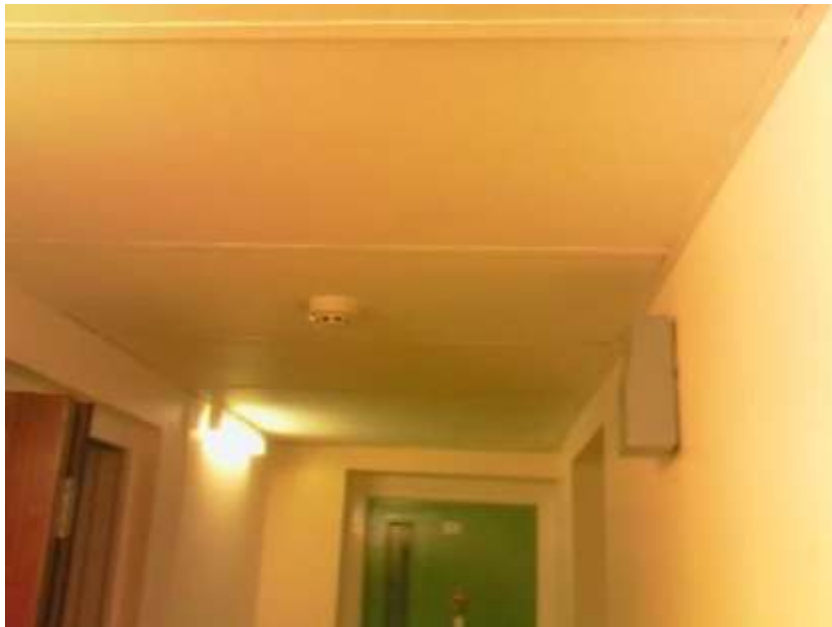
Asbestos Type	Product Type	Amount	Extent of Damage	Surface Treatment	Action Assessment	Material Assessment
Non Asbestos	Insulating Board	N/A	N/A	N/A	N/A	0

Comments: No asbestos was detected in the sample taken from the material.

Recommendations: No further action is required.

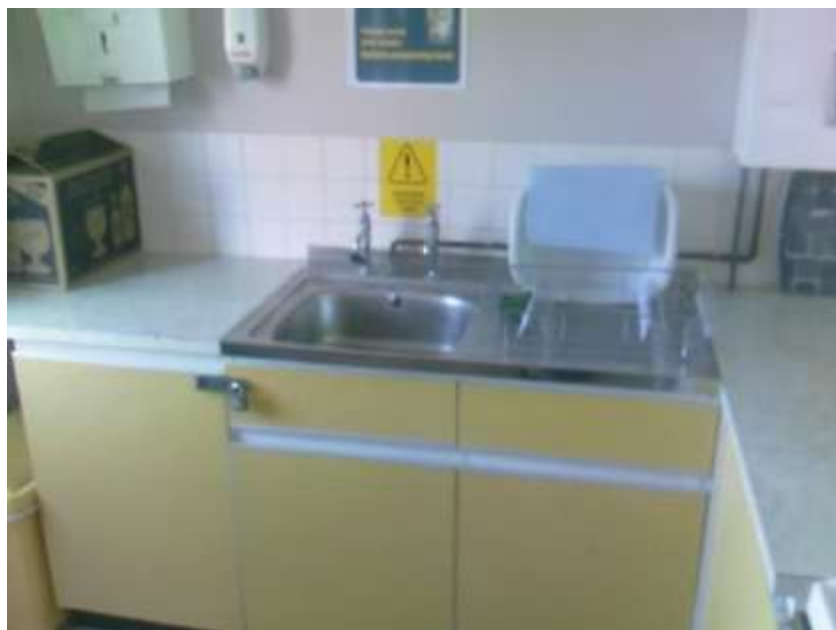
Asbestos Type	Product Type	Amount	Extent of Damage	Surface Treatment	Action Assessment	Material Assessment
Chrysotile (White)	Bitumen	< 1 Sq M	Good condition: No visible damage	Sealed Composite Materials	Manage	2

Comments: The material was seen to be in good condition at the time of the initial inspection.

Recommendations: The condition of the material should be monitored by a competent person/company and its presence made aware to those at risk, as part of a Control of Asbestos Regulations (CAR) 2006 compliant management strategy.

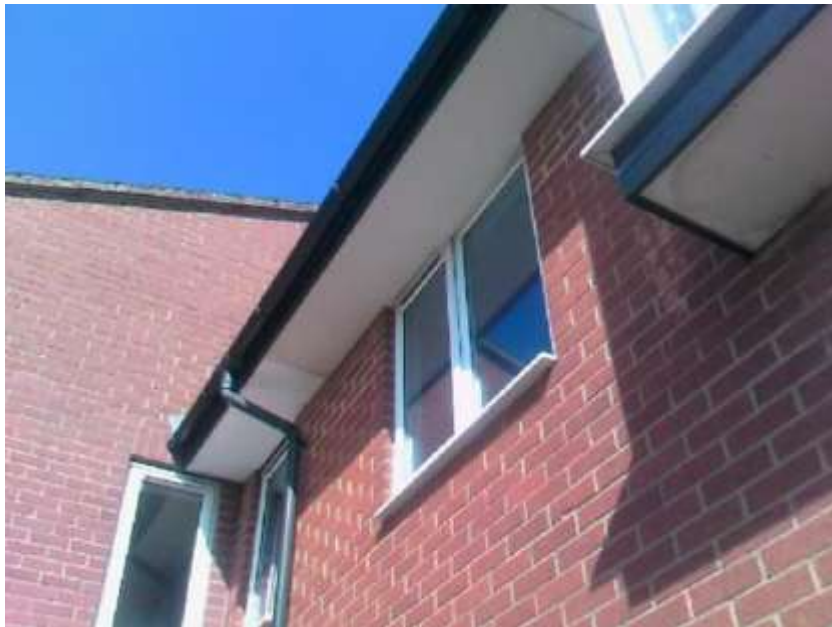
Asbestos Type	Product Type	Amount	Extent of Damage	Surface Treatment	Action Assessment	Material Assessment
Non Asbestos	Insulating Board	N/A	N/A	N/A	N/A	0

Comments: No asbestos was detected in the sample taken from the material.

Recommendations: No further action is required.

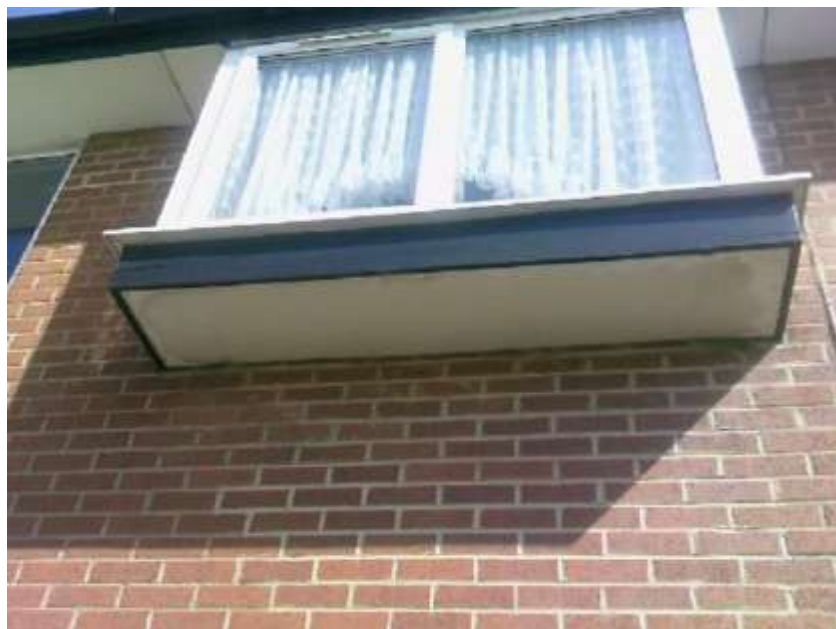
Asbestos Type	Product Type	Amount	Extent of Damage	Surface Treatment	Action Assessment	Material Assessment
Non Asbestos	Insulating Board	N/A	N/A	N/A	N/A	0

Comments: No asbestos was detected in the sample taken from the material.

Recommendations: No further action is required.

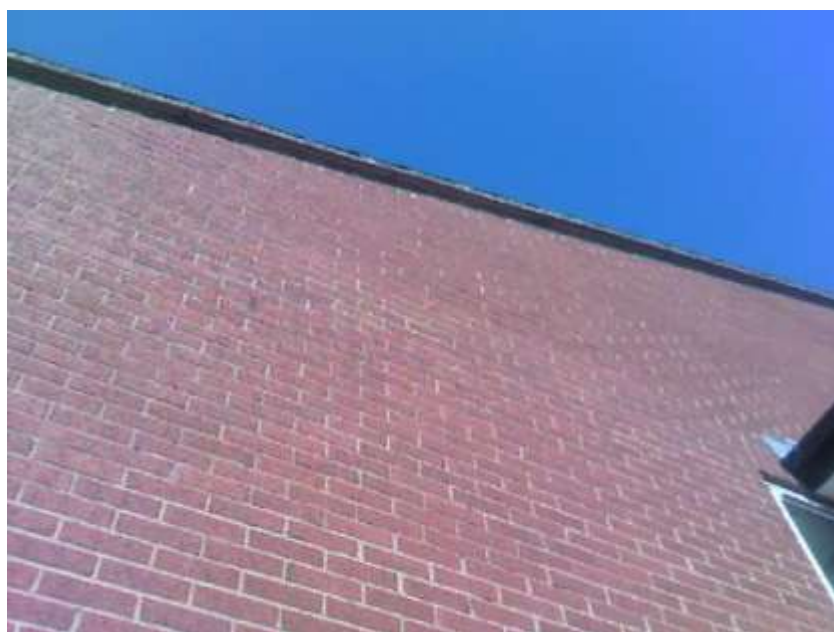
Asbestos Type	Product Type	Amount	Extent of Damage	Surface Treatment	Action Assessment	Material Assessment
Presumed	Cement	< 100 Lin M	Good condition: No visible damage	Sealed Composite Materials	Manage	4

Comments: It has been noted in previous experience that this type of material has been known to contain asbestos.

Recommendations: Until such time as proven otherwise, the material should be managed as an asbestos containing product in accordance with CAR2012 and subject to regular inspection.
