Management Survey (with MA only)

**At
19 Kelvin Hill
Basingstoke
Hampshire,
RG22 6EF**

Sanctuary Group

Job Number	J276835
------------	---------

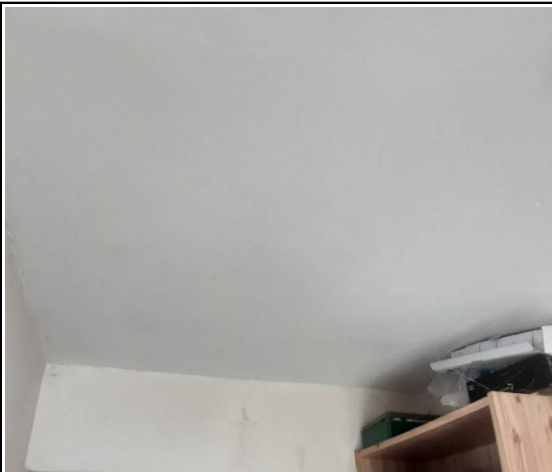
Inspection Number:	1	Intrusive Area – Yes or No:	No
Material Assessment			
Item:	Detail:		
Building:	1 / Three bedroom house		
Location:	Ground / Hall G01		
Sample Number:	Visual		
Description:	No suspect materials visually found		
Position:			
Extent:			
Product Type:	N/A		
Damage & Deterioration:	N/A		
Surface Treatment:	N/A		
Asbestos Type:	-		
Material Score:	0

Room Comments:	plasterboard ceiling solid walls with plaster skim. Concrete floor with carpets covering. Timber doors and frames.

Sample Comments:	N/A	
Total Assessment Score:	0	
Risk Assessment Category:	N/A	
Recommendation:	Not applicable

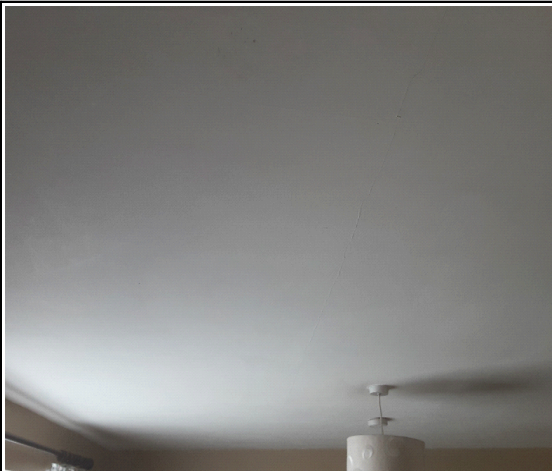
Inspection Number:	2	Intrusive Area – Yes or No:	No
Material Assessment			
Item:	Detail:		
Building:	1 / Three bedroom house		
Location:	Ground / Living Room G02		
Sample Number:	Visual		
Description:	No suspect materials visually found		
Position:			
Extent:			
Product Type:	N/A		
Damage & Deterioration:	N/A		
Surface Treatment:	N/A		
Asbestos Type:	-		
Material Score:	0

Room Comments:	plasterboard ceiling solid walls with plaster skim. Concrete floor with carpets covering. Upvc windows. Timber door and frame.

Sample Comments:	N/A	
Total Assessment Score:	0	
Risk Assessment Category:	N/A	
Recommendation:	Not applicable

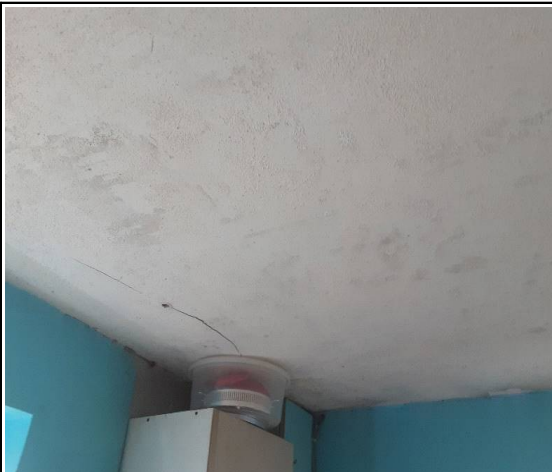
Inspection Number:	3	Intrusive Area – Yes or No:	No
Material Assessment			
Item:		Detail:	
Building:		1 / Three bedroom house	
Location:		Ground / Kitchen G03	
Sample Number:		GD011028	
Description:		Decorative Finishes	
Position:		to ceiling	
Extent:		8m ²	
Product Type:		Textured Coating	
Damage & Deterioration:		Low Damage	
Surface Treatment:		Enclosed sprays and lagging, Sealed AIB	
Asbestos Type:		No Asbestos Detected	
Material Score:		0

Room Comments:	plasterboard ceiling solid walls with plaster skim. Concrete floor. Upvc windows. Timber door and frame.

Sample Comments:	N/A	
Total Assessment Score:	0	
Risk Assessment Category:	N/A	
Recommendation:	Not applicable

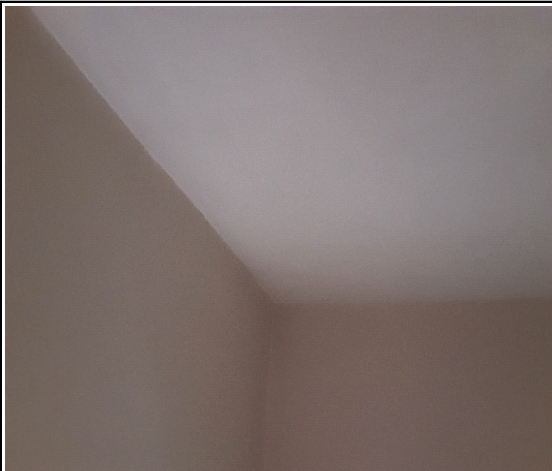
Inspection Number:	4	Intrusive Area – Yes or No:	No
Material Assessment			
Item:		Detail:	
Building:		1 / Three bedroom house	
Location:		First / Landing 101	
Sample Number:		Visual	
Description:		No suspect materials visually found	
Position:			
Extent:			
Product Type:		N/A	
Damage & Deterioration:		N/A	
Surface Treatment:		N/A	
Asbestos Type:		-	
Material Score:		0

Room Comments:	plasterboard ceiling solid walls with plaster skim. Wooden floorboards and stairs with carpets covering. Timber doors and frames.

Sample Comments:	N/A	
Total Assessment Score:	0	
Risk Assessment Category:	N/A	
Recommendation:	Not applicable

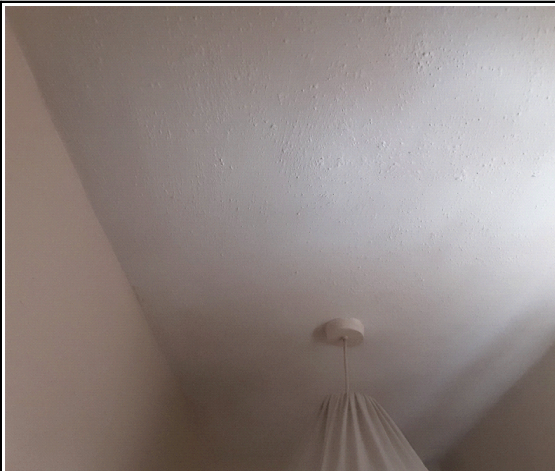
Inspection Number:	5	Intrusive Area – Yes or No:	No
Material Assessment			
Item:	Detail:		
Building:	1 / Three bedroom house		
Location:	First / Toilet 102		
Sample Number:	GD011029		
Description:	Decorative Finishes		
Position:	to ceiling		
Extent:	2m ²		
Product Type:	Textured Coating		
Damage & Deterioration:	Low Damage		
Surface Treatment:	Enclosed sprays and lagging, Sealed AIB		
Asbestos Type:	No Asbestos Detected		
Material Score:	0

Room Comments:	plasterboard ceiling solid walls with plaster skim. Wooden floorboards with carpets covering. Ceramic toilet and cistern. Timber door and frame.

Sample Comments:	N/A	
Total Assessment Score:	0	
Risk Assessment Category:	N/A	
Recommendation:	Not applicable

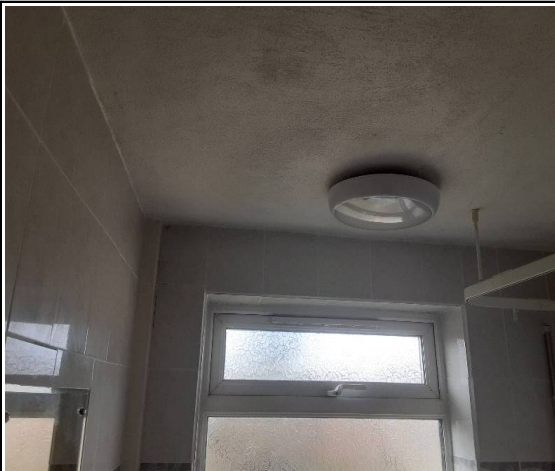
Inspection Number:	6	Intrusive Area – Yes or No:	No
Material Assessment			
Item:	Detail:		
Building:	1 / Three bedroom house		
Location:	First / Bathroom 103		
Sample Number:	AS GD011029		
Description:	Decorative Finishes		
Position:	to ceiling		
Extent:	6m ²		
Product Type:	Textured Coating		
Damage & Deterioration:	Low Damage		
Surface Treatment:	Enclosed sprays and lagging, Sealed AIB		
Asbestos Type:	No Asbestos Detected		
Material Score:	0

Room Comments:	plasterboard ceiling solid walls with plaster skim. Wooden floorboards with modern plastic covering. Metal bath with wood panel. Upvc windows. Timber door and frame.

Sample Comments:	N/A	
Total Assessment Score:	0	
Risk Assessment Category:	N/A	
Recommendation:	Not applicable

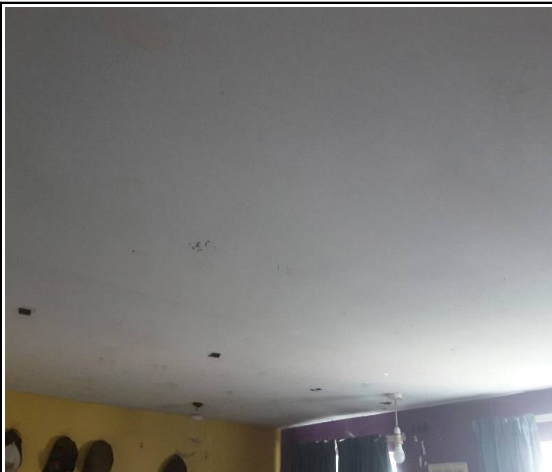
Inspection Number:	7	Intrusive Area – Yes or No:	No
Material Assessment			
Item:	Detail:		
Building:	1 / Three bedroom house		
Location:	First / Bedroom 104		
Sample Number:	Visual		
Description:	No suspect materials visually found		
Position:			
Extent:			
Product Type:	N/A		
Damage & Deterioration:	N/A		
Surface Treatment:	N/A		
Asbestos Type:	-		
Material Score:	0

Room Comments:	plasterboard ceiling solid walls with plaster skim. Wooden floorboards with carpets covering. Upvc windows. Timber door and frame.

Sample Comments:	N/A	
Total Assessment Score:	0	
Risk Assessment Category:	N/A	
Recommendation:	Not applicable

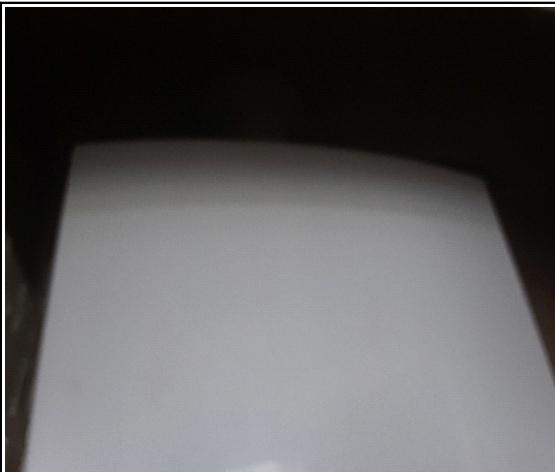
Inspection Number:	8	Intrusive Area – Yes or No:	No
Material Assessment			
Item:	Detail:		
Building:	1 / Three bedroom house		
Location:	First / Cupboard 105		
Sample Number:	Visual		
Description:	No suspect materials visually found		
Position:			
Extent:			
Product Type:	N/A		
Damage & Deterioration:	N/A		
Surface Treatment:	N/A		
Asbestos Type:	-		
Material Score:	0

Room Comments:	plasterboard ceiling solid walls with plaster skim. Wooden floorboards. Boiler fixed to solid wall with metal flue passing through to loft. Timber door and frame.

Sample Comments:	N/A	
Total Assessment Score:	0	
Risk Assessment Category:	N/A	
Recommendation:	Not applicable

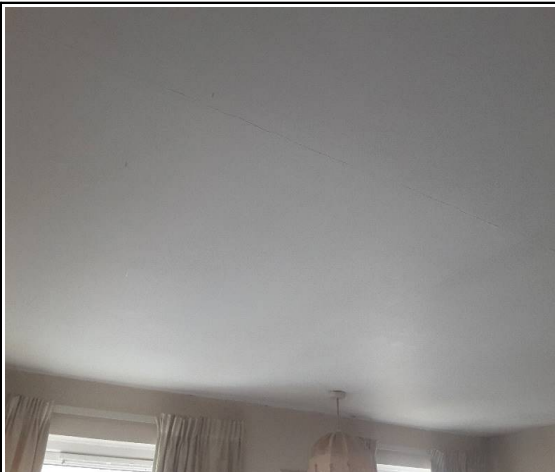
Inspection Number:	9	Intrusive Area – Yes or No:	No
Material Assessment			
Item:		Detail:	
Building:		1 / Three bedroom house	
Location:		First / Bedroom 106	
Sample Number:		Visual	
Description:		No suspect materials visually found	
Position:			
Extent:			
Product Type:		N/A	
Damage & Deterioration:		N/A	
Surface Treatment:		N/A	
Asbestos Type:		-	
Material Score:		0

Room Comments:	plasterboard ceiling solid walls with plaster skim. Wooden floorboards with carpets covering. Upvc windows. Timber door and frame.

Sample Comments:	N/A	
Total Assessment Score:	0	
Risk Assessment Category:	N/A	
Recommendation:	Not applicable

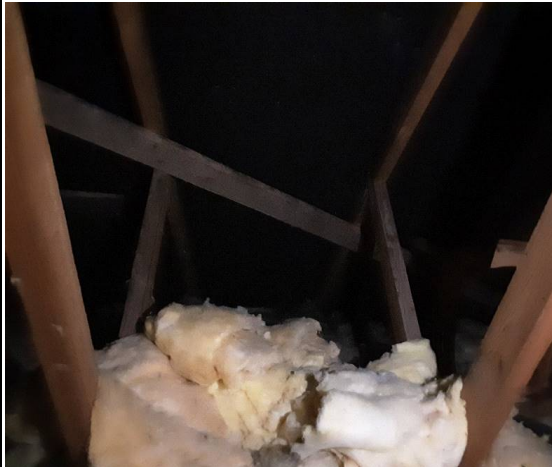
Inspection Number:	11	Intrusive Area – Yes or No:	No
Material Assessment			
Item:		Detail:	
Building:		1 / Three bedroom house	
Location:		Roof / Loft Space R01	
Sample Number:		Visual	
Description:		No suspect materials visually found	
Position:			
Extent:			
Product Type:		N/A	
Damage & Deterioration:		N/A	
Surface Treatment:		N/A	
Asbestos Type:		-	
Material Score:		0

Room Comments:	plasterboard floor forming ceiling below timber joists with mmmf lagging above. Modern felt to underside of roof. Wooden hatch.

Sample Comments:	N/A	
Total Assessment Score:	0	
Risk Assessment Category:	N/A	
Recommendation:	Not applicable

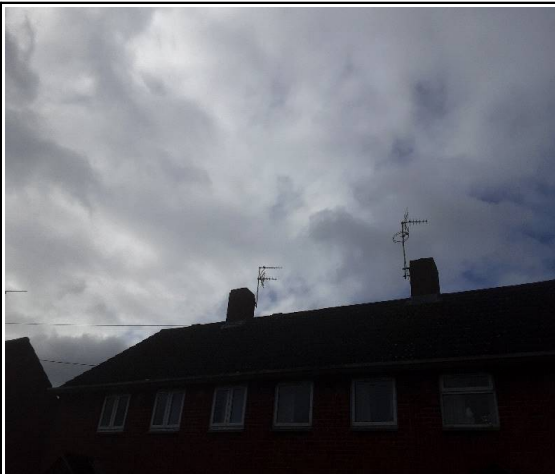
Inspection Number:	12	Intrusive Area – Yes or No:	No
Material Assessment			
Item:		Detail:	
Building:		1 / Three bedroom house	
Location:		External / External E01	
Sample Number:		Visual	
Description:		No suspect materials visually found	
Position:			
Extent:			
Product Type:		N/A	
Damage & Deterioration:		N/A	
Surface Treatment:		N/A	
Asbestos Type:		-	
Material Score:		0

Room Comments:	Two storey building with a pitched stone tiled roof. Concrete gutters plastic downpipe.

Sample Comments:	N/A	
Total Assessment Score:	0	
Risk Assessment Category:	N/A	
Recommendation:	Not applicable
