**An Asbestos Management Survey with part Refurbishment/Demolition (MA and PA) to  
the areas affected by fire alarm upgrade**

**at  
1 Phoenix House  
Dommetts Lane  
Frome  
Somerset  
BA11 4JT**

<b>Survey Carried Out On:</b>	<b>06 September 2018</b>	 
<b>Commissioned By:</b>	<b>Daniel Edwards Guinness Partnership The Guinness Partnership 30 Brock Street Regents Place London NW1 3FG</b>	
<b>Date:</b>	<b>16 September 2018</b>	
<b>Our Reference:</b>	<b>J118461</b>	
<b>Surveyed By:</b>	<b>Fiona Williamson</b>

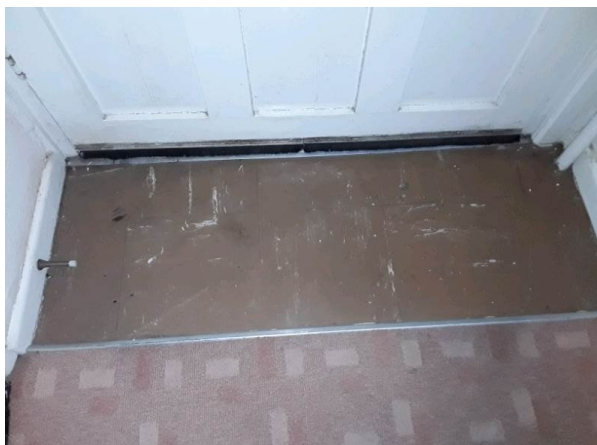
<b>Building:</b> Building	<b>Floor Level:</b> Ground	<b>Room Name:</b> (001) Hall
<b>Component:</b> Thermoplastic Floor Tiles (Asbestos Reinforced Composite)

Sample Reference	Asbestos Type	Material	Surface Treatment Score	
AZ002688 (Sample 1)	Chrysotile (1)	Floor Tile + Bitumen Backing (1)	0	
Extent of damage	Material Assessment**	Accessibility	Extent/amount	Location
Low Damage (1)	Very Low (3)	1	8.0m² (1)	2
Occupant Activity	No. of Occupants	Frequency of Use	Average Time Area is in Use	
1 (Low disturbance)	1 (1 to 3)	3 (Daily)	1 (1 to 3 hours)	
Type of Maintenance		Frequency of Maintenance	Priority Assessment	
1 (Low disturbance)		1 (<1 per year)	6	
Recommendations				
Who	What		When	
Licensed contractor	Remediate in-line with refurb scope		Prior to refurbishment if likely to be disturbed	
Further Recommendations: Bitumen backed Brown floor tiles to concrete floor (mainly located under carpet)				
General Notes: Plaster ceiling Woodchip wallpaper to plaster to brick walls Bitumen backed brown floor tiles to concrete floor (mainly located under carpet) Modern electrics Modern radiator

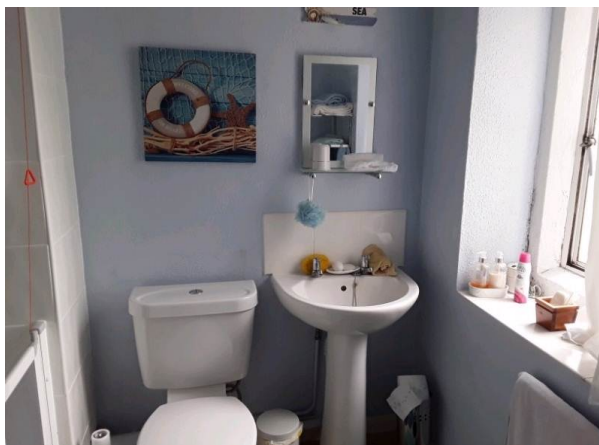
<b>Building:</b> Building	<b>Floor Level:</b> Ground	<b>Room Name:</b> (002) Bathroom
<b>Component:</b> No Asbestos Product Type

Sample Reference	Asbestos Type	Material	Surface Treatment Score	
	No suspect materials			
Extent of damage	Material Assessment**	Accessibility	Extent/amount	Location
Occupant Activity	No. of Occupants	Frequency of Use	Average Time Area is in Use	
Type of Maintenance		Frequency of Maintenance	Priority Assessment	
Recommendations				
Who	What		When	
-	No further action required		-	
Further Recommendations: None				
General Notes: Plaster ceiling Woodchip wallpaper to plaster to brick walls Modern flooring to concrete floor - no access below flooring (excessive damage) Ceramic tiles to boxing adjacent to shower - no access within boxing (excessive damage) Metal windows Modern radiator

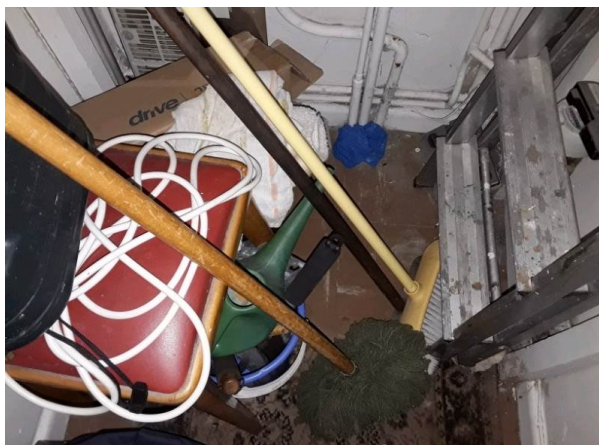
<b>Building:</b> Building	<b>Floor Level:</b> Ground	<b>Room Name:</b> (003) Cupboard
<b>Component:</b> Thermoplastic Floor Tiles (Asbestos Reinforced Composite)

Sample Reference	Asbestos Type	Material	Surface Treatment Score	
As AZ002688 (Ref Sample 1)	Chrysotile (1)	Floor Tile + Bitumen Backing (1)	0	
Extent of damage	Material Assessment**	Accessibility	Extent/amount	Location
Low Damage (1)	Very Low (3)	1	5.0m² (1)	2
Occupant Activity	No. of Occupants	Frequency of Use	Average Time Area is in Use	
1 (Low disturbance)	1 (1 to 3)	3 (Daily)	0 (<1 hour)	
Type of Maintenance		Frequency of Maintenance	Priority Assessment	
1 (Low disturbance)		1 (<1 per year)	6	
Recommendations				
Who	What		When	
Competent person	Manage and Inspect		Now and periodically	
Further Recommendations: Bitumen backed Brown floor tiles to concrete floor				
General Notes:				
Plaster ceiling Plaster to brick walls Bitumen backed brown floor tiles to concrete floor Modern Valliant boiler Metal flue

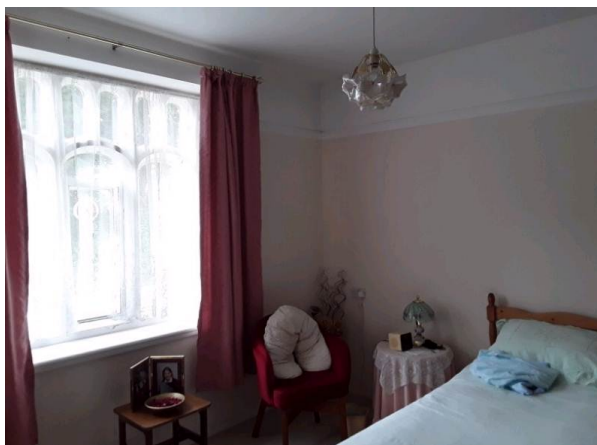
<b>Building:</b> Building	<b>Floor Level:</b> Ground	<b>Room Name:</b> (004) Bedroom
<b>Component:</b> No Asbestos Product Type

Sample Reference	Asbestos Type		Material	Surface Treatment Score	
	No suspect materials				
Extent of damage	Material Assessment**		Accessibility	Extent/amount	Location
Occupant Activity	No. of Occupants		Frequency of Use	Average Time Area is in Use	
Type of Maintenance		Frequency of Maintenance		Priority Assessment	
Recommendations					
Who	What			When	
-	No further action required			-	
Further Recommendations: None					
General Notes: Plaster ceiling Woodchip wallpaper to plaster to brick walls Carpet to wooden floorboards Metal and wooden windows Modern radiator

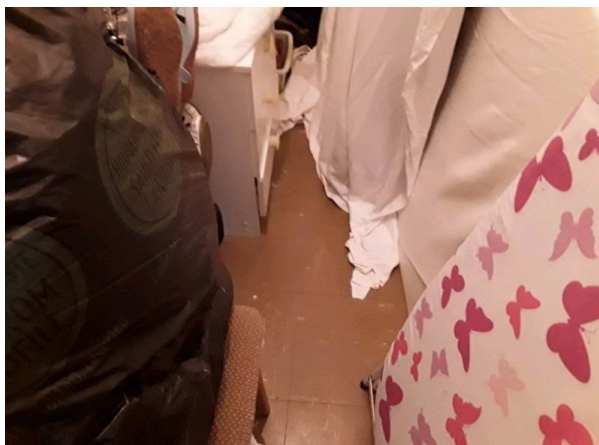
<b>Building:</b> Building	<b>Floor Level:</b> Ground	<b>Room Name:</b> (005) Cupboard
<b>Component:</b> Thermoplastic Floor Tiles (Asbestos Reinforced Composite)

Sample Reference	Asbestos Type	Material	Surface Treatment Score	
As AZ002688 (Ref Sample 1)	Chrysotile (1)	Floor Tile + Bitumen Backing (1)	0	
Extent of damage	Material Assessment**	Accessibility	Extent/amount	Location
Low Damage (1)	Very Low (3)	1	5.0m <sup>2</sup> (1)	2
Occupant Activity	No. of Occupants	Frequency of Use	Average Time Area is in Use	
1 (Low disturbance)	1 (1 to 3)	3 (Daily)	0 (<1 hour)	
Type of Maintenance		Frequency of Maintenance	Priority Assessment	
1 (Low disturbance)		1 (<1 per year)	6	
Recommendations				
Who	What		When	
Competent person	Manage and Inspect		Now and periodically	
Further Recommendations: Bitumen backed Brown floor tiles to wooden floorboards				
General Notes:				
Plaster ceiling Woodchip wallpaper to plaster to brick walls Bitumen backed brown floor tiles to concrete floor

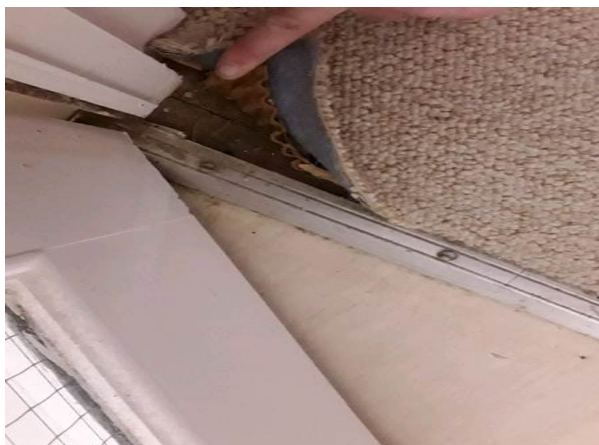
<b>Building:</b> Building	<b>Floor Level:</b> Ground	<b>Room Name:</b> (006) Lounge
<b>Component:</b> Thermoplastic Floor Tiles (Asbestos Reinforced Composite)

Sample Reference	Asbestos Type	Material	Surface Treatment Score	
As AZ002688 (Ref Sample 1)	Chrysotile (1)	Floor Tile + Bitumen Backing (1)	0	
Extent of damage	Material Assessment**	Accessibility	Extent/amount	Location
Low Damage (1)	Very Low (3)	1	12.0m² (2)	2
Occupant Activity	No. of Occupants	Frequency of Use	Average Time Area is in Use	
1 (Low disturbance)	1 (1 to 3)	3 (Daily)	3 (>6 hours)	
Type of Maintenance		Frequency of Maintenance	Priority Assessment	
1 (Low disturbance)		1 (<1 per year)	7	
Recommendations				
Who	What		When	
Competent person	Manage and Inspect		Now and periodically	
Further Recommendations: Bitumen backed Brown floor tiles to concrete floor (under carpet)				
General Notes: Plaster ceiling Woodchip wallpaper plaster to brick walls Bitumen backed brown floor tiles to concrete floor (under carpet) Metal and wooden Windows Wooden fireplace Modern radiator

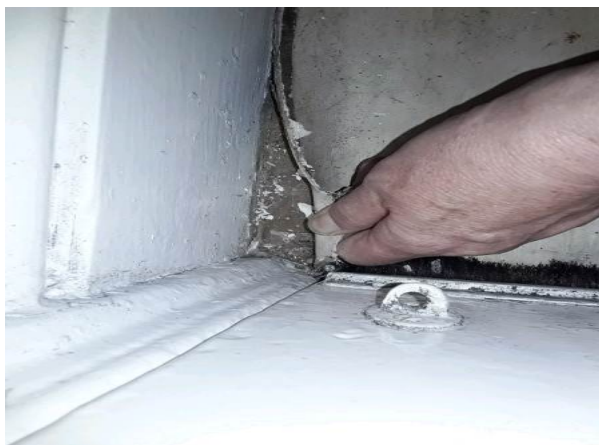
<b>Building:</b> Building	<b>Floor Level:</b> Ground	<b>Room Name:</b> (007) kitchen
<b>Component:</b> Thermoplastic Floor Tiles (Asbestos Reinforced Composite)

Sample Reference	Asbestos Type	Material	Surface Treatment Score	
As AZ002688 (Ref Sample 1)	Chrysotile (1)	Floor Tile + Bitumen Backing (1)	0	
Extent of damage	Material Assessment**	Accessibility	Extent/amount	Location
Low Damage (1)	Very Low (3)	1	7.0m² (1)	2
Occupant Activity	No. of Occupants	Frequency of Use	Average Time Area is in Use	
1 (Low disturbance)	1 (1 to 3)	3 (Daily)	1 (1 to 3 hours)	
Type of Maintenance		Frequency of Maintenance	Priority Assessment	
1 (Low disturbance)		1 (<1 per year)	6	
Recommendations				
Who	What		When	
Licensed contractor	Remediate in-line with refurb scope		Prior to refurbishment if likely to be disturbed	
Further Recommendations: Bitumen backed Brown floor tiles to concrete floor (under modern linoleum)				
General Notes: Woodchip wallpaper to plaster ceiling Woodchip wallpaper to plaster to brick walls Bitumen backed brown floor tiles to concrete floor (under modern linoleum) Wooden Windows Modern radiator Modern sink pad
