**An Asbestos Management Survey with part Refurbishment/Demolition (MA and PA) to
the refurbishment survey to areas affected by kitchen replacement**

**at
2 Wellsway Park
Bath
BA2 2DD**

Survey Carried Out On:	20 August 2018	 
Commissioned By:	Daniel Edwards Guinness Partnership The Guinness Partnership 30 Brock Street Regents Place London NW1 3FG	
Date:	24 August 2018	
Our Reference:	J117228	
Surveyed By:	Fiona Williamson

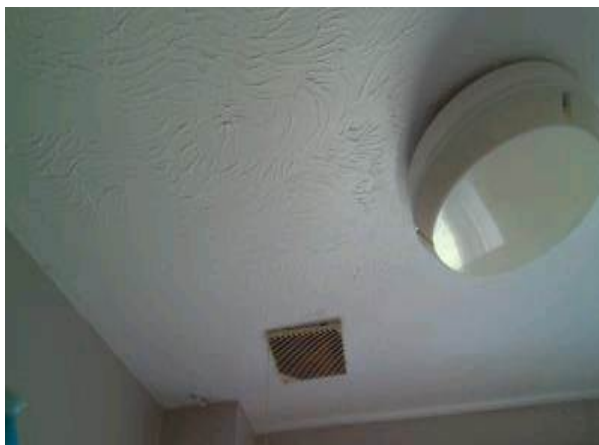
Building: N/A	Floor Level: First	Room Name: (001) Bathroom
Component: Textured Coating (Asbestos Reinforced Composite)

Sample Reference	Asbestos Type	Material	Surface Treatment Score	
DV000173 (Sample 1)	No Asbestos Detected			
Extent of damage	Material Assessment**	Accessibility	Extent/amount	Location
Occupant Activity	No. of Occupants	Frequency of Use	Average Time Area is in Use	
Type of Maintenance	Frequency of Maintenance		Priority Assessment	
Recommendations				
Who	What		When	
-	No further action required		-	
Further Recommendations: None				
General Notes: Textured coating to plasterboard ceiling Plaster to brick and plasterboard walls Modern linoleum to wood floorboards uPVC window Ceramic sill Wood bath panel - no access behind panel (excessive damage) Plaster boxing adjacent to toilet - no access within boxing (excessive damage) Modern extract fan in ceiling

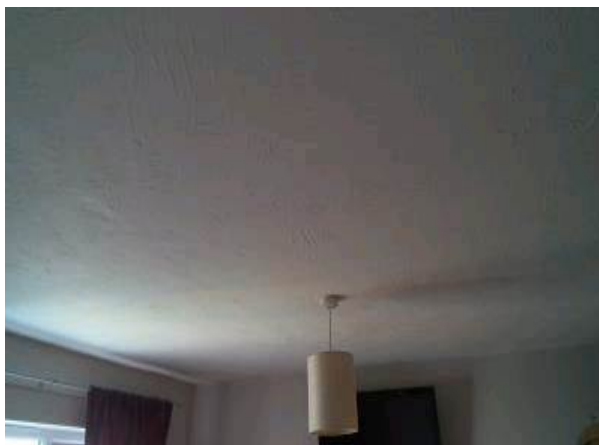
Building: N/A	Floor Level: First	Room Name: (002) Bedroom
Component: Textured Coating (Asbestos Reinforced Composite)

Sample Reference	Asbestos Type	Material	Surface Treatment Score	
As DV000173 (Ref Sample 1)	No asbestos detected in visually consistent material			
Extent of damage	Material Assessment**	Accessibility	Extent/amount	Location
Occupant Activity	No. of Occupants	Frequency of Use	Average Time Area is in Use	
Type of Maintenance		Frequency of Maintenance	Priority Assessment	
Recommendations				
Who	What		When	
-	No further action required		-	
Further Recommendations: None				
General Notes: Textured coating to plasterboard ceiling Plaster to brick and plasterboard walls Carpet to wood floorboards uPVC window Wood sill

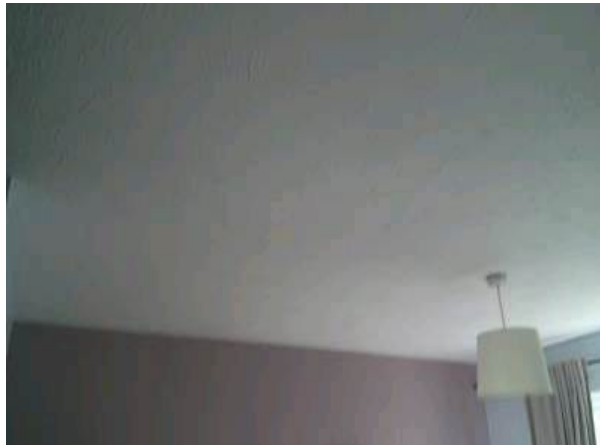
Building: N/A	Floor Level: First	Room Name: (003) Bedroom
Component: Textured Coating (Asbestos Reinforced Composite)

Sample Reference	Asbestos Type	Material	Surface Treatment Score	
As DV000173 (Ref Sample 1)	No asbestos detected in visually consistent material			
Extent of damage	Material Assessment**	Accessibility	Extent/amount	Location
Occupant Activity	No. of Occupants	Frequency of Use	Average Time Area is in Use	
Type of Maintenance		Frequency of Maintenance	Priority Assessment	
Recommendations				
Who	What		When	
-	No further action required		-	
Further Recommendations: None				
General Notes: Textured coating to plasterboard ceiling Plaster to brick and plasterboard walls Carpet to wood floorboards uPVC window Wood sill

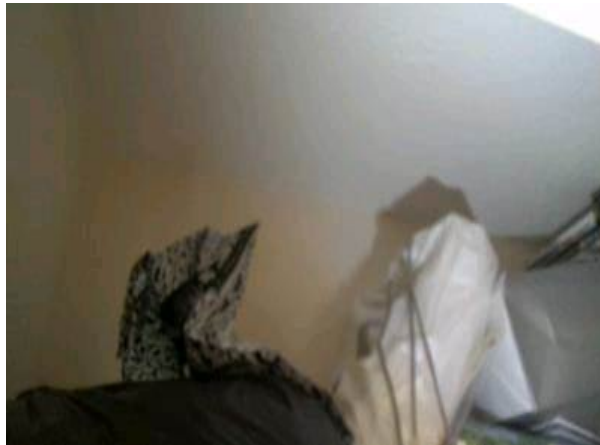
Building: N/A	Floor Level: First	Room Name: (004) Cupboard
Component: Textured Coating (Asbestos Reinforced Composite)

Sample Reference	Asbestos Type	Material	Surface Treatment Score	
As DV000173 (Ref Sample 1)	No asbestos detected in visually consistent material			
Extent of damage	Material Assessment**	Accessibility	Extent/amount	Location
Occupant Activity	No. of Occupants	Frequency of Use	Average Time Area is in Use	
Type of Maintenance		Frequency of Maintenance	Priority Assessment	
Recommendations				
Who	What		When	
-	No further action required		-	
Further Recommendations: None				
General Notes: Textured coating to plasterboard ceiling Plaster to brick and plasterboard walls Carpet to wood floorboards

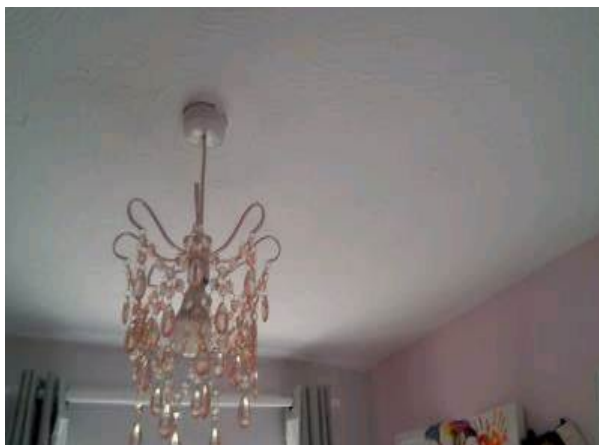
Building: N/A	Floor Level: First	Room Name: (005) Bedroom
Component: Textured Coating (Asbestos Reinforced Composite)

Sample Reference	Asbestos Type	Material	Surface Treatment Score	
As DV000173 (Ref Sample 1)	No asbestos detected in visually consistent material			
Extent of damage	Material Assessment**	Accessibility	Extent/amount	Location
Occupant Activity	No. of Occupants	Frequency of Use	Average Time Area is in Use	
Type of Maintenance		Frequency of Maintenance	Priority Assessment	
Recommendations				
Who	What		When	
-	No further action required		-	
Further Recommendations: None				
General Notes: Textured coating to plasterboard ceiling Plaster to brick and plasterboard walls Carpet to wood floorboards uPVC window Wood sill

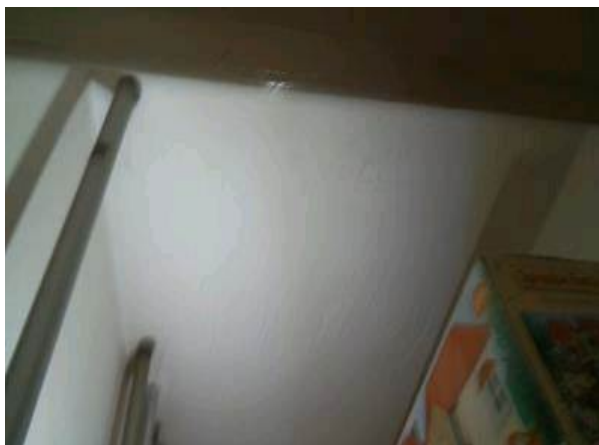
Building: N/A	Floor Level: First	Room Name: (006) Cupboard
Component: Textured Coating (Asbestos Reinforced Composite)

Sample Reference	Asbestos Type	Material	Surface Treatment Score	
As DV000173 (Ref Sample 1)	No asbestos detected in visually consistent material			
Extent of damage	Material Assessment**	Accessibility	Extent/amount	Location
Occupant Activity	No. of Occupants	Frequency of Use	Average Time Area is in Use	
Type of Maintenance		Frequency of Maintenance	Priority Assessment	
Recommendations				
Who	What		When	
-	No further action required		-	
Further Recommendations: None				
General Notes: Textured coating to plasterboard ceiling Plaster to brick and plasterboard walls Wood floorboards Modern emersion heater

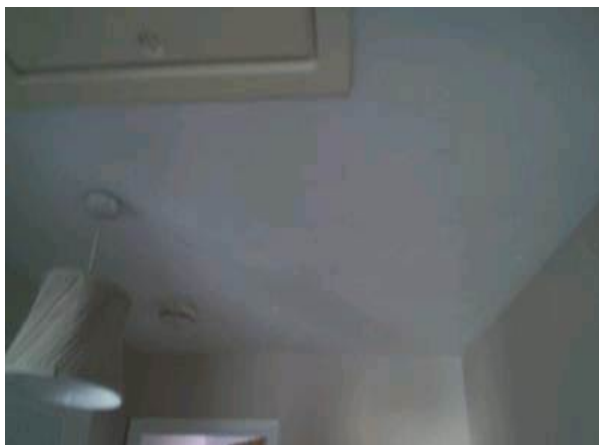
Building: N/A	Floor Level: First	Room Name: (007) Landing
Component: Textured Coating (Asbestos Reinforced Composite)

Sample Reference	Asbestos Type	Material	Surface Treatment Score	
DV000174 (Sample 2)	No Asbestos Detected			
Extent of damage	Material Assessment**	Accessibility	Extent/amount	Location
Occupant Activity	No. of Occupants	Frequency of Use	Average Time Area is in Use	
Type of Maintenance		Frequency of Maintenance	Priority Assessment	
Recommendations				
Who	What		When	
-	No further action required		-	
Further Recommendations: None				
General Notes: Textured coating to plasterboard ceiling Plaster to brick and plasterboard walls Carpet to wood floorboards Polystyrene to plastic loft hatch

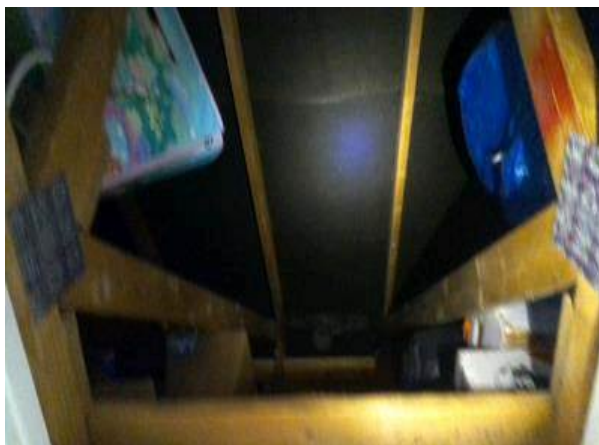
Building: N/A	Floor Level: First	Room Name: (008) Loft
Component: No Asbestos Product Type

Sample Reference	Asbestos Type	Material	Surface Treatment Score	
	No suspect materials			
Extent of damage	Material Assessment**	Accessibility	Extent/amount	Location
Occupant Activity	No. of Occupants	Frequency of Use	Average Time Area is in Use	
Type of Maintenance		Frequency of Maintenance	Priority Assessment	
Recommendations				
Who	What		When	
-	No further action required		-	
Further Recommendations: None				
General Notes: Modern roof felt Brick walls Plasterboard floor panels MMMF insulation Plastic tank

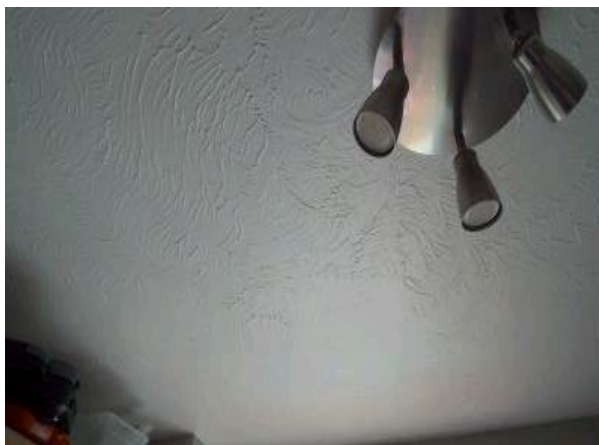
Building: N/A	Floor Level: Ground	Room Name: (009) Kitchen
Component: Textured Coating (Asbestos Reinforced Composite)

Sample Reference	Asbestos Type	Material	Surface Treatment Score	
DV000175 (Sample 3)	No Asbestos Detected			
Extent of damage	Material Assessment**	Accessibility	Extent/amount	Location
Occupant Activity	No. of Occupants	Frequency of Use	Average Time Area is in Use	
Type of Maintenance		Frequency of Maintenance	Priority Assessment	
Recommendations				
Who	What		When	
-	No further action required		-	
Further Recommendations: None				
General Notes: Textured coating to plasterboard ceiling Plaster to brick and plasterboard walls Modern linoleum to wood floorboards uPVC window Ceramic tile sill Sink pad Plasterboard boxing adjacent to window - no access within boxing (excessive damage) Wood panels to void area under cabinets - no access to void area (excessive damage)

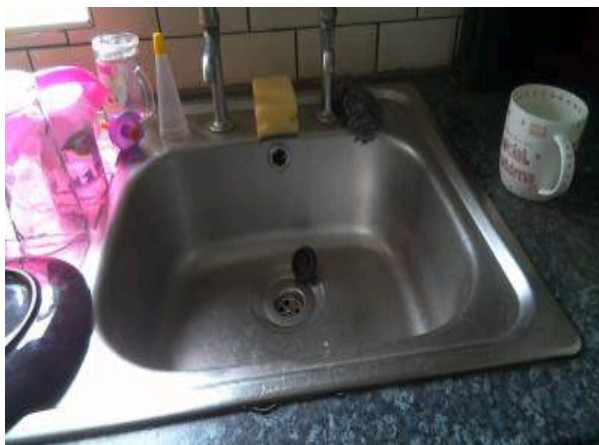
Building: N/A	Floor Level: Ground	Room Name: (009) Kitchen
Component: Bitumen Products (Asbestos Reinforced Composite)

Sample Reference	Asbestos Type		Material	Surface Treatment Score	
DV000176 (Sample 4)	No Asbestos Detected				
Extent of damage	Material Assessment**		Accessibility	Extent/amount	Location
Occupant Activity	No. of Occupants		Frequency of Use	Average Time Area is in Use	
Type of Maintenance		Frequency of Maintenance		Priority Assessment	
Recommendations					
Who		What			When
-		No further action required			-
Further Recommendations: None					
General Notes: Textured coating to plasterboard ceiling Plaster to brick and plasterboard walls Modern linoleum to wood floorboards uPVC window Ceramic tile sill Sink pad Plasterboard boxing adjacent to window - no access within boxing (excessive damage) Wood panels to void area under cabinets - no access to void area (excessive damage)

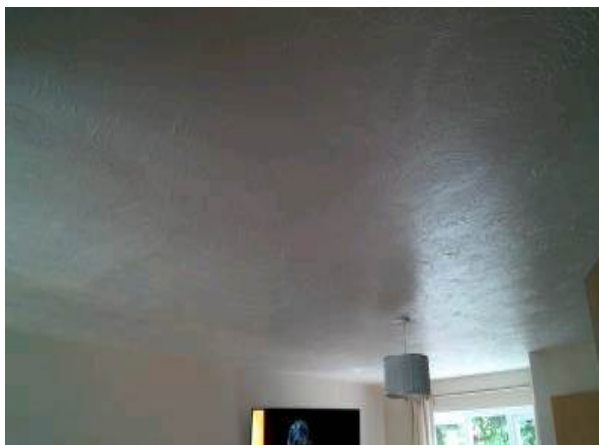
Building: N/A	Floor Level: Ground	Room Name: (010) Lounge
Component: Textured Coating (Asbestos Reinforced Composite)

Sample Reference	Asbestos Type	Material	Surface Treatment Score	
As DV000175 (Ref Sample 3)	No asbestos detected in visually consistent material			
Extent of damage	Material Assessment**	Accessibility	Extent/amount	Location
Occupant Activity	No. of Occupants	Frequency of Use	Average Time Area is in Use	
Type of Maintenance		Frequency of Maintenance	Priority Assessment	
Recommendations				
Who	What		When	
-	No further action required		-	
Further Recommendations: None				
General Notes: Textured coating to plasterboard ceiling Plaster to brick and plasterboard walls Carpet to wood floorboards uPVC windows and doors Wood sill

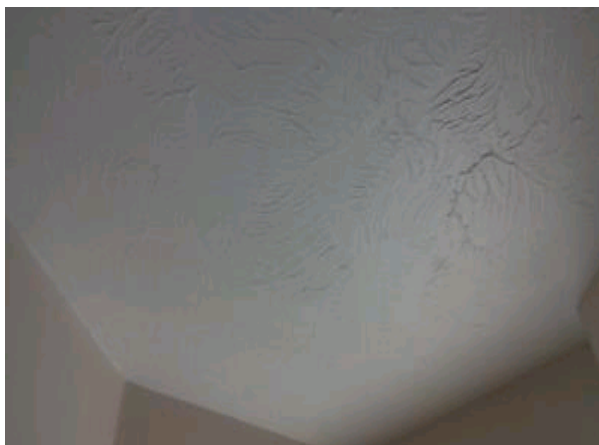
Building: N/A	Floor Level: Ground	Room Name: (011) Hall
Component: Textured Coating (Asbestos Reinforced Composite)

Sample Reference	Asbestos Type	Material	Surface Treatment Score	
DV000177 (Sample 5)	No Asbestos Detected			
Extent of damage	Material Assessment**	Accessibility	Extent/amount	Location
Occupant Activity	No. of Occupants	Frequency of Use	Average Time Area is in Use	
Type of Maintenance		Frequency of Maintenance	Priority Assessment	
Recommendations				
Who	What		When	
-	No further action required		-	
Further Recommendations: None				
General Notes: Textured coating to plasterboard ceiling Plaster to brick and plasterboard walls Carpet to wood floorboards Wood door

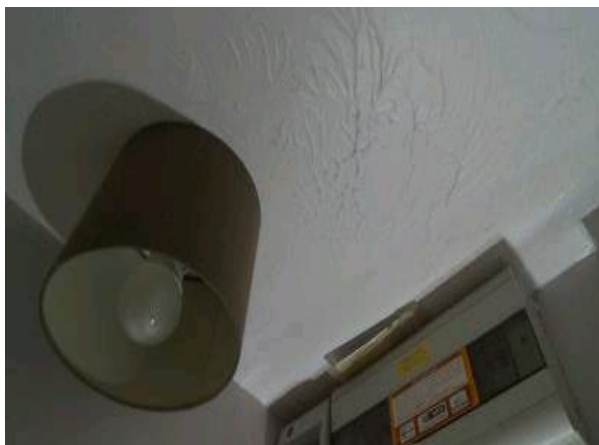
Building: N/A	Floor Level: Ground	Room Name: (013) Bathroom
Component: Textured Coating (Asbestos Reinforced Composite)

Sample Reference	Asbestos Type	Material	Surface Treatment Score	
As DV000175 (Ref Sample 3)	No asbestos detected in visually consistent material			
Extent of damage	Material Assessment**	Accessibility	Extent/amount	Location
Occupant Activity	No. of Occupants	Frequency of Use	Average Time Area is in Use	
Type of Maintenance		Frequency of Maintenance	Priority Assessment	
Recommendations				
Who	What		When	
-	No further action required		-	
Further Recommendations: None				
General Notes: Textured coating to plasterboard ceiling Plaster to brick and plasterboard walls Carpet to wood floorboards uPVC window Ceramic tile sill Ceramic cistern Modern electrics

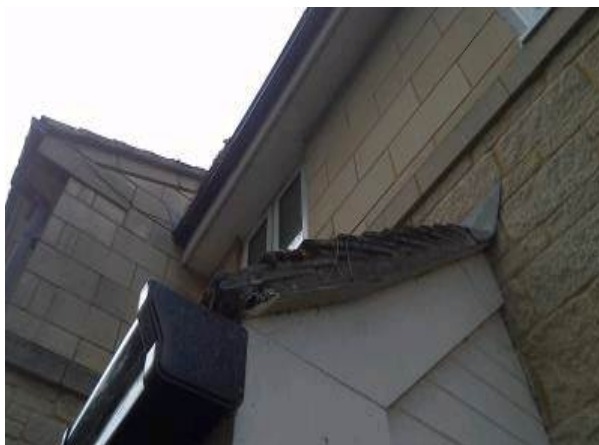
Building: N/A	Floor Level: External	Room Name: (014) External
Component: Asbestos Cement (Asbestos Reinforced Composite)

Location	Result (asbestos type)	Action	Sample Ref
N/A External (014) External Asbestos Cement (Asbestos Reinforced Composite)	Chrysotile	Manage and Inspect	DV000178 (Sample 6)

Sample Reference	Asbestos Type	Material	Surface Treatment Score	
DV000178 (Sample 6)	Chrysotile (1)	Cement (1)	1	
Extent of damage	Material Assessment**	Accessibility	Extent/amount	Location
Low Damage (1)	Very Low (4)	1	5m² (1)	0
Occupant Activity	No. of Occupants	Frequency of Use	Average Time Area is in Use	
1 (Low disturbance)	0 (None)	3 (Daily)	0 (<1 hour)	
Type of Maintenance		Frequency of Maintenance	Priority Assessment	
1 (Low disturbance)		1 (<1 per year)	4	
Recommendations				
Who	What		When	
Competent person	Manage and Inspect		Now and periodically	
Further Recommendations: Cement undercloak to roof and entrance canopy				
General Notes: Modern roof tiles Wood soffits Cement undercloak to roof Modern damp proof course uPVC windows
