**An Asbestos Management Survey (MA & PA) at
11 CHELSCOMBE, BATH, SOMERSET
BA1 4DA**

Survey Conducted:	21 October 2022	
Date of approval:	25 Oct 2022	
Our Reference:	J295772	
Surveyed By:	Fiona Williamson	
UPRN:	13199	
Scope of Works:	Management survey to all accessible areas of the property.	
Requested By:

Pennington Choices Ltd carried out an Asbestos Management Survey (MA & PA) at VOID 11 Chelscombe. The survey and this report are in accordance with HSG264 – Asbestos: The Survey Guide.

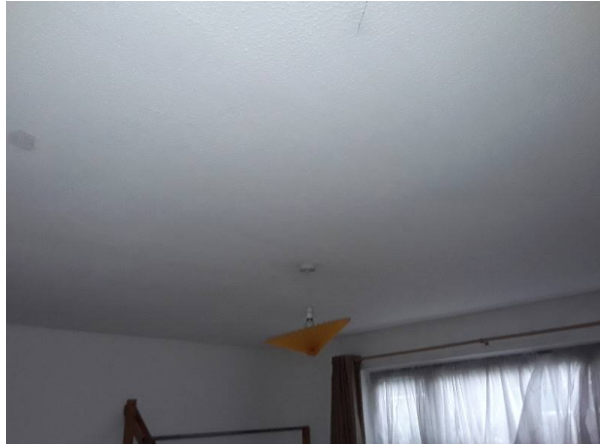
Building:	11 Chelscombe	Floor Level:	Ground	Item Ref:	J295772-1
Room Name:	(001) Bedroom				
Sample Ref:	FW008057				
Component:	Textured coating to plasterboard ceiling				
Extent:	14m ²

Material Assessment		
Product Type	Extent of damage	Surface Treatment Score
Textured Coating (1)	Low Damage (1)	1
Asbestos Type	Material Assessment Score (MA)	Very Low (4)
Chrysotile (1)

Priority Assessment		
Occupant Activity	Location Score	Accessibility Score
1 (Low disturbance)	2	1
Extent Score	No. of occupants	Frequency of Use
2 (10m ² - 50m ² or 10m - 50m pipe run)	1 (1 to 3)	3 (Daily)
Avg. time area is in use	Type of Maintenance	Freq. of Maintenance
3 (>6 hours)	1 (Low disturbance)	1 (<1 per year)
Priority Assessment Score (PA)		7

Conclusions and Actions	
Recommendation:	Manage and Inspect
Further Information:	None
General Notes: Textured coating to plasterboard ceiling. Plaster to brick walls. Bitumen backed brown and beige floor tiles to concrete floor. uPVC windows and uPVC over wooden sills. Metal grill in floor - no access behind grill (excessive damage). Wooden header panel above door to hall. Modern storage heater on wall.

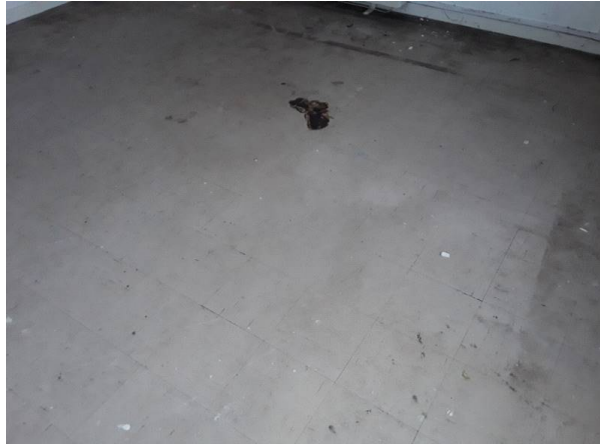
Building:	11 Chelscombe	Floor Level:	Ground	Item Ref:	J295772-2
Room Name:	(001) Bedroom				
Sample Ref:	FW008058				
Component:	Bitumen backed brown floor tiles to concrete floor				
Extent:	11m ²

Material Assessment		
Product Type	Extent of damage	Surface Treatment Score
Floor Tile + Bitumen Backing (1)	Low Damage (1)	0
Asbestos Type	Material Assessment Score (MA)	Very Low (3)
Chrysotile (1)

Priority Assessment		
Occupant Activity	Location Score	Accessibility Score
1 (Low disturbance)	2	3
Extent Score	No. of occupants	Frequency of Use
2 (10m ² - 50m ² or 10m - 50m pipe run)	1 (1 to 3)	3 (Daily)
Avg. time area is in use	Type of Maintenance	Freq. of Maintenance
3 (>6 hours)	1 (Low disturbance)	1 (<1 per year)
Priority Assessment Score (PA)		8

Conclusions and Actions	
Recommendation:	Manage and Inspect
Further Information:	None
General Notes: Textured coating to plasterboard ceiling. Plaster to brick walls. Bitumen backed brown and beige floor tiles to concrete floor. uPVC windows and uPVC over wooden sills. Metal grill in floor - no access behind grill (excessive damage). Wooden header panel above door to hall. Modern storage heater on wall.

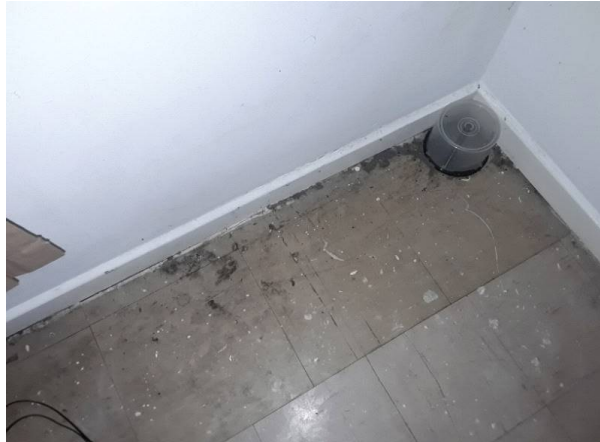
Building:	11 Chelscombe	Floor Level:	Ground	Item Ref:	J295772-3
Room Name:	(001) Bedroom				
Sample Ref:	FW008059				
Component:	Replacement bitumen backed beige floor tiles to concrete floor				
Extent:	3m ²

Material Assessment		
Product Type	Extent of damage	Surface Treatment Score
Floor Tile + Bitumen Backing (1)	Low Damage (1)	0
Asbestos Type	Material Assessment Score (MA)	Very Low (3)
Chrysotile (1)

Priority Assessment		
Occupant Activity	Location Score	Accessibility Score
1 (Low disturbance)	2	3
Extent Score	No. of occupants	Frequency of Use
1 (<10m ² or <10m pipe run)	1 (1 to 3)	3 (Daily)
Avg. time area is in use	Type of Maintenance	Freq. of Maintenance
3 (>6 hours)	1 (Low disturbance)	1 (<1 per year)
Priority Assessment Score (PA)		7

Conclusions and Actions	
Recommendation:	Manage and Inspect
Further Information:	None
General Notes: Textured coating to plasterboard ceiling. Plaster to brick walls. Bitumen backed brown and beige floor tiles to concrete floor. uPVC windows and uPVC over wooden sills. Metal grill in floor - no access behind grill (excessive damage). Wooden header panel above door to hall. Modern storage heater on wall.

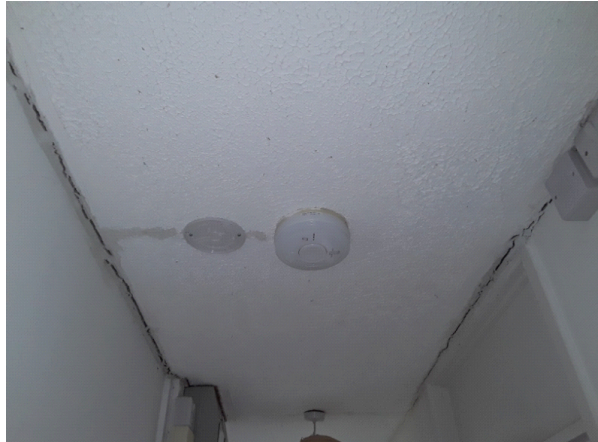
Building:	11 Chelscombe	Floor Level:	Ground	Item Ref:	J295772-4
Room Name:	(002) Hall				
Sample Ref:	As FW008057				
Component:	Textured coating to plasterboard ceiling				
Extent:	8m ²

Material Assessment		
Product Type	Extent of damage	Surface Treatment Score
Textured Coating (1)	Low Damage (1)	1
Asbestos Type	Material Assessment Score (MA)	Very Low (4)
Chrysotile (1)

Priority Assessment		
Occupant Activity	Location Score	Accessibility Score
1 (Low disturbance)	2	1
Extent Score	No. of occupants	Frequency of Use
1 (<10m ² or <10m pipe run)	1 (1 to 3)	3 (Daily)
Avg. time area is in use	Type of Maintenance	Freq. of Maintenance
0 (<1 hour)	1 (Low disturbance)	1 (<1 per year)
Priority Assessment Score (PA)		6

Conclusions and Actions	
Recommendation:	Manage and Inspect
Further Information:	None
General Notes: Textured coating to plasterboard ceiling. Plaster to brick walls. Wooden rear wall panel to alcove. Bitumen backed tan and brown floor tiles to concrete floor. Modern linoleum to wooden panel in alcove - no access behind wooden panel (excessive damage). uPVC front and rear doors. Wooden panel to rear of modern electrics on wall. Wooden panels to left and right hand side walls to alcove - no access behind panels (excessive damage). Wooden header panels above doors to bedroom and bathroom. Modern storage heater on wall.

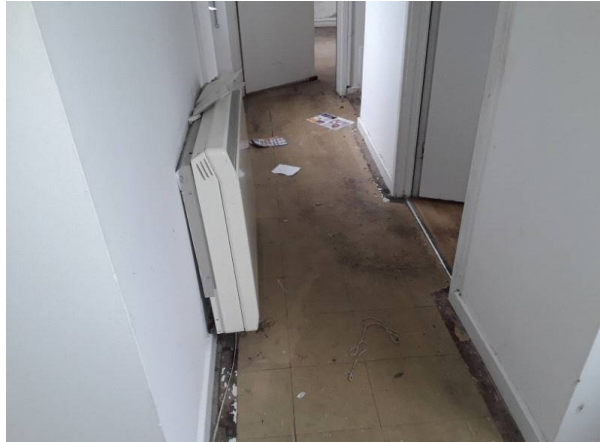
Building:	11 Chelscombe	Floor Level:	Ground	Item Ref:	J295772-5
Room Name:	(002) Hall				
Sample Ref:	FW008060				
Component:	Bitumen backed tan floor tiles to concrete floor				
Extent:	6m ²

Material Assessment		
Product Type	Extent of damage	Surface Treatment Score
Floor Tile + Bitumen Backing (1)	Low Damage (1)	0
Asbestos Type	Material Assessment Score (MA)	Very Low (3)
Chrysotile (1)

Priority Assessment		
Occupant Activity	Location Score	Accessibility Score
1 (Low disturbance)	2	3
Extent Score	No. of occupants	Frequency of Use
1 (<10m ² or <10m pipe run)	1 (1 to 3)	3 (Daily)
Avg. time area is in use	Type of Maintenance	Freq. of Maintenance
0 (<1 hour)	1 (Low disturbance)	1 (<1 per year)
Priority Assessment Score (PA)		6

Conclusions and Actions	
Recommendation:	Manage and Inspect
Further Information:	None
General Notes: Textured coating to plasterboard ceiling. Plaster to brick walls. Wooden rear wall panel to alcove. Bitumen backed tan and brown floor tiles to concrete floor. Modern linoleum to wooden panel in alcove - no access behind wooden panel (excessive damage). uPVC front and rear doors. Wooden panel to rear of modern electrics on wall. Wooden panels to left and right hand side walls to alcove - no access behind panels (excessive damage). Wooden header panels above doors to bedroom and bathroom. Modern storage heater on wall.

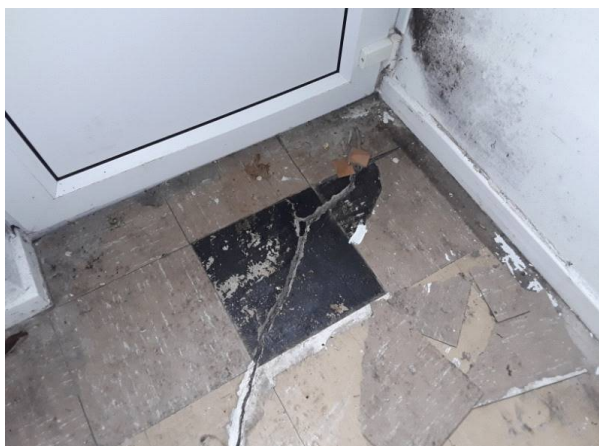
Building:	11 Chelscombe	Floor Level:	Ground	Item Ref:	J295772-6
Room Name:	(002) Hall				
Sample Ref:	FW008061				
Component:	Replacement bitumen backed brown floor tiles to concrete floor				
Extent:	2m ²

Location (Plan room references in brackets)	Result (asbestos type)	Action	Sample Ref	Extent
11 Chelscombe Ground (002) Hall Replacement bitumen backed brown floor tiles to concrete floor	Chrysotile	Remove	FW008061	2m ²

Material Assessment		
Product Type	Extent of damage	Surface Treatment Score
Floor Tile + Bitumen Backing (1)	High Damage (3)	0
Asbestos Type	Material Assessment Score (MA)	Low (5)
Chrysotile (1)

Priority Assessment		
Occupant Activity	Location Score	Accessibility Score
1 (Low disturbance)	2	3
Extent Score	No. of occupants	Frequency of Use
1 (<10m ² or <10m pipe run)	1 (1 to 3)	3 (Daily)
Avg. time area is in use	Type of Maintenance	Freq. of Maintenance
0 (<1 hour)	1 (Low disturbance)	1 (<1 per year)
Priority Assessment Score (PA)		6

Conclusions and Actions	
Recommendation:	Remove
Further Information:	None
General Notes: Textured coating to plasterboard ceiling. Plaster to brick walls. Wooden rear wall panel to alcove. Bitumen backed tan and brown floor tiles to concrete floor. Modern linoleum to wooden panel in alcove - no access behind wooden panel (excessive damage). uPVC front and rear doors. Wooden panel to rear of modern electrics on wall. Wooden panels to left and right hand side walls to alcove - no access behind panels (excessive damage). Wooden header panels above doors to bedroom and bathroom. Modern storage heater on wall.

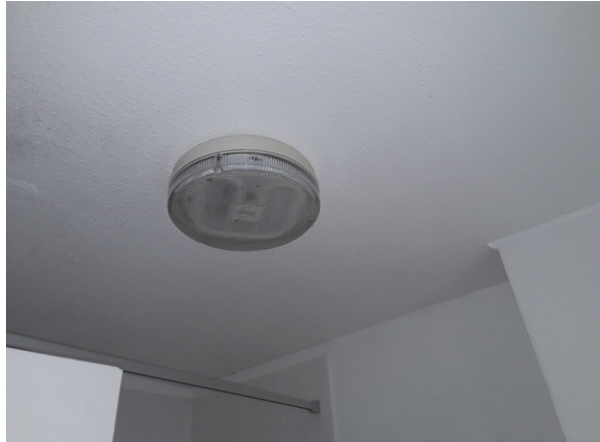
Building:	11 Chelscombe	Floor Level:	Ground	Item Ref:	J295772-7
Room Name:	(003) Bathroom				
Sample Ref:	As FW008057				
Component:	Textured coating to plasterboard ceiling				
Extent:	6m ²

Material Assessment		
Product Type	Extent of damage	Surface Treatment Score
Textured Coating (1)	Low Damage (1)	1
Asbestos Type	Material Assessment Score (MA)	Very Low (4)
Chrysotile (1)

Priority Assessment		
Occupant Activity	Location Score	Accessibility Score
1 (Low disturbance)	2	1
Extent Score	No. of occupants	Frequency of Use
1 (<10m ² or <10m pipe run)	1 (1 to 3)	3 (Daily)
Avg. time area is in use	Type of Maintenance	Freq. of Maintenance
0 (<1 hour)	1 (Low disturbance)	1 (<1 per year)
Priority Assessment Score (PA)		6

Conclusions and Actions	
Recommendation:	Manage and Inspect
Further Information:	None
General Notes: Textured coating to plasterboard ceiling. Plaster to brick walls. Modern linoleum to floor - no access under modern linoleum (excessive damage). Wooden boxing behind sink - no access within boxing (excessive damage). Wooden bath panel - no access behind bath panel (excessive damage). Ceramic cistern. uPVC window and uPVC window over wooden sill. Wooden header panel above door to hall. Modern heater on wall.

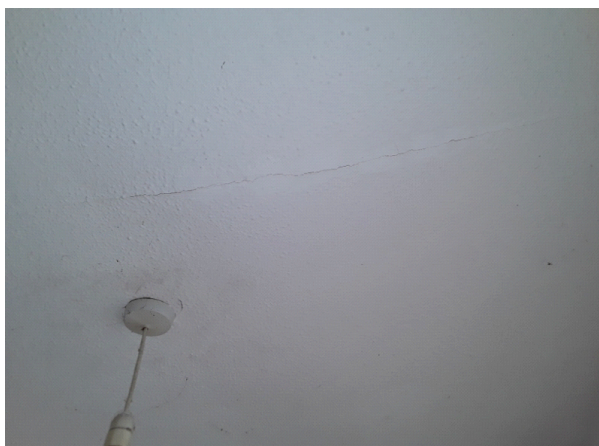
Building:	11 Chelscombe	Floor Level:	Ground	Item Ref:	J295772-8
Room Name:	(004) Lounge				
Sample Ref:	As FW008057				
Component:	Textured coating to plasterboard ceiling				
Extent:	15m ²

Material Assessment		
Product Type	Extent of damage	Surface Treatment Score
Textured Coating (1)	Low Damage (1)	1
Asbestos Type	Material Assessment Score (MA)	Very Low (4)
Chrysotile (1)

Priority Assessment		
Occupant Activity	Location Score	Accessibility Score
1 (Low disturbance)	2	1
Extent Score	No. of occupants	Frequency of Use
2 (10m ² - 50m ² or 10m - 50m pipe run)	1 (1 to 3)	3 (Daily)
Avg. time area is in use	Type of Maintenance	Freq. of Maintenance
2 (3 to 6 hours)	1 (Low disturbance)	1 (<1 per year)
Priority Assessment Score (PA)		6

Conclusions and Actions	
Recommendation:	Manage and Inspect
Further Information:	None
General Notes: Textured coating to plasterboard ceiling. Plaster to brick walls. Bitumen backed brown floor tiles to concrete floor. uPVC windows and uPVC over wooden sills. Modern storage heater on wall.

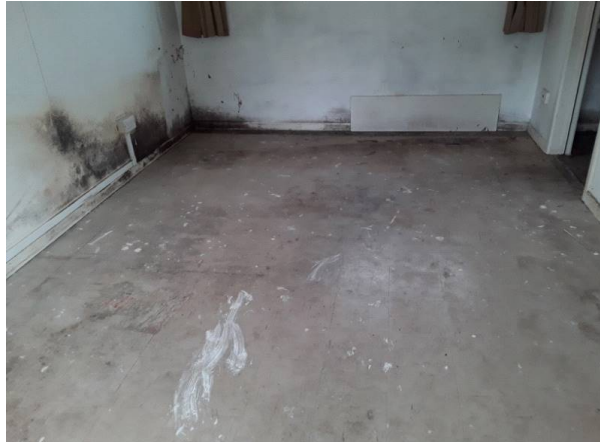
Building:	11 Chelscombe	Floor Level:	Ground	Item Ref:	J295772-9
Room Name:	(004) Lounge				
Sample Ref:	As FW008058				
Component:	Bitumen backed brown floor tiles to concrete floor				
Extent:	15m ²

Material Assessment		
Product Type	Extent of damage	Surface Treatment Score
Floor Tile + Bitumen Backing (1)	Low Damage (1)	0
Asbestos Type	Material Assessment Score (MA)	Very Low (3)
Chrysotile (1)

Priority Assessment		
Occupant Activity	Location Score	Accessibility Score
1 (Low disturbance)	2	3
Extent Score	No. of occupants	Frequency of Use
2 (10m ² - 50m ² or 10m - 50m pipe run)	1 (1 to 3)	3 (Daily)
Avg. time area is in use	Type of Maintenance	Freq. of Maintenance
2 (3 to 6 hours)	1 (Low disturbance)	1 (<1 per year)
Priority Assessment Score (PA)		7

Conclusions and Actions	
Recommendation:	Manage and Inspect
Further Information:	None
General Notes: Textured coating to plasterboard ceiling. Plaster to brick walls. Bitumen backed brown floor tiles to concrete floor. uPVC windows and uPVC over wooden sills. Modern storage heater on wall.

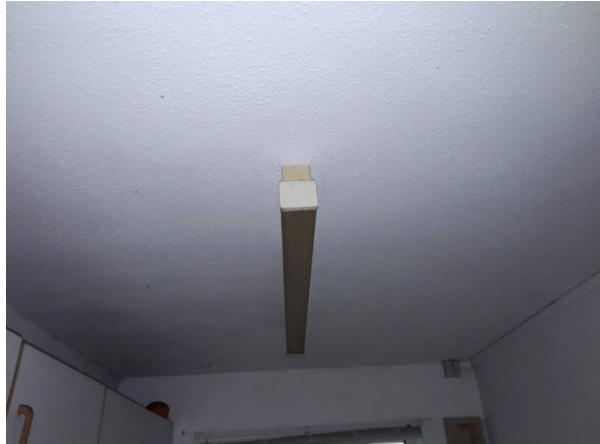
Building:	11 Chelscombe	Floor Level:	Ground	Item Ref:	J295772-10
Room Name:	(005) Kitchen				
Sample Ref:	FW008062				
Component:	Textured coating to plasterboard ceiling				
Extent:	9m ²

Material Assessment		
Product Type	Extent of damage	Surface Treatment Score
Textured Coating (1)	Low Damage (1)	1
Asbestos Type	Material Assessment Score (MA)	Very Low (4)
Chrysotile (1)

Priority Assessment		
Occupant Activity	Location Score	Accessibility Score
1 (Low disturbance)	2	1
Extent Score	No. of occupants	Frequency of Use
1 (<10m ² or <10m pipe run)	1 (1 to 3)	3 (Daily)
Avg. time area is in use	Type of Maintenance	Freq. of Maintenance
1 (1 to 3 hours)	1 (Low disturbance)	1 (<1 per year)
Priority Assessment Score (PA)		6

Conclusions and Actions	
Recommendation:	Manage and Inspect
Further Information:	None
General Notes: Textured coating to plasterboard ceiling. Plaster to brick walls. Bitumen backed brown floor tiles to concrete floor (under modern linoleum). Modern sink pad. uPVC window and sill. Modern heater on wall.

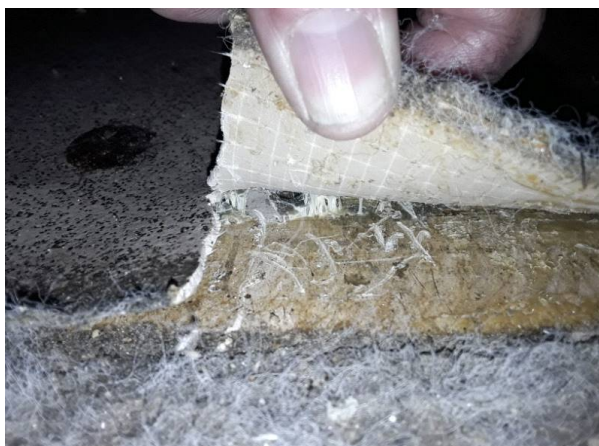
Building:	11 Chelscombe	Floor Level:	Ground	Item Ref:	J295772-12
Room Name:	(005) Kitchen				
Sample Ref:	As FW008058				
Component:	Bitumen backed brown floor tiles to concrete floor (under modern linoleum).				
Extent:	9m ²

Material Assessment		
Product Type	Extent of damage	Surface Treatment Score
Floor Tile + Bitumen Backing (1)	Low Damage (1)	0
Asbestos Type	Material Assessment Score (MA)	Very Low (3)
Chrysotile (1)

Priority Assessment		
Occupant Activity	Location Score	Accessibility Score
1 (Low disturbance)	2	2
Extent Score	No. of occupants	Frequency of Use
1 (<10m ² or <10m pipe run)	1 (1 to 3)	3 (Daily)
Avg. time area is in use	Type of Maintenance	Freq. of Maintenance
1 (1 to 3 hours)	1 (Low disturbance)	1 (<1 per year)
Priority Assessment Score (PA)		6

Conclusions and Actions	
Recommendation:	Manage and Inspect
Further Information:	None
General Notes: Textured coating to plasterboard ceiling. Plaster to brick walls. Bitumen backed brown floor tiles to concrete floor (under modern linoleum). Modern sink pad. uPVC window and sill. Modern heater on wall.

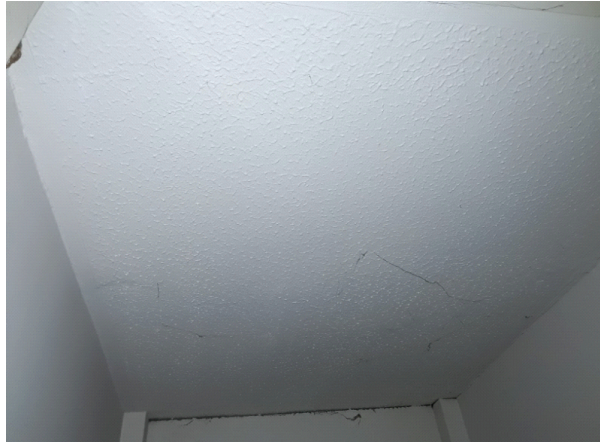
Building:	11 Chelscombe	Floor Level:	Ground	Item Ref:	J295772-11
Room Name:	(006) Cupboard				
Sample Ref:	FW008063				
Component:	Textured coating to plasterboard ceiling				
Extent:	1.5m ²

Material Assessment		
Product Type	Extent of damage	Surface Treatment Score
Textured Coating (1)	Low Damage (1)	1
Asbestos Type	Material Assessment Score (MA)	Very Low (4)
Chrysotile (1)

Priority Assessment		
Occupant Activity	Location Score	Accessibility Score
0 (Rare disturbance)	2	1
Extent Score	No. of occupants	Frequency of Use
1 (<10m ² or <10m pipe run)	1 (1 to 3)	3 (Daily)
Avg. time area is in use	Type of Maintenance	Freq. of Maintenance
0 (<1 hour)	1 (Low disturbance)	1 (<1 per year)
Priority Assessment Score (PA)		5

Conclusions and Actions	
Recommendation:	Manage and Inspect
Further Information:	None
General Notes: Textured coating to plasterboard ceiling. Plaster to brick left and right hand side walls. Wooden rear wall. Wooden boxing to floor no access within boxing (excessive damage). Metal grill in wooden panel below door - no access behind panel (excessive damage). Modern immersion heater.

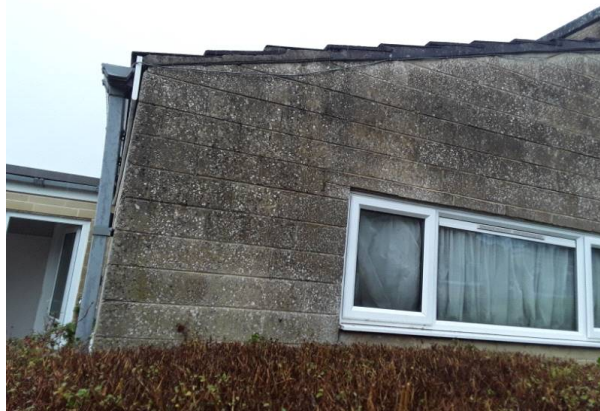
Building:	11 Chelscombe	Floor Level:	External	Item Ref:	J295772-15
Room Name:	(009) External				
Sample Ref:	Presumed				
Component:	Cement board undercloak to pitch roof section				
Extent:	5lm

Material Assessment		
Product Type	Extent of damage	Surface Treatment Score
Cement (1)	Low Damage (1)	1
Asbestos Type	Material Assessment Score (MA)	Low (6)
Crocidolite (3)

Priority Assessment		
Occupant Activity	Location Score	Accessibility Score
0 (Rare disturbance)	0	0
Extent Score	No. of occupants	Frequency of Use
1 (<10m ² or <10m pipe run)	1 (1 to 3)	3 (Daily)
Avg. time area is in use	Type of Maintenance	Freq. of Maintenance
0 (<1 hour)	0 (Minor disturbance)	1 (<1 per year)
Priority Assessment Score (PA)		4

Conclusions and Actions	
Recommendation:	Manage and Inspect
Further Information:	None
General Notes: Modern roof tiles. uPVC fascias. Plastic drainpipes and guttering. Cement board undercloak to pitch roof section. Modern roof covering over flat roof section. uPVC windows and sills. uPVC front and rear doors
