**An Asbestos Management Survey (MA & PA) at  
88 Hackney Way, Westbury, Wiltshire  
BA13 2GF**

<b>Survey Conducted:</b>	<b>9 July 2019</b>	
<b>Date of approval:</b>	<b>10 Jul 2019</b>	
<b>Our Reference:</b>	<b>J167105</b>	
<b>Surveyed By:</b>	<b>Fiona Williamson</b>	
<b>UPRN:</b>	<b>136315</b>	
<b>Scope of Works:</b>	<b>Management survey to all accessible areas of property</b>

Pennington Choices Ltd carried out an Asbestos Management Survey (MA & PA) at VOID 88 Hackney Way. The survey and this report are in accordance with HSG264 – Asbestos: The Survey Guide.

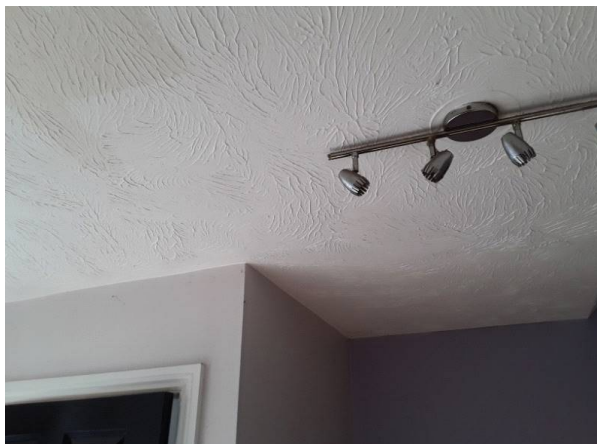
<b>Building:</b>	88 Hackney Way	<b>Floor Level:</b>	Ground	<b>Item Ref:</b>	J167105-1
<b>Room Name:</b>	(001) Hall				
<b>Sample Ref:</b>	FW000633 (Sample 1)				
<b>Component:</b>	Textured coating to plasterboard ceiling

Material Assessment		
<b>Product Type</b>	<b>Extent of damage</b>	<b>Surface Treatment Score</b>
<b>Asbestos Type</b>	<b>Material Assessment Score (MA)</b>	
No Asbestos Detected

Conclusions and Actions	
<b>Recommendation:</b>	No further action required
<b>Further Information:</b>	None
<b>General Notes:</b> Textured coating to plasterboard ceiling. Plaster to brick and plasterboard walls. Beige floor tiles to concrete floor (mainly under modern linoleum). Carpet to wooden stairs. uPVC front door. Modern electrics.

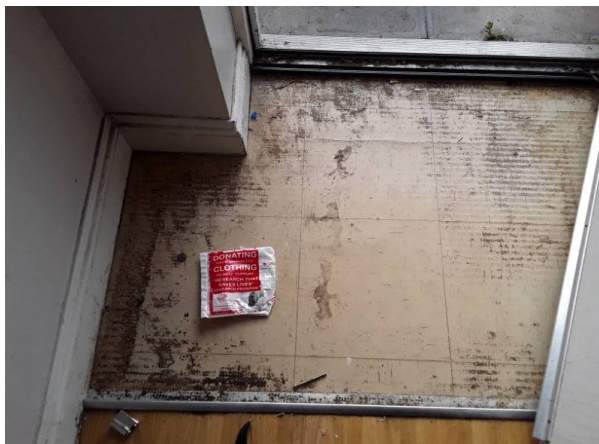
<b>Building:</b>	88 Hackney Way	<b>Floor Level:</b>	Ground	<b>Item Ref:</b>	<b>J167105-2</b>
<b>Room Name:</b>	(001) Hall				
<b>Sample Ref:</b>	FW000634 (Sample 2)				
<b>Component:</b>	Beige floor tiles to concrete floor (mainly under modern linoleum)

Material Assessment		
<b>Product Type</b>	<b>Extent of damage</b>	<b>Surface Treatment Score</b>
<b>Asbestos Type</b>	<b>Material Assessment Score (MA)</b>	
No Asbestos Detected

Conclusions and Actions	
<b>Recommendation:</b>	No further action required
<b>Further Information:</b>	None
<b>General Notes:</b> Textured coating to plasterboard ceiling. Plaster to brick and plasterboard walls. Beige floor tiles to concrete floor (mainly under modern linoleum). Carpet to wooden stairs. uPVC front door. Modern electrics.

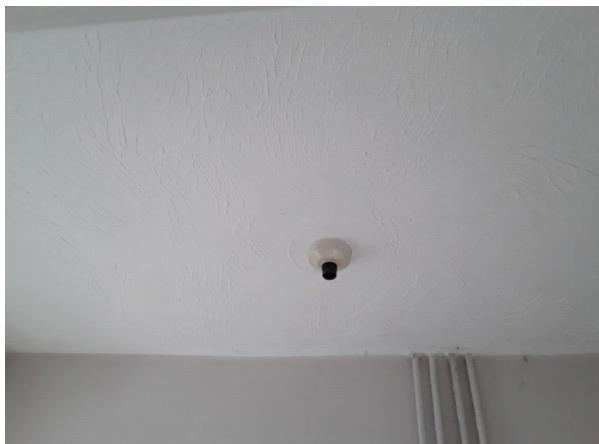
<b>Building:</b>	88 Hackney Way	<b>Floor Level:</b>	Ground	<b>Item Ref:</b>	<b>J167105-3</b>
<b>Room Name:</b>	(002) WC				
<b>Sample Ref:</b>	As FW000633 (Ref Sample 1)				
<b>Component:</b>	Textured coating to plasterboard ceiling

Material Assessment		
<b>Product Type</b>	<b>Extent of damage</b>	<b>Surface Treatment Score</b>
<b>Asbestos Type</b>	<b>Material Assessment Score (MA)</b>	
No asbestos detected in visually consistent material

Conclusions and Actions	
<b>Recommendation:</b>	No further action required
<b>Further Information:</b>	None
<b>General Notes:</b> Textured coating to plasterboard ceiling. Plaster to brick and plasterboard walls. Ceramic tiles to floor - no access under ceramic tiles (excessive damage). uPVC window and wooden sill. Modern radiator

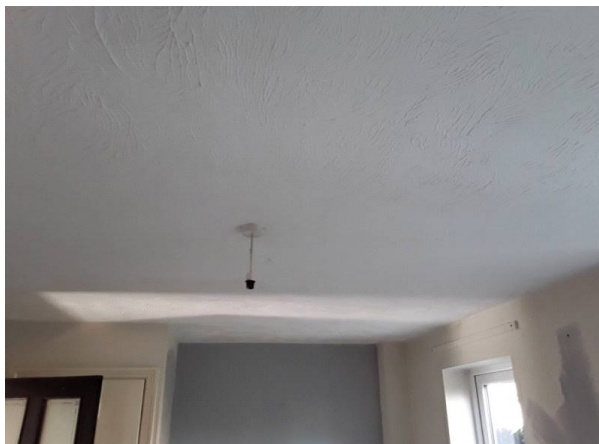
<b>Building:</b>	88 Hackney Way	<b>Floor Level:</b>	Ground	<b>Item Ref:</b>	<b>J167105-4</b>
<b>Room Name:</b>	(003) Lounge				
<b>Sample Ref:</b>	As FW000633 (Ref Sample 1)				
<b>Component:</b>	Textured coating to plasterboard ceiling

Material Assessment		
<b>Product Type</b>	<b>Extent of damage</b>	<b>Surface Treatment Score</b>
<b>Asbestos Type</b>	<b>Material Assessment Score (MA)</b>	
No asbestos detected in visually consistent material

Conclusions and Actions	
<b>Recommendation:</b>	No further action required
<b>Further Information:</b>	None
<b>General Notes:</b> Textured coating to plasterboard ceiling. Plaster to brick and plasterboard walls. Beige floor tiles to concrete floor (under carpet). uPVC door to garden. uPVC window and wooden sill. Modern radiator

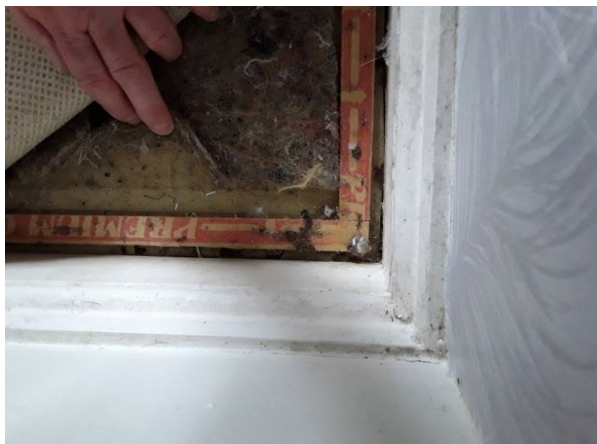
<b>Building:</b>	88 Hackney Way	<b>Floor Level:</b>	Ground	<b>Item Ref:</b>	<b>J167105-5</b>
<b>Room Name:</b>	(003) Lounge				
<b>Sample Ref:</b>	As FW000634 (Ref Sample 2)				
<b>Component:</b>	Beige floor tiles to concrete floor (under carpet)

Material Assessment		
<b>Product Type</b>	<b>Extent of damage</b>	<b>Surface Treatment Score</b>
<b>Asbestos Type</b>	<b>Material Assessment Score (MA)</b>	
No asbestos detected in visually consistent material

Conclusions and Actions	
<b>Recommendation:</b>	No further action required
<b>Further Information:</b>	None
<b>General Notes:</b> Textured coating to plasterboard ceiling. Plaster to brick and plasterboard walls. Beige floor tiles to concrete floor (under carpet). uPVC door to garden. uPVC window and wooden sill. Modern radiator

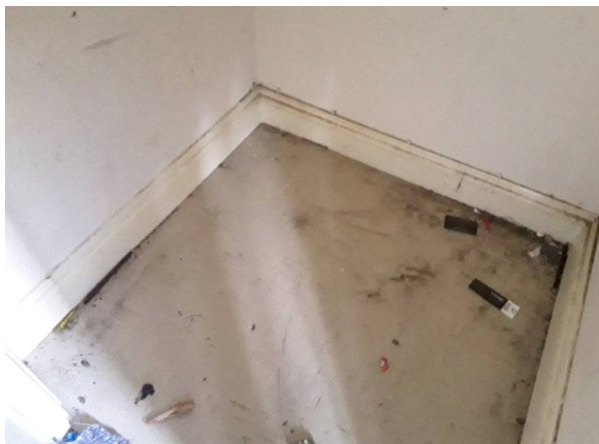
<b>Building:</b>	88 Hackney Way	<b>Floor Level:</b>	Ground	<b>Item Ref:</b>	<b>J167105-7</b>
<b>Room Name:</b>	(004) Cupboard 1				
<b>Sample Ref:</b>	As FW000634 (Ref Sample 2)				
<b>Component:</b>	Beige floor tiles to concrete floor (mainly under modern linoleum)

Material Assessment		
<b>Product Type</b>	<b>Extent of damage</b>	<b>Surface Treatment Score</b>
<b>Asbestos Type</b>	<b>Material Assessment Score (MA)</b>	
No asbestos detected in visually consistent material

Conclusions and Actions	
<b>Recommendation:</b>	No further action required
<b>Further Information:</b>	None
<b>General Notes:</b> Textured coating to plasterboard ceiling. Plaster to brick and plasterboard walls. Beige floor tiles to concrete floor (mainly under modern linoleum). Carpet to wooden stairs. uPVC front door. Modern electrics

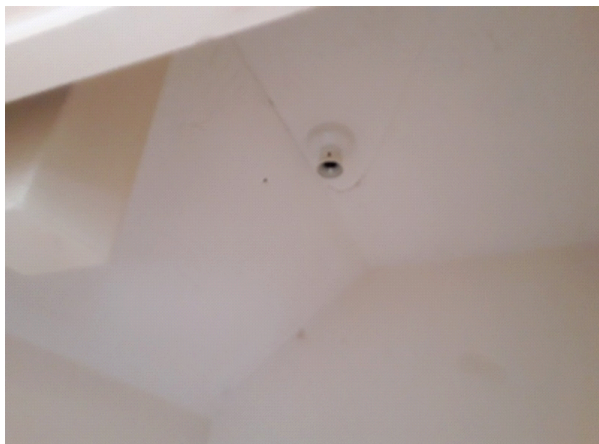
<b>Building:</b>	88 Hackney Way	<b>Floor Level:</b>	Ground	<b>Item Ref:</b>	J167105-17
<b>Room Name:</b>	(004) Cupboard 1				
<b>Sample Ref:</b>	FW000637 (Sample 5)				
<b>Component:</b>	Textured coating to plasterboard ceiling

Material Assessment		
<b>Product Type</b>	<b>Extent of damage</b>	<b>Surface Treatment Score</b>
<b>Asbestos Type</b>	<b>Material Assessment Score (MA)</b>	
No Asbestos Detected

Conclusions and Actions	
<b>Recommendation:</b>	No further action required
<b>Further Information:</b>	None
<b>General Notes:</b> Textured coating to plasterboard ceiling. Plaster to brick and plasterboard walls. Beige floor tiles to concrete floor (mainly under modern linoleum). Carpet to wooden stairs. uPVC front door. Modern electrics

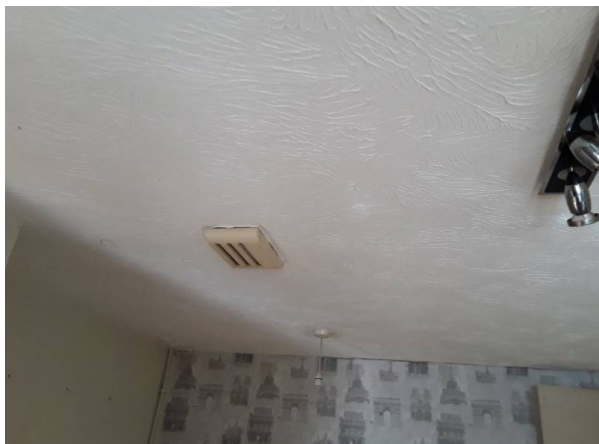
<b>Building:</b>	88 Hackney Way	<b>Floor Level:</b>	Ground	<b>Item Ref:</b>	<b>J167105-8</b>
<b>Room Name:</b>	(005) Kitchen				
<b>Sample Ref:</b>	As FW000633 (Ref Sample 1)				
<b>Component:</b>	Textured coating to plasterboard ceiling

Material Assessment		
<b>Product Type</b>	<b>Extent of damage</b>	<b>Surface Treatment Score</b>
<b>Asbestos Type</b>	<b>Material Assessment Score (MA)</b>	
No asbestos detected in visually consistent material

Conclusions and Actions	
<b>Recommendation:</b>	No further action required
<b>Further Information:</b>	None
<b>General Notes:</b> Textured coating to plasterboard ceiling, Plaster to brick and plasterboard walls, Ceramic tiles to floor - no access under ceramic tiles (excessive damage), uPVC window and ceramic tile sill, Modern Worcester boiler with plastic flue, Modern extract fan in ceiling, Modern radiator

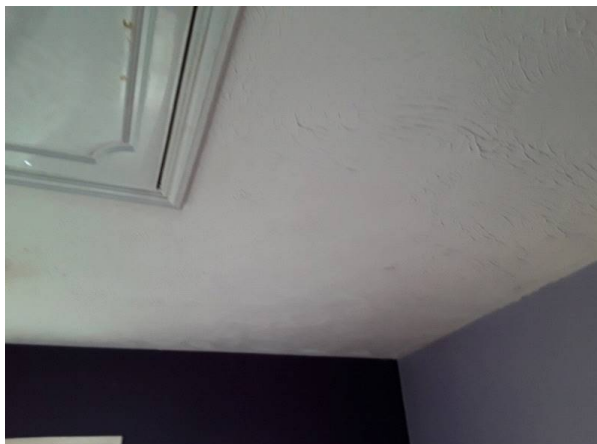
<b>Building:</b>	88 Hackney Way	<b>Floor Level:</b>	First	<b>Item Ref:</b>	J167105-9
<b>Room Name:</b>	(006) Landing				
<b>Sample Ref:</b>	FW000635 (Sample 3)				
<b>Component:</b>	Textured coating to plasterboard ceiling

Material Assessment		
<b>Product Type</b>	<b>Extent of damage</b>	<b>Surface Treatment Score</b>
<b>Asbestos Type</b>	<b>Material Assessment Score (MA)</b>	
No Asbestos Detected

Conclusions and Actions	
<b>Recommendation:</b>	No further action required
<b>Further Information:</b>	None
<b>General Notes:</b> Textured coating to plasterboard ceiling, Plaster to brick and plasterboard walls, Carpet to hardboard floor and wooden stairs, Wooden loft hatch access panel

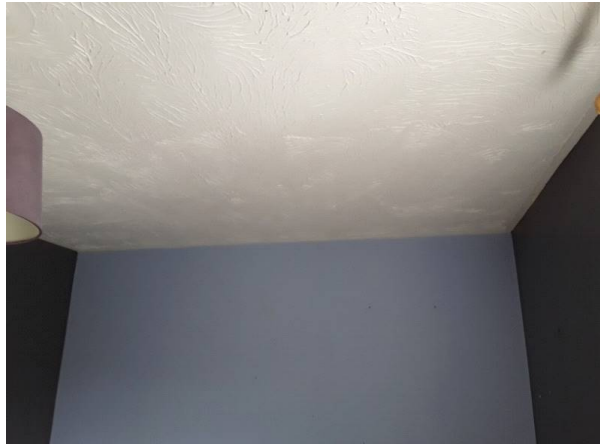
<b>Building:</b>	88 Hackney Way	<b>Floor Level:</b>	First	<b>Item Ref:</b>	J167105-10
<b>Room Name:</b>	(007) Bedroom 1				
<b>Sample Ref:</b>	As FW000635 (Ref Sample 3)				
<b>Component:</b>	Textured coating to plasterboard ceiling

Material Assessment		
<b>Product Type</b>	<b>Extent of damage</b>	<b>Surface Treatment Score</b>
<b>Asbestos Type</b>	<b>Material Assessment Score (MA)</b>	
No asbestos detected in visually consistent material

Conclusions and Actions	
<b>Recommendation:</b>	No further action required
<b>Further Information:</b>	None
<b>General Notes:</b> Textured coating to plasterboard ceiling, Plaster to brick and plasterboard walls, Carpet to hardboard floor uPVC window and wooden sill, Modern radiator

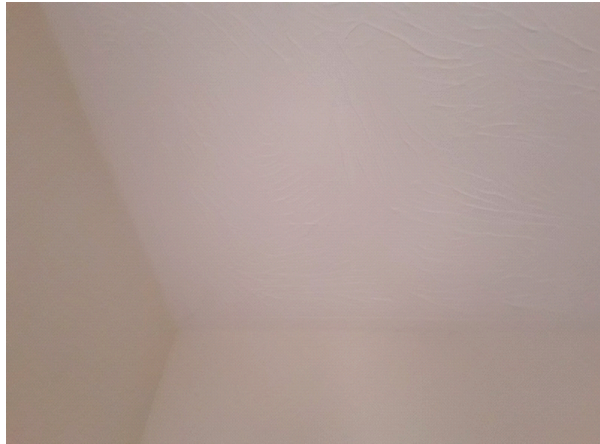
<b>Building:</b>	88 Hackney Way	<b>Floor Level:</b>	First	<b>Item Ref:</b>	J167105-11
<b>Room Name:</b>	(008) Cupboard 2				
<b>Sample Ref:</b>	As FW000635 (Ref Sample 3)				
<b>Component:</b>	Textured coating to plasterboard ceiling

Material Assessment		
<b>Product Type</b>	<b>Extent of damage</b>	<b>Surface Treatment Score</b>
<b>Asbestos Type</b>	<b>Material Assessment Score (MA)</b>	
No asbestos detected in visually consistent material

Conclusions and Actions	
<b>Recommendation:</b>	No further action required
<b>Further Information:</b>	None
<b>General Notes:</b> Textured coating to plasterboard ceiling. Plaster to brick and plasterboard walls. Carpet to hardboard floor

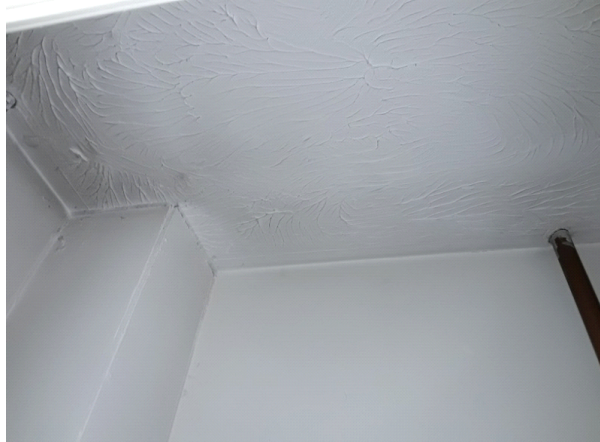
<b>Building:</b>	88 Hackney Way	<b>Floor Level:</b>	First	<b>Item Ref:</b>	J167105-12
<b>Room Name:</b>	(009) Cupboard 3				
<b>Sample Ref:</b>	As FW000635 (Ref Sample 3)				
<b>Component:</b>	Textured coating to plasterboard ceiling

Material Assessment		
<b>Product Type</b>	<b>Extent of damage</b>	<b>Surface Treatment Score</b>
<b>Asbestos Type</b>	<b>Material Assessment Score (MA)</b>	
No asbestos detected in visually consistent material

Conclusions and Actions	
<b>Recommendation:</b>	No further action required
<b>Further Information:</b>	None
<b>General Notes:</b> Textured coating to plasterboard ceiling. Plaster to brick and plasterboard walls. Hardboard floor. Wooden boxing over plastic ducting from extract fan in kitchen. Modern immersion heater. Foam lagging to metal pipework

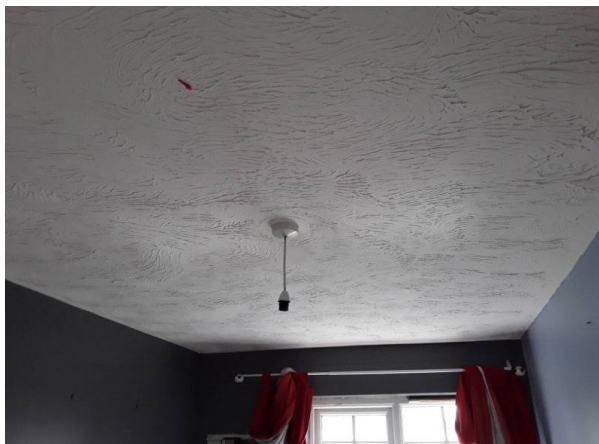
<b>Building:</b>	88 Hackney Way	<b>Floor Level:</b>	First	<b>Item Ref:</b>	<b>J167105-13</b>
<b>Room Name:</b>	(010) Bedroom 2				
<b>Sample Ref:</b>	As FW000635 (Ref Sample 3)				
<b>Component:</b>	Textured coating to plasterboard ceiling

Material Assessment		
<b>Product Type</b>	<b>Extent of damage</b>	<b>Surface Treatment Score</b>
<b>Asbestos Type</b>	<b>Material Assessment Score (MA)</b>	
No asbestos detected in visually consistent material

Conclusions and Actions	
<b>Recommendation:</b>	No further action required
<b>Further Information:</b>	None
<b>General Notes:</b> Textured coating to plasterboard ceiling. Plaster to brick and plasterboard walls. Carpet to hardboard floor uPVC window and wooden sill. Modern radiator

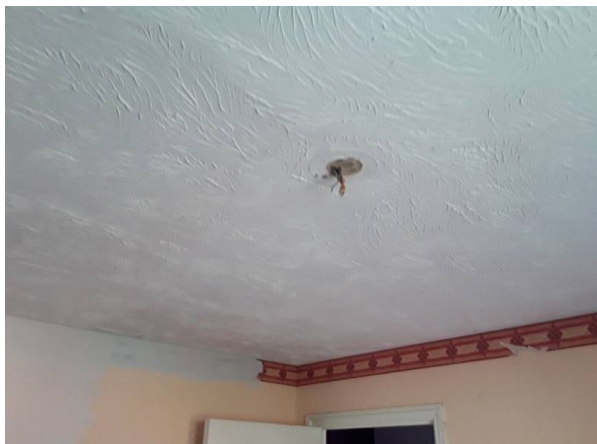
<b>Building:</b>	88 Hackney Way	<b>Floor Level:</b>	First	<b>Item Ref:</b>	J167105-14
<b>Room Name:</b>	(011) Bedroom 3				
<b>Sample Ref:</b>	FW000636 (Sample 4)				
<b>Component:</b>	Textured coating to plasterboard ceiling

Material Assessment		
<b>Product Type</b>	<b>Extent of damage</b>	<b>Surface Treatment Score</b>
<b>Asbestos Type</b>	<b>Material Assessment Score (MA)</b>	
No Asbestos Detected

Conclusions and Actions	
<b>Recommendation:</b>	No further action required
<b>Further Information:</b>	None
<b>General Notes:</b> Textured coating to plasterboard ceiling. Plaster to brick and plasterboard walls. Carpet to hardboard floor uPVC window and wooden sill. Modern radiator

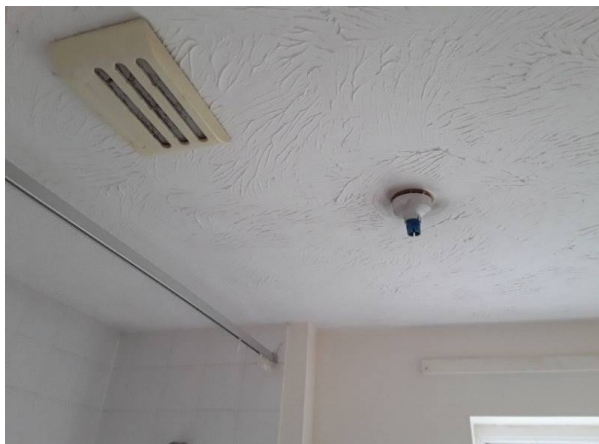
<b>Building:</b>	88 Hackney Way	<b>Floor Level:</b>	First	<b>Item Ref:</b>	<b>J167105-15</b>
<b>Room Name:</b>	(012) Bathroom				
<b>Sample Ref:</b>	As FW000636 (Ref Sample 4)				
<b>Component:</b>	Textured coating to plasterboard ceiling

Material Assessment		
<b>Product Type</b>	<b>Extent of damage</b>	<b>Surface Treatment Score</b>
<b>Asbestos Type</b>	<b>Material Assessment Score (MA)</b>	
No asbestos detected in visually consistent material

Conclusions and Actions	
<b>Recommendation:</b>	No further action required
<b>Further Information:</b>	None
<b>General Notes:</b> Textured coating to plasterboard ceiling. Plaster to brick and plasterboard walls. Ceramic tiles to hardboard floor. Wooden bath panel - no access behind bath panel (excessive damage). uPVC window and ceramic tile sill. Modern radiator

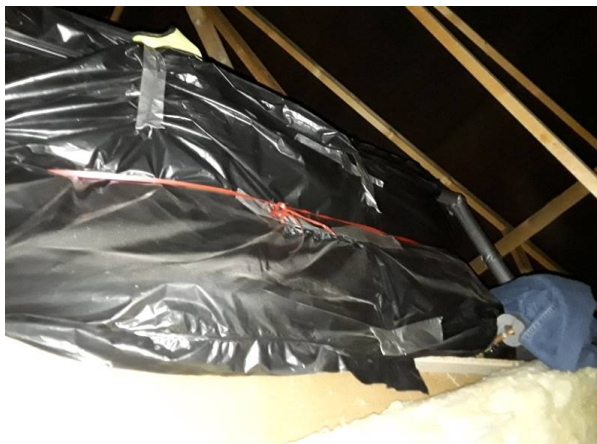
<b>Building:</b>	88 Hackney Way	<b>Floor Level:</b>	Roof Void	<b>Item Ref:</b>	<b>J167105-16</b>
<b>Room Name:</b>	(013) Loft				
<b>Sample Ref:</b>					
<b>Component:</b>	No asbestos containing materials found

Material Assessment		
<b>Product Type</b>	<b>Extent of damage</b>	<b>Surface Treatment Score</b>
<b>Asbestos Type</b>	<b>Material Assessment Score (MA)</b>	
No suspect materials

Conclusions and Actions	
<b>Recommendation:</b>	No further action required
<b>Further Information:</b>	None
<b>General Notes:</b> Modern sarking felt. Breeze block walls. Plasterboard floor panels. MMMF insulation. Bagged MMMF to plastic water tank. Foam lagging on metal pipework. Plastic loft hatch access panel

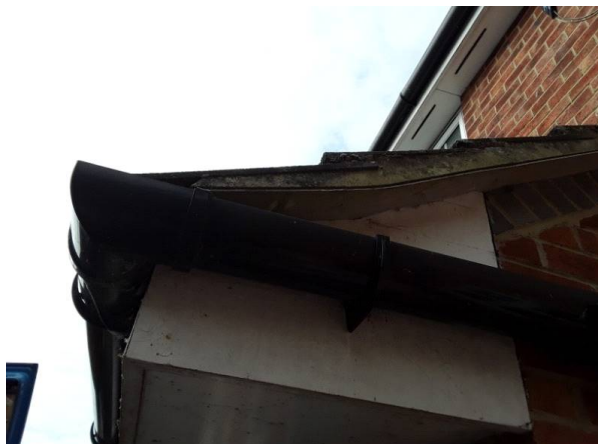
<b>Building:</b>	88 Hackney Way	<b>Floor Level:</b>	External	<b>Item Ref:</b>	<b>J167105-18</b>
<b>Room Name:</b>	(014) External				
<b>Sample Ref:</b>	FW000638 (Sample 6)				
<b>Component:</b>	Cement board undercloak to entrance canopy

Material Assessment		
<b>Product Type</b>	<b>Extent of damage</b>	<b>Surface Treatment Score</b>
<b>Asbestos Type</b>	<b>Material Assessment Score (MA)</b>	
No Asbestos Detected

Conclusions and Actions	
<b>Recommendation:</b>	No further action required
<b>Further Information:</b>	None
<b>General Notes:</b> Modern roof tiles, uPVC soffits. Plastic drainpipes and guttering. uPVC panelling to rear of guttering. uPVC windows and sills. Cement board undercloak to entrance canopy. Wooden ceiling panels to entrance. uPVC front and rear doors. Modern damp proof course.
