**An Asbestos Management with part Refurbishment Survey (MA & PA) at
8 Millard Close
Bristol
BS10 6EY**

Survey Conducted:	12 September 2023	
Date of approval:	14 Sep 2023	
Our Reference:	J333333	
Surveyed By:	Fiona Williamson	
UPRN:	13348	
Scope of Works:	Refurbishment to the kitchen flooring prior to renovations with a management survey to the remainder of the property.	
Requested By:

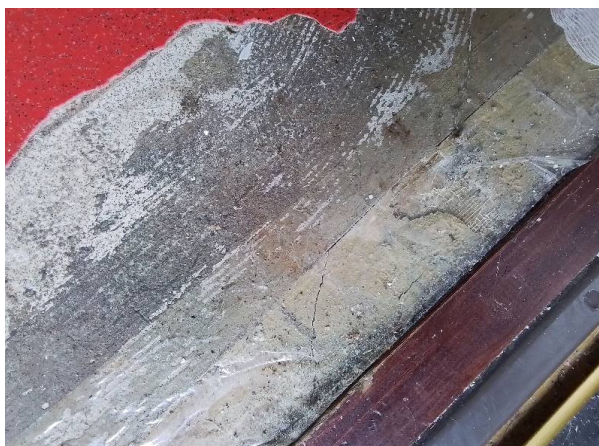
Building:	8 Millard Close	Floor Level:	Ground	Item Ref:	J333333-1
Room Name:	(001) Kitchen				
Sample Ref:	JZ001409				
Component:	Beige floor tiles to concrete floor under modern linoleum				
Extent:	7m ²

Material Assessment		
Product Type	Extent of damage	Surface Treatment Score
Asbestos Type	Material Assessment Score (MA)	
No Asbestos Detected

Conclusions and Actions	
Recommendation:	No further action required
Further Information:	None
General Notes: Plasterboard ceiling. Plaster to brick walls. Bitumen backed beige floor tiles to concrete floor under modern linoleum. Modern sink pad. Wooden door set to garden. Modern radiator.

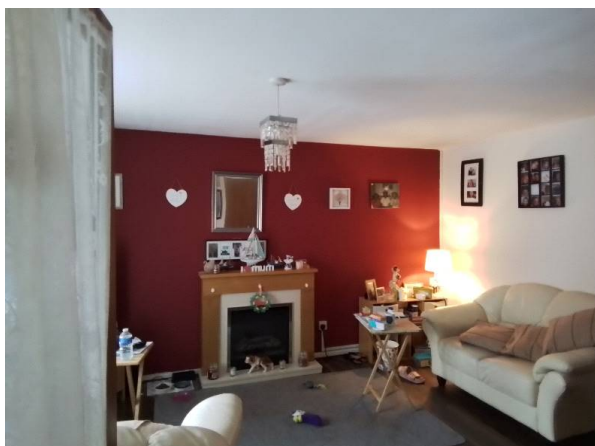
Building:	8 Millard Close	Floor Level:	Ground	Item Ref:	J333333-3
Room Name:	(002) Lounge				
Sample Ref:					
Component:	No asbestos containing materials found				
Extent:

Conclusions and Actions	
Recommendation:	No further action required
Further Information:	None
General Notes: Plasterboard ceiling. Plaster to brick walls. Laminate paneling to floor - no access under laminate paneling due to excessive damage. uPVC window and wooden sill. Modern radiator.

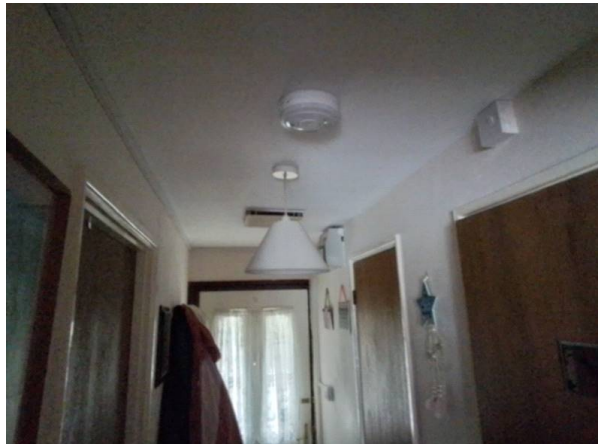
Building:	8 Millard Close	Floor Level:	Ground	Item Ref:	J333333-4
Room Name:	(003) Hall				
Sample Ref:					
Component:	No asbestos containing materials found				
Extent:

Conclusions and Actions	
Recommendation:	No further action required
Further Information:	None
General Notes: Plasterboard ceiling. Plaster to brick walls. Laminate paneling to floor - no access under laminate paneling due to excessive damage. Wooden front door. Modern electrics on wall. Modern extract fan in ceiling.

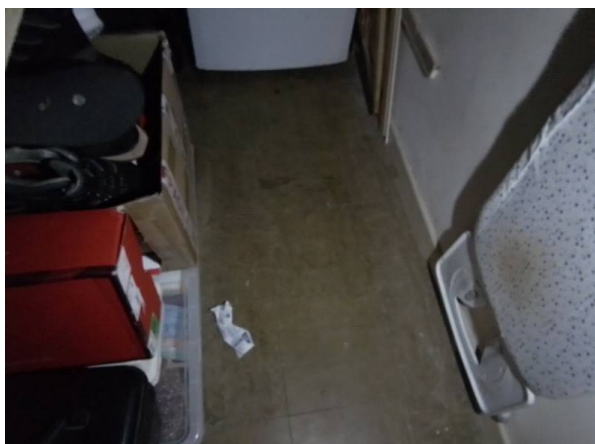
Building:	8 Millard Close	Floor Level:	Ground	Item Ref:	J333333-5
Room Name:	(004) Cupboard				
Sample Ref:	As JZ001409				
Component:	Bitumen backed brown floor tiles to concrete floor				
Extent:	4m ²

Material Assessment		
Product Type	Extent of damage	Surface Treatment Score
Asbestos Type	Material Assessment Score (MA)	
No asbestos detected in visually consistent material

Conclusions and Actions	
Recommendation:	No further action required
Further Information:	None
General Notes: Plasterboard ceiling. Plaster to brick walls. Bitumen backed brown floor tiles to concrete floor. Modern Vaillant boiler with a metal flue. Wooden loft hatch access panel.

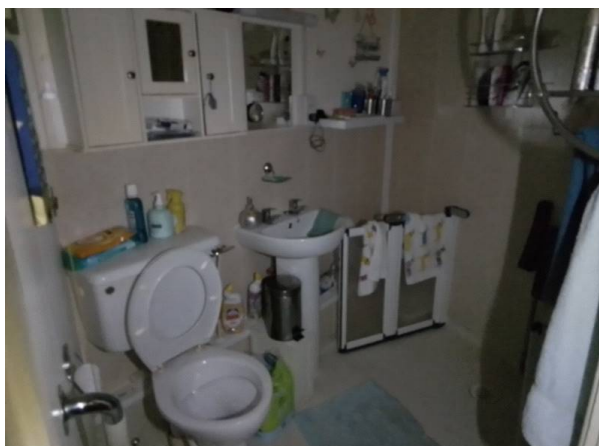
Building:	8 Millard Close	Floor Level:	Ground	Item Ref:	J333333-6
Room Name:	(005) Bathroom				
Sample Ref:					
Component:	No asbestos containing materials found				
Extent:

Conclusions and Actions	
Recommendation:	No further action required
Further Information:	None
General Notes: Plasterboard ceiling. Plaster to brick walls. Modern linoleum to floor - no access under modern linoleum due to excessive damage. Ceramic tiled boxing under the toilet and sink - no access behind ceramic tiles due to excessive damage. Ceramic cistern. Wooden panel to rear of extract fan in the ceiling. Modern radiator.

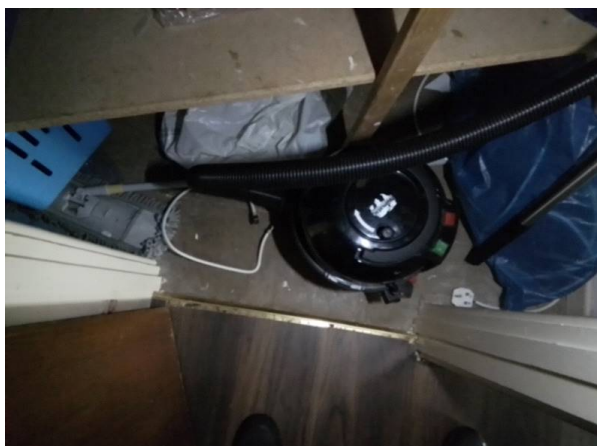
Building:	8 Millard Close	Floor Level:	Ground	Item Ref:	J333333-7
Room Name:	(006) Cupboard				
Sample Ref:	As JZ001409				
Component:	Bitumen backed brown floor tiles to concrete floor				
Extent:	2m ²

Material Assessment		
Product Type	Extent of damage	Surface Treatment Score
Asbestos Type	Material Assessment Score (MA)	
No asbestos detected in visually consistent material

Conclusions and Actions	
Recommendation:	No further action required
Further Information:	None
General Notes: Plasterboard ceiling. Plaster to brick walls. Bitumen backed brown floor tiles to concrete floor.

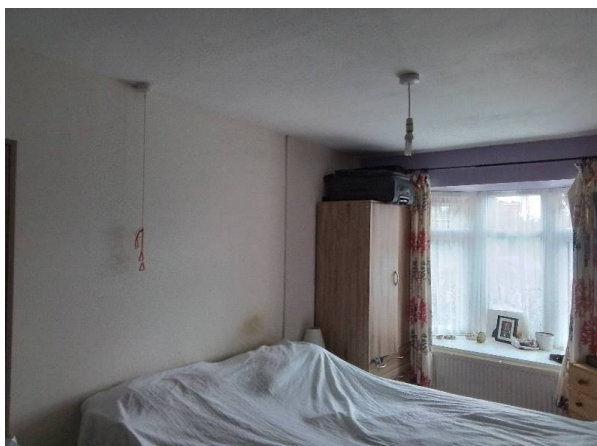
Building:	8 Millard Close	Floor Level:	Ground	Item Ref:	J333333-8
Room Name:	(007) Bedroom				
Sample Ref:					
Component:	No asbestos containing materials found				
Extent:

Conclusions and Actions	
Recommendation:	No further action required
Further Information:	None
General Notes: Plasterboard ceiling. Plaster to brick walls. Carpet to floor - no access under carpet due to excessive damage. uPVC window and wooden sill. Modern radiator.

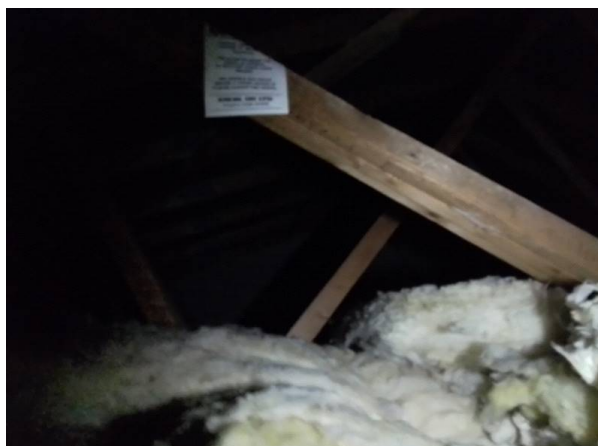
Building:	8 Millard Close	Floor Level:	Roof Void	Item Ref:	J333333-9
Room Name:	(008) Loft				
Sample Ref:					
Component:	No asbestos containing materials found				
Extent:

Conclusions and Actions	
Recommendation:	No further action required
Further Information:	None
General Notes: Modern sarking felt. Breeze block walls. Plasterboard floor panels. MMM insulation. Wooden loft hatch access panel.

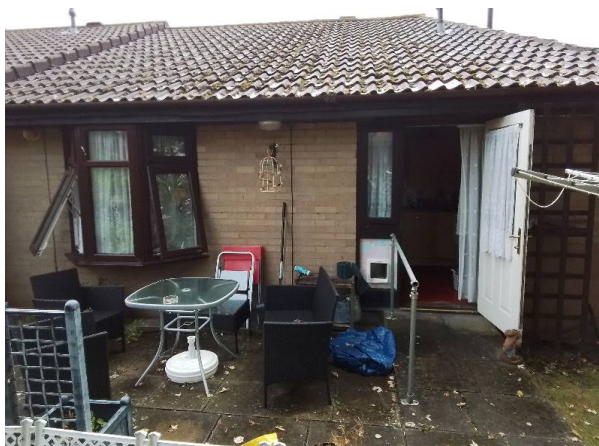
Building:	8 Millard Close	Floor Level:	External	Item Ref:	J333333-2
Room Name:	(009) External				
Sample Ref:					
Component:	No asbestos containing materials found				
Extent:

Conclusions and Actions	
Recommendation:	No further action required
Further Information:	None
General Notes: Modern roof tiles. Wooden soffits and fascias. Plastic drainpipes and guttering. uPVC windows and sills. Wooden front and rear doors. Modern damp proof course.
