Guinness Property - Empty Homes - Handover Form

24 Avondown House, Langdon Road, Bath, BA2 1ND

Works Order Number	5528257/1
--------------------	-----------

Conducted on	18.09.2023 11:01 BST
--------------	----------------------

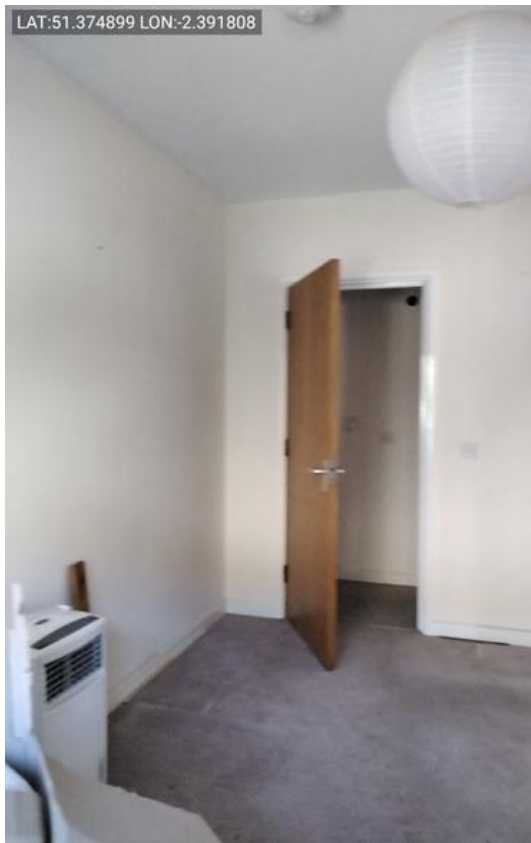
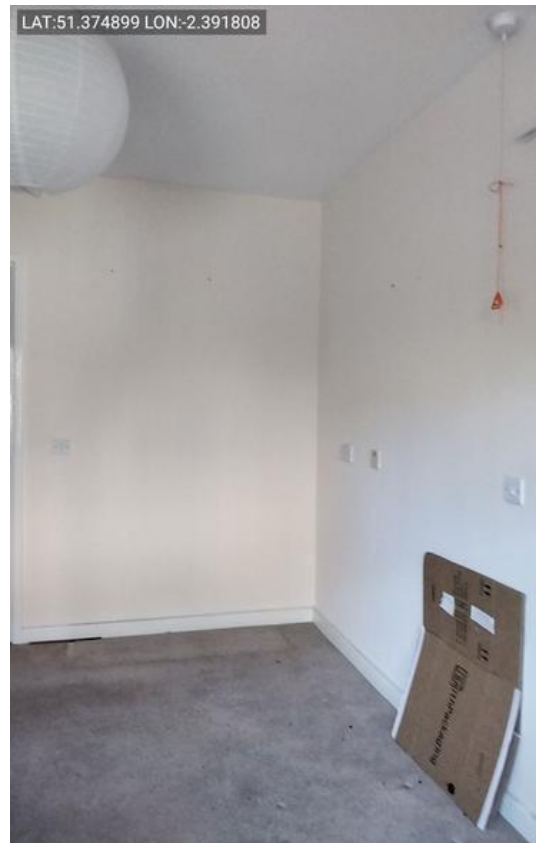
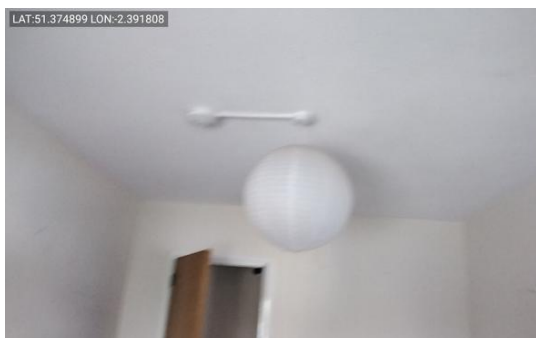
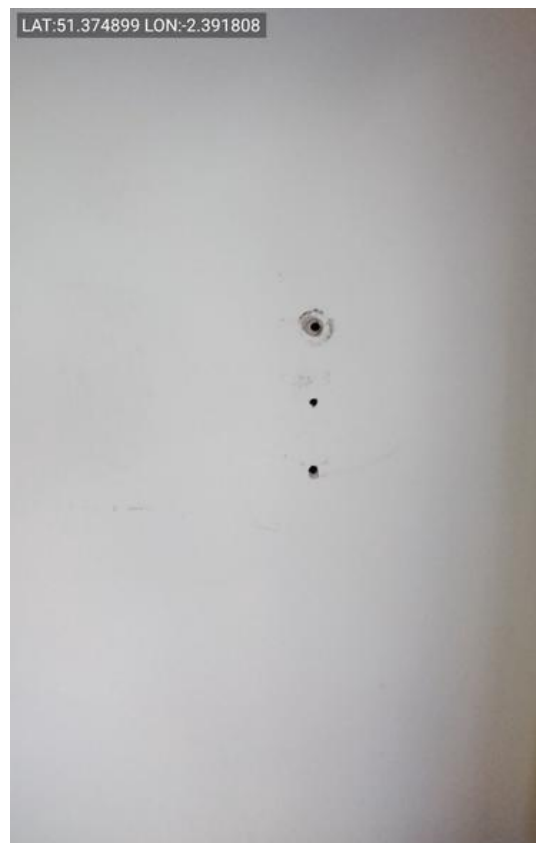
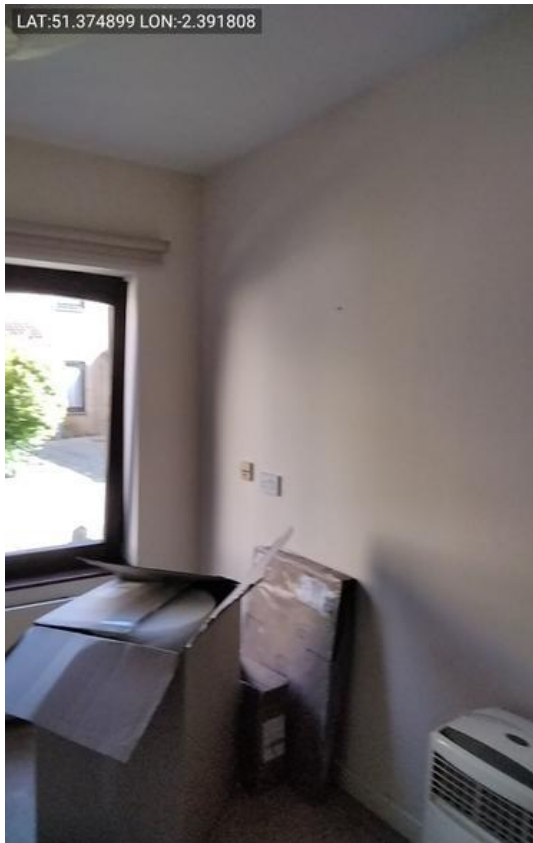
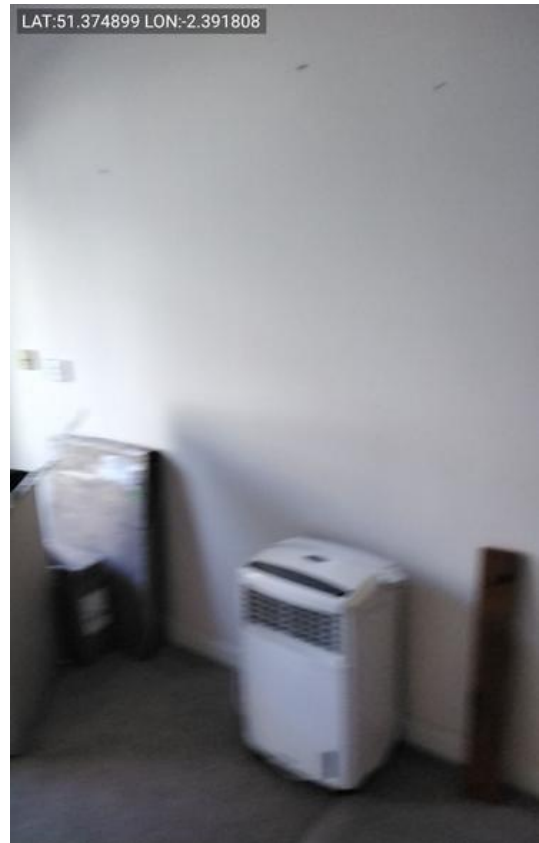
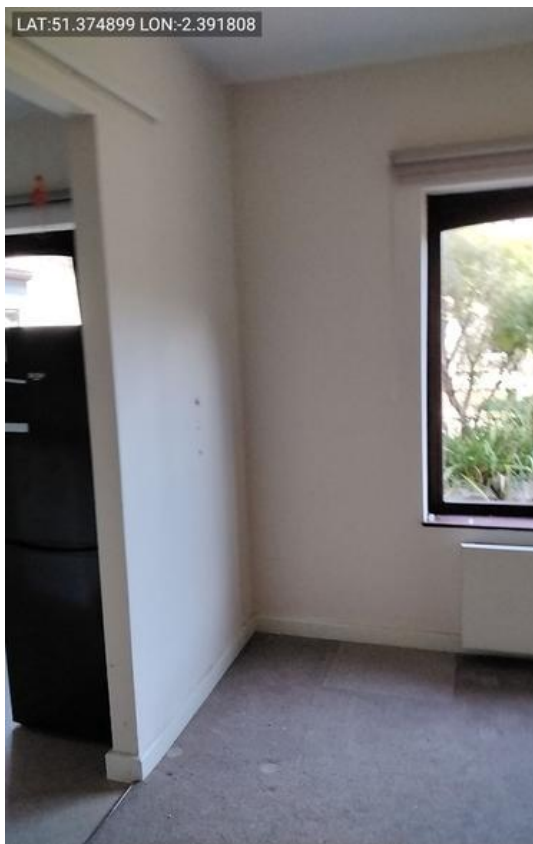
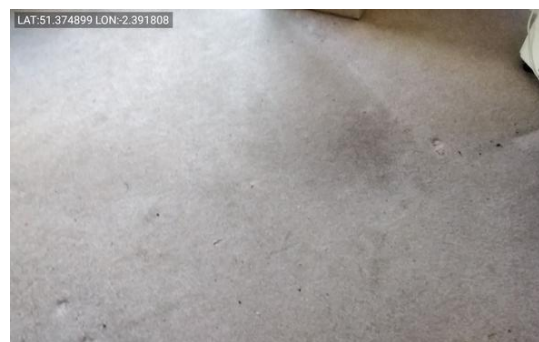
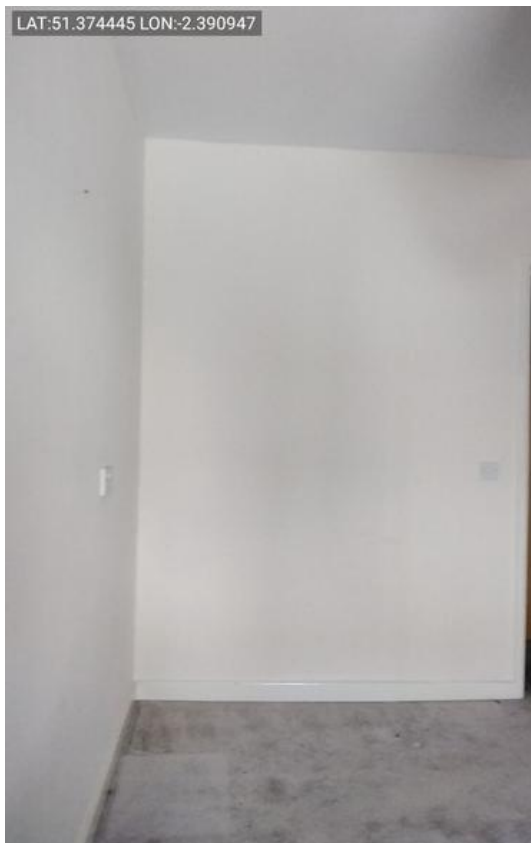
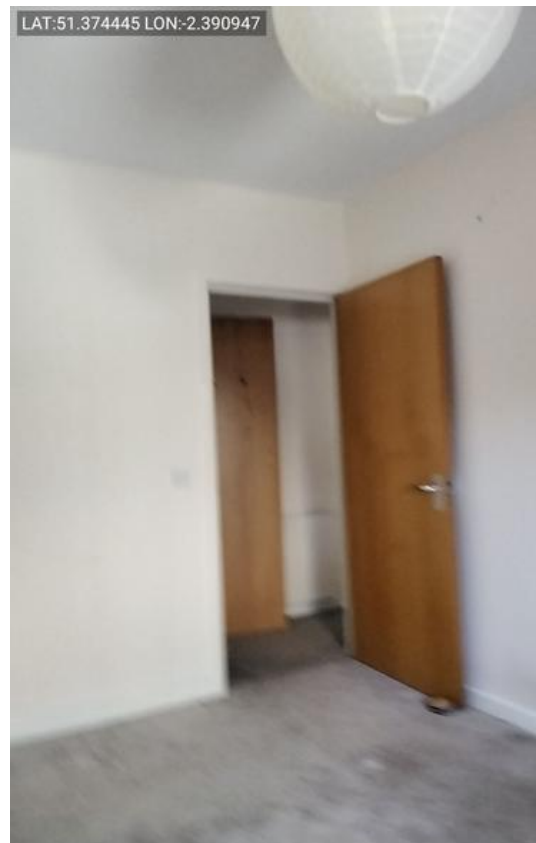
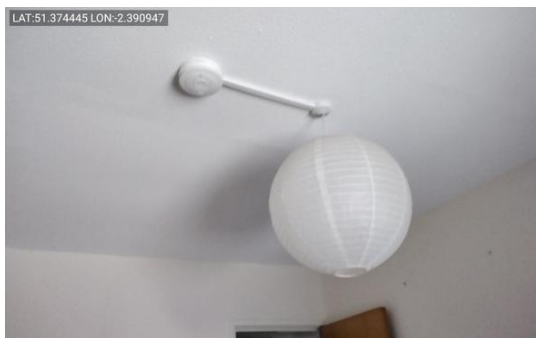
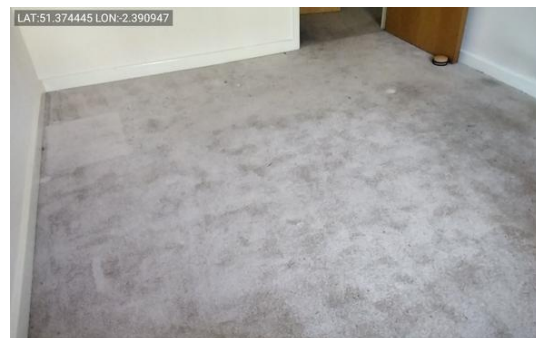
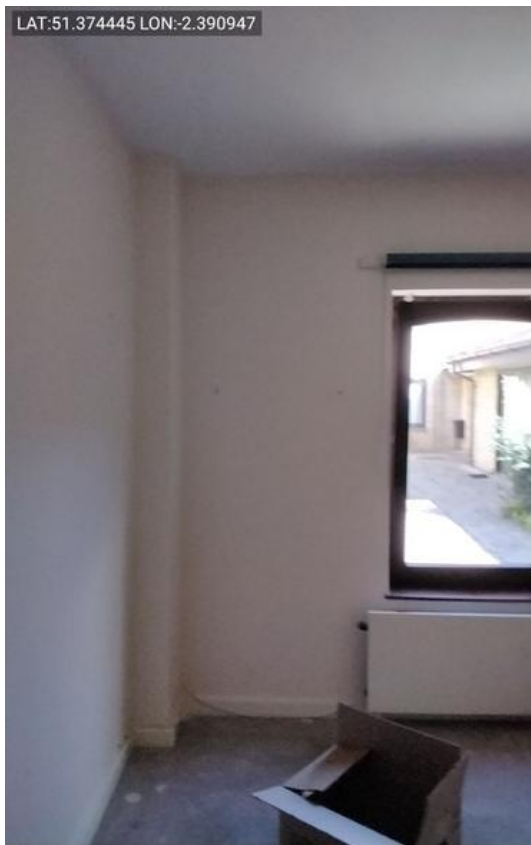
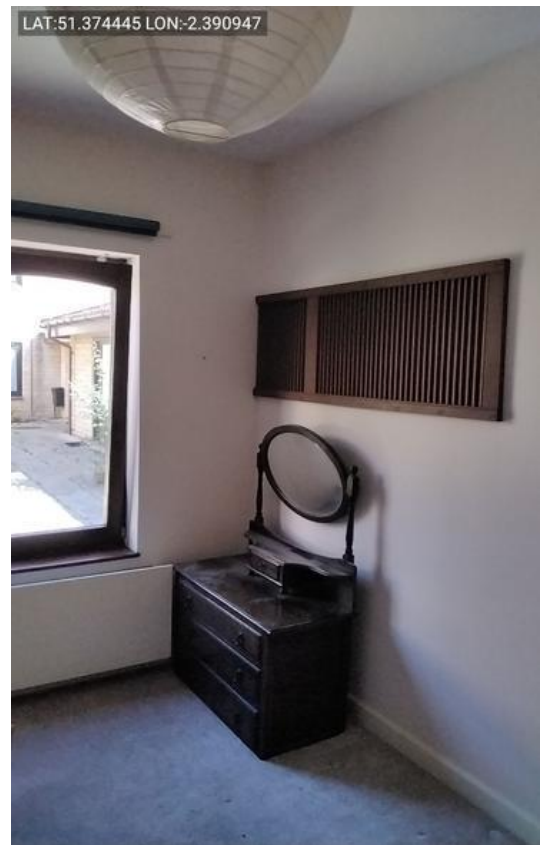
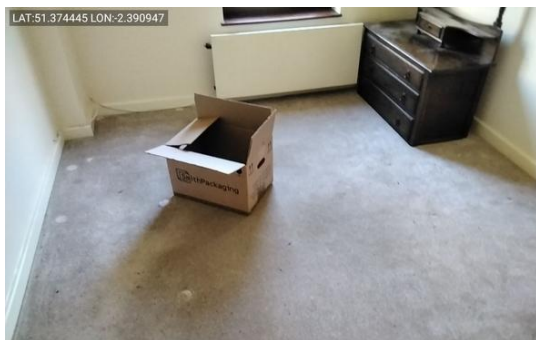
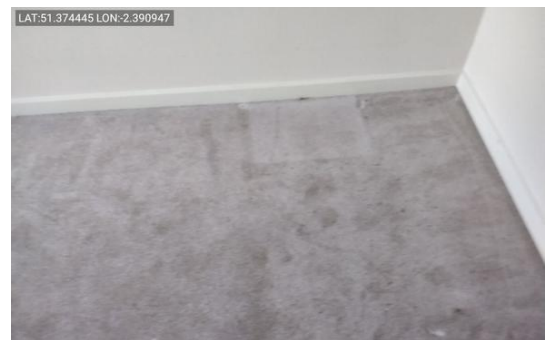
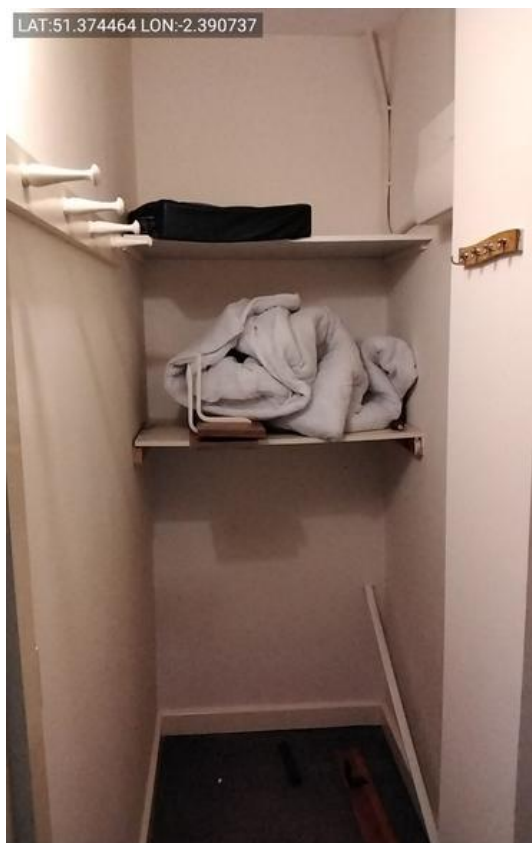
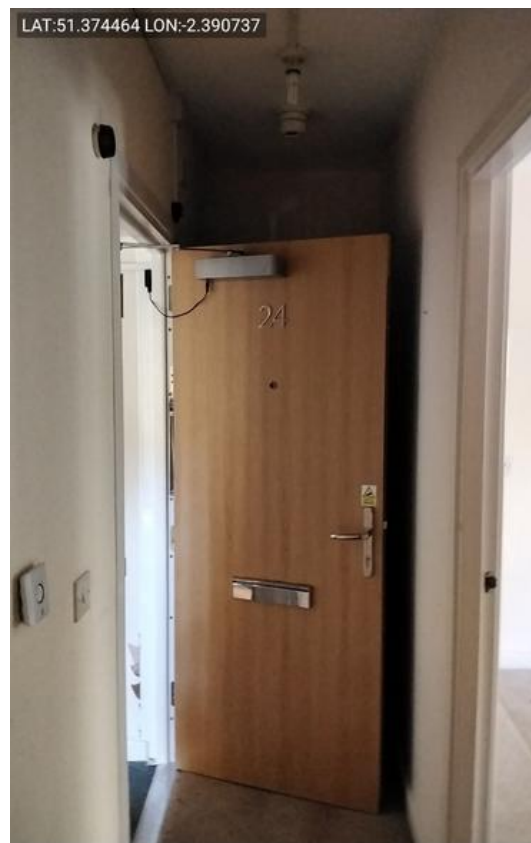
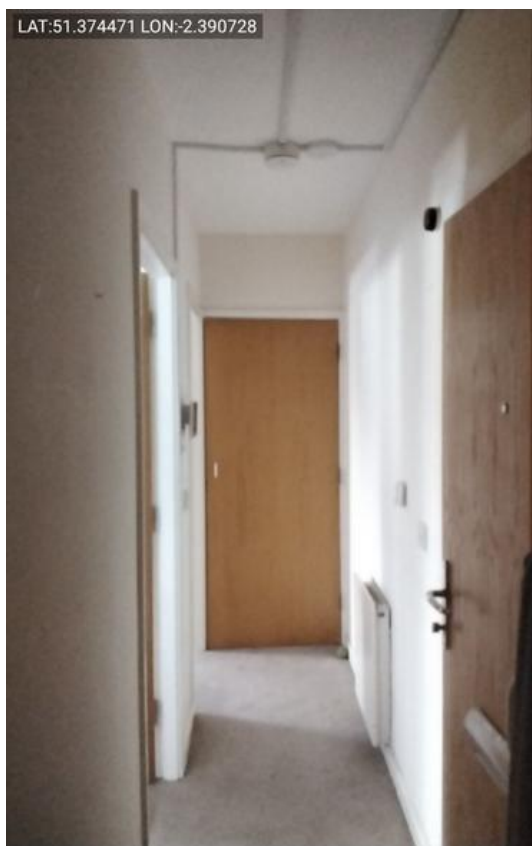
1 BED FLAT

Lounge.
Fill holes in walls etc.
Replace red pull cord.
Clean carpet.
Replace pendant, dispose of lightshade.

Bedroom.
Replace pendant, dispose of lightshade.
Replace red pull cord.
Clean carpet.
Remove louvre door from wall.
Fill all holes etc.

Hallway.
Clear store cupboard.
Clean carpet.

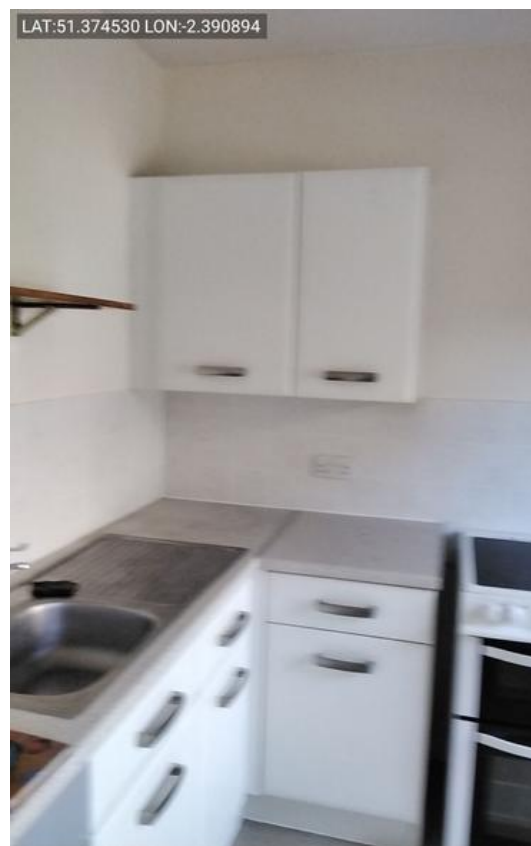
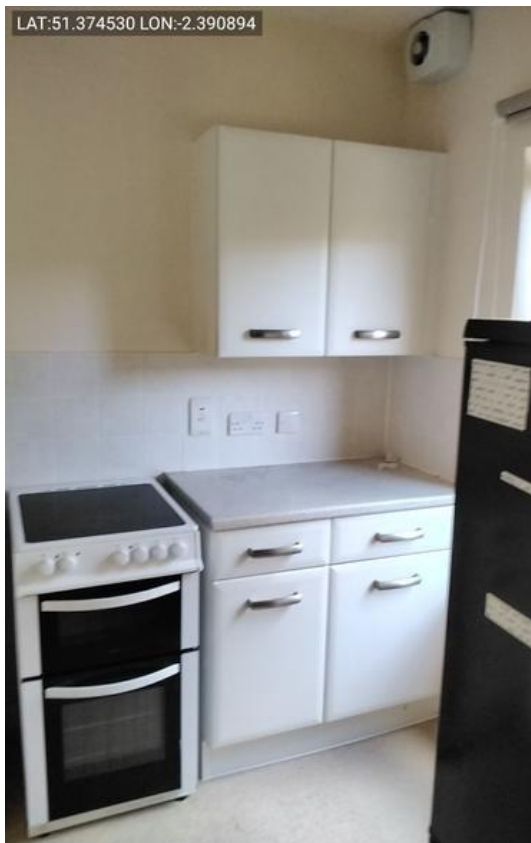
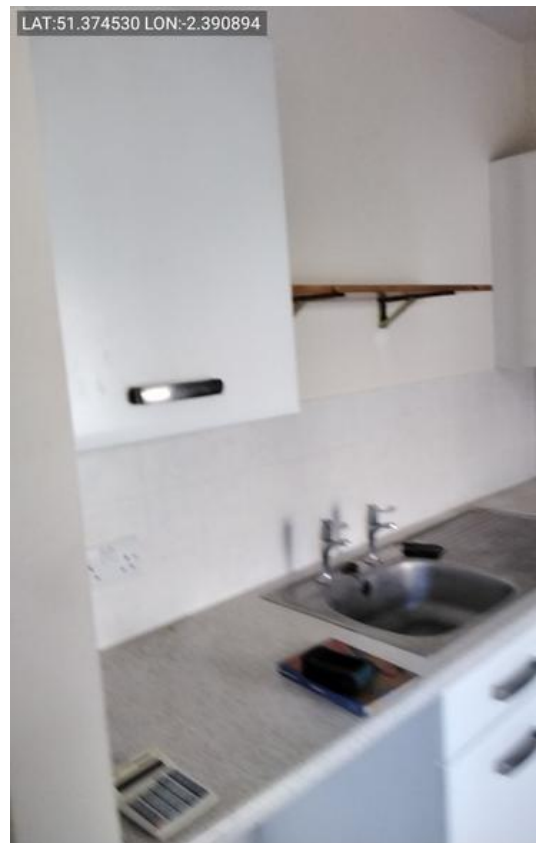
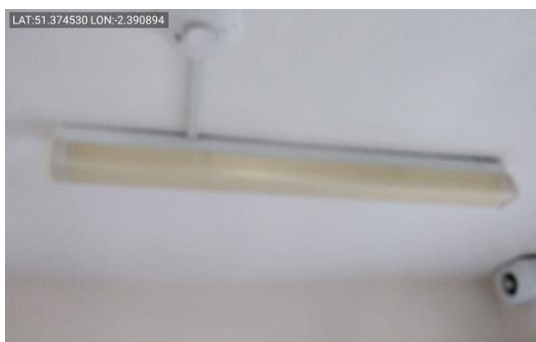
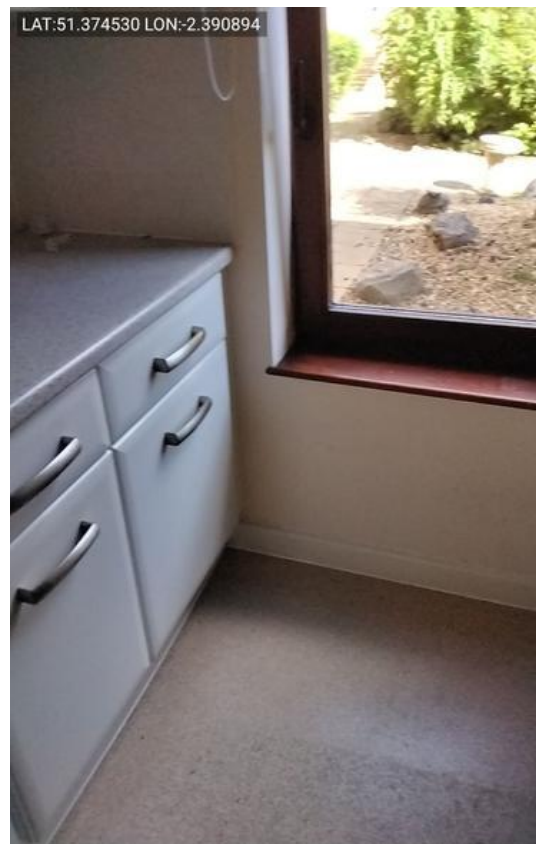
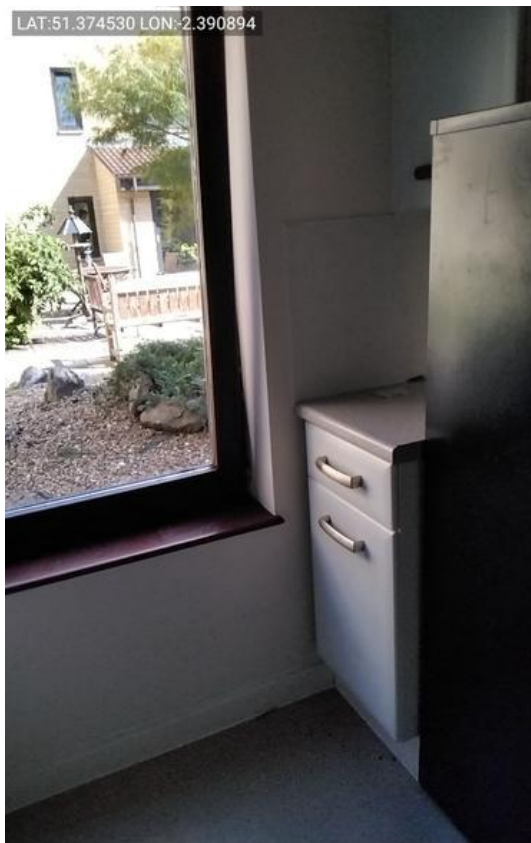
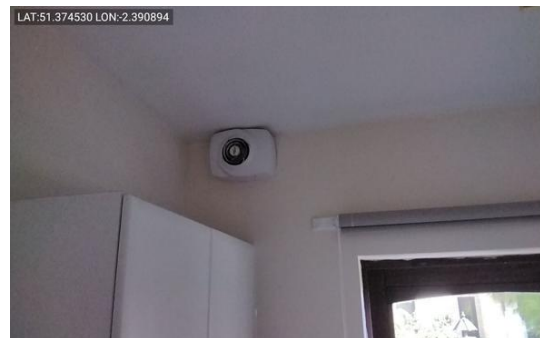
KITCHEN

Clean/service extractor.
Replacesink plug/chain.
Renew diffuser.
Replace red pull cord.
Service/clean smoke detectors throughout.
Service/clean CO2 detectors throughout.

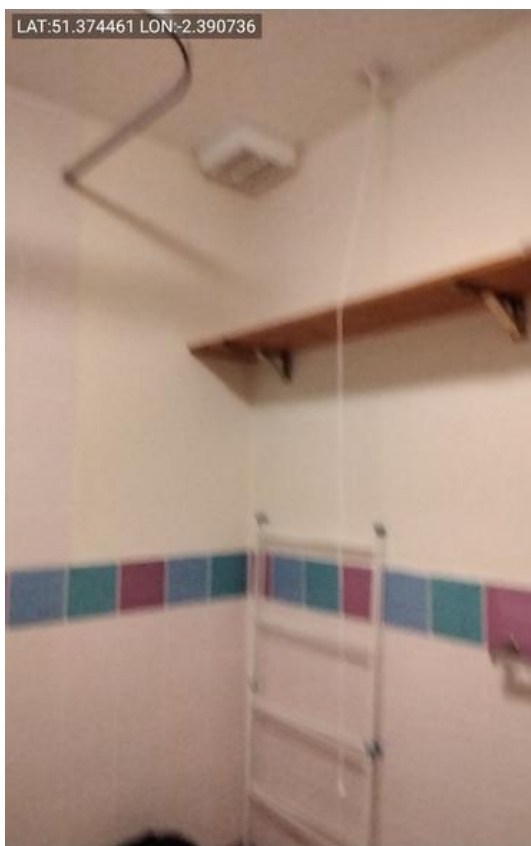
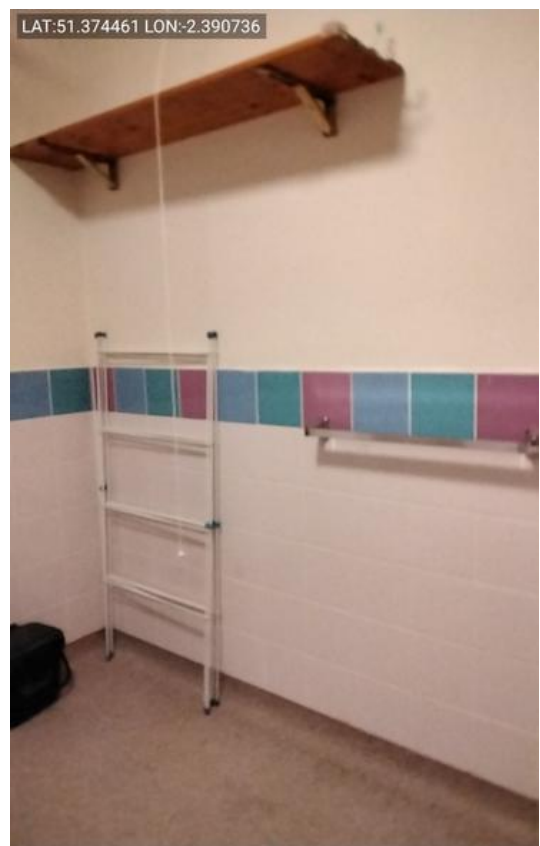
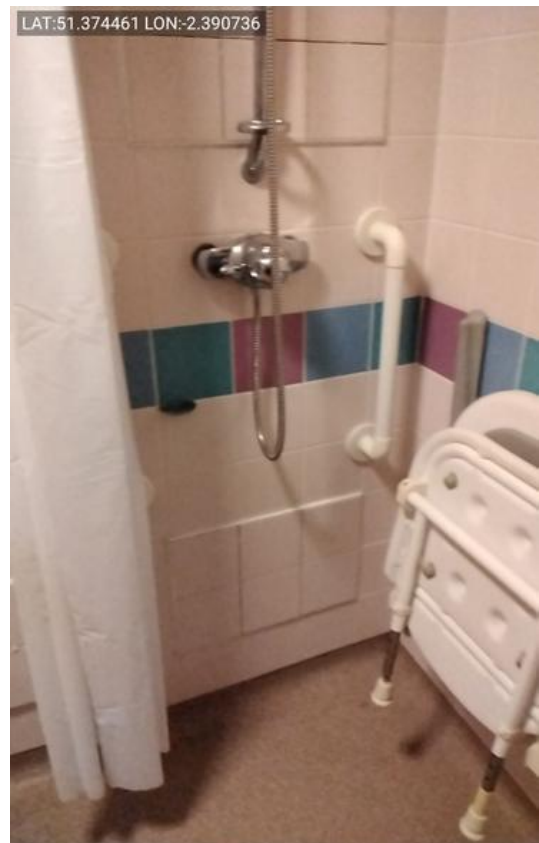
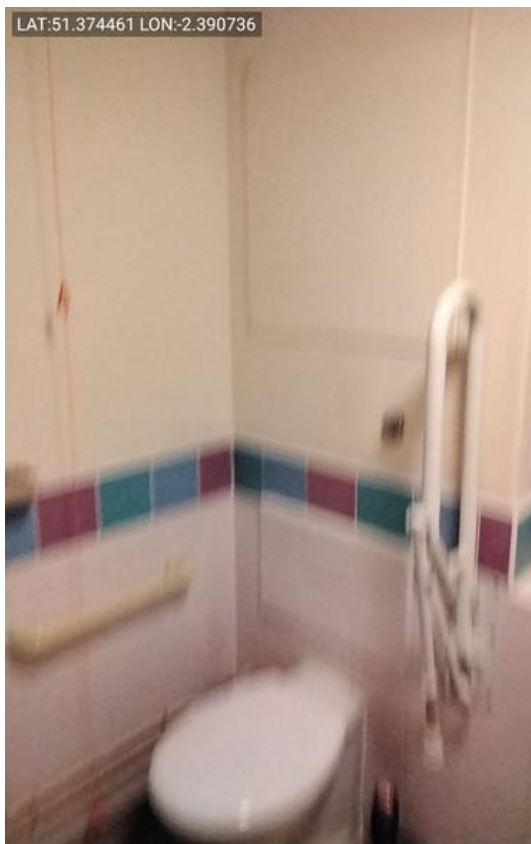
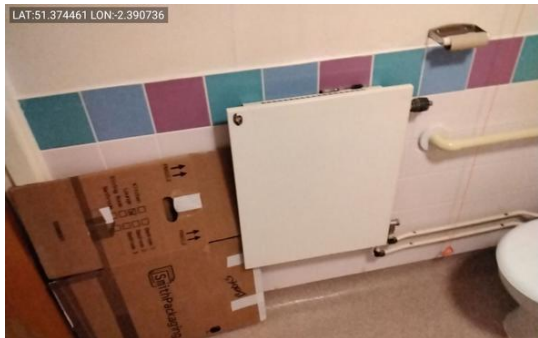
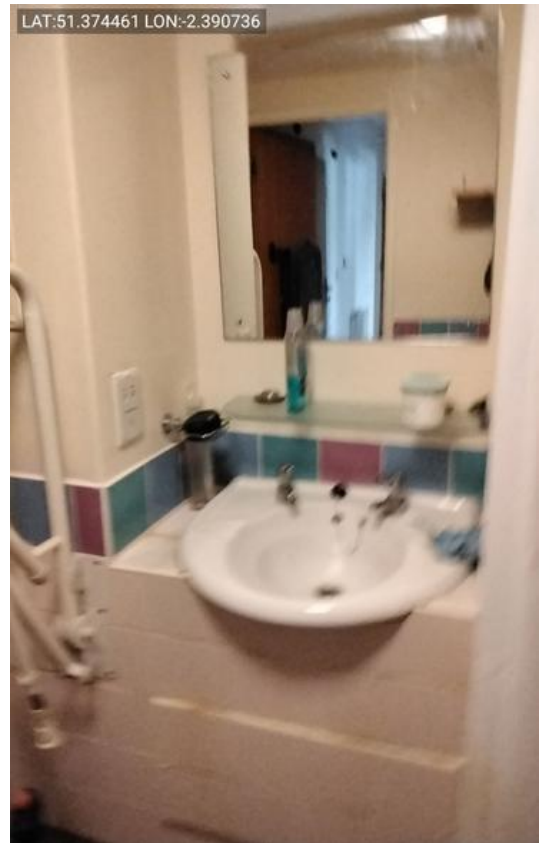
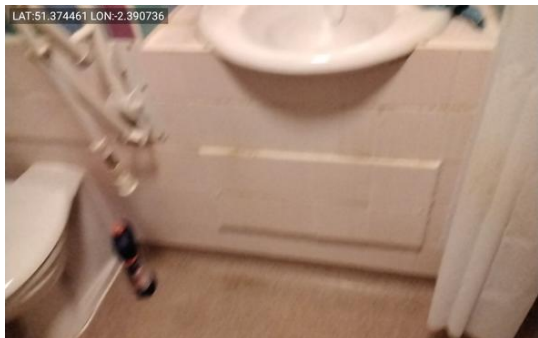
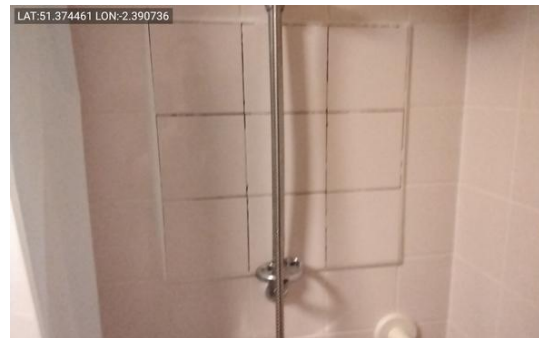
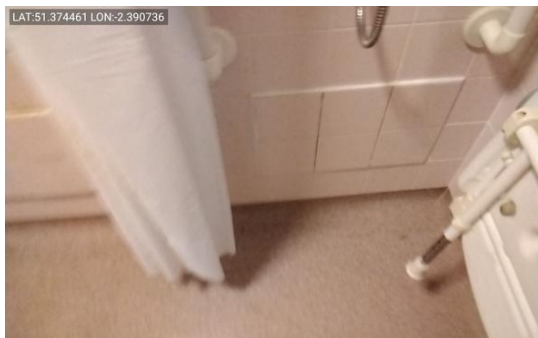
BATHROOM

Clean/service extractor.
Replace red and white pull cords.
Replace basin plug/chain.
Replace toilet seat/cover.
Replace shower curtain.
Replace shower head and hose.
Clear items left.
Reseal inspection cover under basin, white silicone.
RegROUT inspection covers in shower.

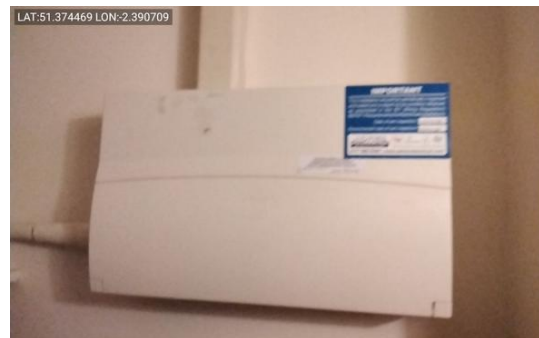
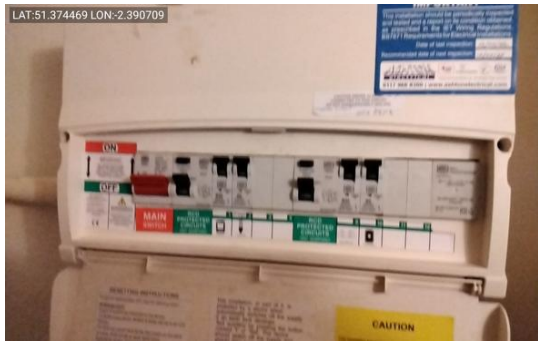
In hallway storage room.
