**An Asbestos Management Survey (MA & PA) at  
24 Avondown House, The Hollow, Langdon Road, Twerton, Bath, Avon  
BA2 1ND**

<b>Survey Conducted:</b>	<b>11 February 2020</b>	
<b>Date of approval:</b>	<b>13 Feb 2020</b>	
<b>Our Reference:</b>	<b>J191665</b>	
<b>Surveyed By:</b>	<b>Fiona Williamson</b>	
<b>UPRN:</b>	<b>13482</b>	
<b>Scope of Works:</b>	<b>Management survey to all accessible areas of the property.</b>

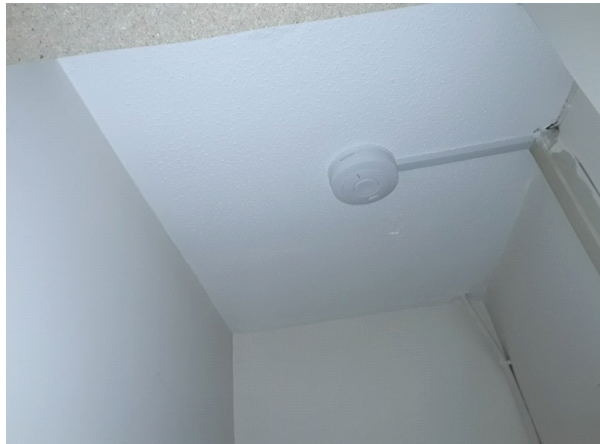
<b>Building:</b>	24 Avondown House	<b>Floor Level:</b>	Ground	<b>Item Ref:</b>	J191665-1
<b>Room Name:</b>	(001) Cupboard				
<b>Sample Ref:</b>	FW002590 (Sample 1)				
<b>Component:</b>	Textured coating to plasterboard ceiling

Material Assessment		
Product Type	Extent of damage	Surface Treatment Score
Textured Coating (1)	Low Damage (1)	1
Asbestos Type	Material Assessment Score (MA)	Very Low (4)
Chrysotile (1)

Priority Assessment		
Occupant Activity	Location Score	Accessibility Score
0 (Rare disturbance)	2	1
Extent / amount	No. of occupants	Frequency of Use
5m² (1)	1 (1 to 3)	3 (Daily)
Avg. time area is in use	Type of Maintenance	Freq. of Maintenance
0 (<1 hour)	1 (Low disturbance)	1 (<1 per year)
Priority Assessment Score (PA)		5

<b>RISK ASSESSMENT TOTAL SCORE (MA+PA)</b>	<b>9</b>
--	----------

Conclusions and Actions	
<b>Recommendation:</b>	Manage and Inspect
<b>Further Information:</b>	None
<b>General Notes:</b> Textured coating to plasterboard ceiling. Plaster to brick walls. Carpet to hardboard floor. Wooden access panel in plasterboard boxing - no access within boxing (excessive damage). Modern electrics.

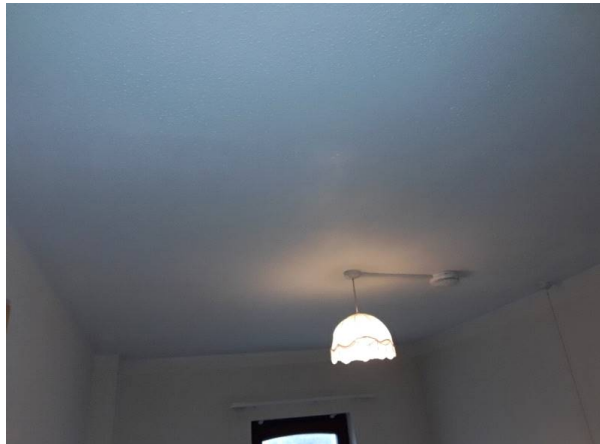
<b>Building:</b>	24 Avondown House	<b>Floor Level:</b>	Ground	<b>Item Ref:</b>	J191665-2
<b>Room Name:</b>	(002) Bedroom				
<b>Sample Ref:</b>	As FW002590 (Ref Sample 1)				
<b>Component:</b>	Textured coating to plasterboard ceiling

Material Assessment		
Product Type	Extent of damage	Surface Treatment Score
Textured Coating (1)	Low Damage (1)	1
Asbestos Type	Material Assessment Score (MA)	Very Low (4)
Chrysotile (1)

Priority Assessment		
Occupant Activity	Location Score	Accessibility Score
1 (Low disturbance)	2	1
Extent / amount	No. of occupants	Frequency of Use
12m <sup>2</sup> (2)	1 (1 to 3)	3 (Daily)
Avg. time area is in use	Type of Maintenance	Freq. of Maintenance
3 (>6 hours)	1 (Low disturbance)	1 (<1 per year)
Priority Assessment Score (PA)		7

<b>RISK ASSESSMENT TOTAL SCORE (MA+PA)</b>	<b>11</b>
--	-----------

Conclusions and Actions	
<b>Recommendation:</b>	Manage and Inspect
<b>Further Information:</b>	None
<b>General Notes:</b> Textured coating to plasterboard ceiling. Plaster to brick walls. Carpet to hardboard floor. Plasterboard boxing to left hand side of window - no access within boxing (excessive damage). Wooden window and sill. Modern radiator.

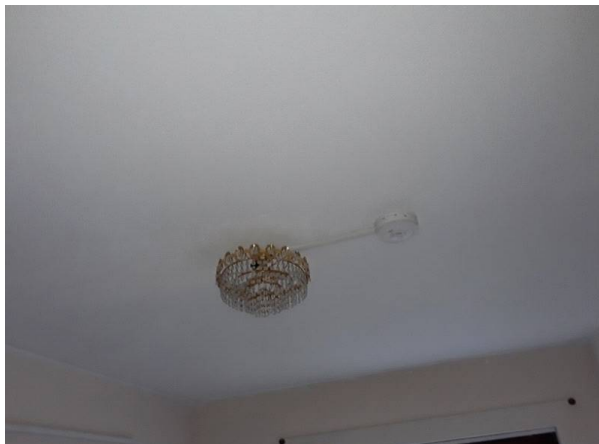
<b>Building:</b>	24 Avondown House	<b>Floor Level:</b>	Ground	<b>Item Ref:</b>	<b>J191665-3</b>
<b>Room Name:</b>	(003) Lounge				
<b>Sample Ref:</b>	As FW002590 (Ref Sample 1)				
<b>Component:</b>	Textured coating to plasterboard ceiling

Material Assessment		
Product Type	Extent of damage	Surface Treatment Score
Textured Coating (1)	Low Damage (1)	1
Asbestos Type	Material Assessment Score (MA)	Very Low (4)
Chrysotile (1)

Priority Assessment		
Occupant Activity	Location Score	Accessibility Score
1 (Low disturbance)	2	1
Extent / amount	No. of occupants	Frequency of Use
14m <sup>2</sup> (2)	1 (1 to 3)	3 (Daily)
Avg. time area is in use	Type of Maintenance	Freq. of Maintenance
2 (3 to 6 hours)	1 (Low disturbance)	1 (<1 per year)
Priority Assessment Score (PA)		6

<b>RISK ASSESSMENT TOTAL SCORE (MA+PA)</b>	<b>10</b>
--	-----------

Conclusions and Actions	
<b>Recommendation:</b>	Manage and Inspect
<b>Further Information:</b>	None
<b>General Notes:</b> Textured coating to plasterboard ceiling. Plaster to brick walls. Carpet to hardboard floor. Wooden access Wooden window and sill. Modern radiator.

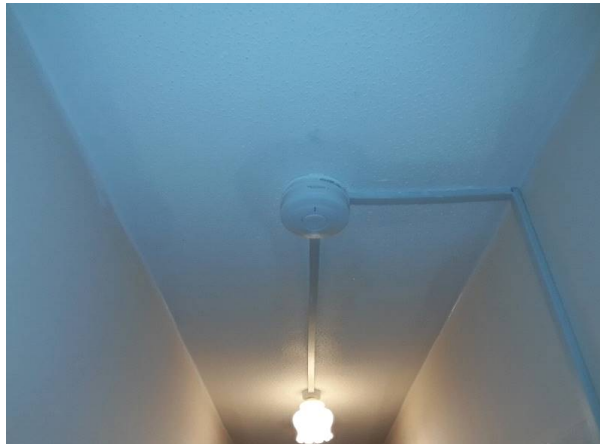
<b>Building:</b>	24 Avondown House	<b>Floor Level:</b>	Ground	<b>Item Ref:</b>	<b>J191665-4</b>
<b>Room Name:</b>	(004) Hall				
<b>Sample Ref:</b>	FW002591 (Sample 2)				
<b>Component:</b>	Textured coating to plasterboard ceiling

Material Assessment		
Product Type	Extent of damage	Surface Treatment Score
Textured Coating (1)	Low Damage (1)	1
Asbestos Type	Material Assessment Score (MA)	Very Low (4)
Chrysotile (1)

Priority Assessment		
Occupant Activity	Location Score	Accessibility Score
1 (Low disturbance)	2	1
Extent / amount	No. of occupants	Frequency of Use
5m² (1)	1 (1 to 3)	3 (Daily)
Avg. time area is in use	Type of Maintenance	Freq. of Maintenance
0 (<1 hour)	1 (Low disturbance)	1 (<1 per year)
Priority Assessment Score (PA)		6

<b>RISK ASSESSMENT TOTAL SCORE (MA+PA)</b>	<b>10</b>
--	-----------

Conclusions and Actions	
<b>Recommendation:</b>	Manage and Inspect
<b>Further Information:</b>	None
<b>General Notes:</b> Textured coating to plasterboard ceiling. Plaster to brick walls. Carpet to hardboard floor. Wooden front door. Modern radiator.

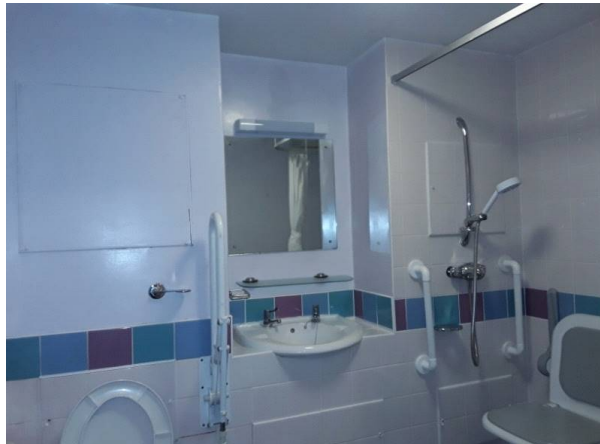
<b>Building:</b>	24 Avondown House	<b>Floor Level:</b>	Ground	<b>Item Ref:</b>	<b>J191665-5</b>
<b>Room Name:</b>	(005) Bathroom				
<b>Sample Ref:</b>					
<b>Component:</b>	No asbestos containing materials found

Material Assessment		
<b>Product Type</b>	<b>Extent of damage</b>	<b>Surface Treatment Score</b>
<b>Asbestos Type</b>	<b>Material Assessment Score (MA)</b>	
No suspect materials

Conclusions and Actions	
<b>Recommendation:</b>	No further action required
<b>Further Information:</b>	None
<b>General Notes:</b> Plasterboard ceiling. Plaster to brick walls. Modern linoleum to floor - no access under modern linoleum (excessive damage). Five wooden access panels (four ceramic tiled) to plasterboard boxing to toilet, sink and shower - no access within boxing (excessive damage). Modern extract fan in ceiling. Modern radiator.

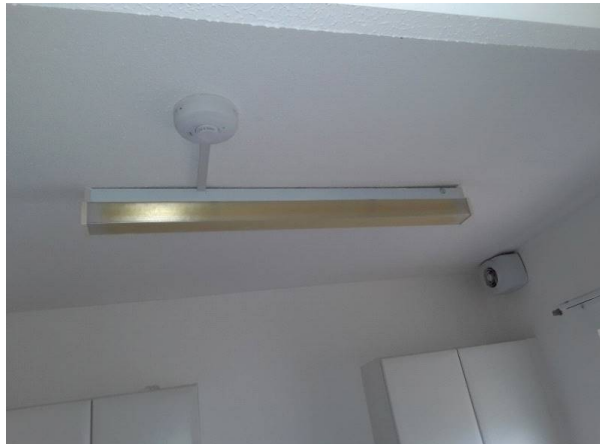
<b>Building:</b>	24 Avondown House	<b>Floor Level:</b>	Ground	<b>Item Ref:</b>	J191665-6
<b>Room Name:</b>	(006) Kitchen				
<b>Sample Ref:</b>	As FW002591 (Ref Sample 2)				
<b>Component:</b>	Textured coating to plasterboard ceiling and boxing below ceiling

Material Assessment		
Product Type	Extent of damage	Surface Treatment Score
Textured Coating (1)	Low Damage (1)	1
Asbestos Type	Material Assessment Score (MA)	Very Low (4)
Chrysotile (1)

Priority Assessment		
Occupant Activity	Location Score	Accessibility Score
1 (Low disturbance)	2	1
Extent / amount	No. of occupants	Frequency of Use
5m² (1)	1 (1 to 3)	3 (Daily)
Avg. time area is in use	Type of Maintenance	Freq. of Maintenance
1 (1 to 3 hours)	1 (Low disturbance)	1 (<1 per year)
Priority Assessment Score (PA)		6

<b>RISK ASSESSMENT TOTAL SCORE (MA+PA)</b>	<b>10</b>
--	-----------

Conclusions and Actions	
<b>Recommendation:</b>	Manage and Inspect
<b>Further Information:</b>	None
<b>General Notes:</b> Textured coating to plasterboard ceiling. Plaster to brick walls. Modern linoleum to hardboard floor. Textured coating to plasterboard boxing below ceiling - no access within boxing (excessive damage). Modern sink pad. Wooden window and sill. Modern extract fan in wall.
