Guinness Property - Empty Homes - Handover Form

8 Brush Walk, Mere, Wiltshire, BA12 6FP

Works Order Number

5520832/1

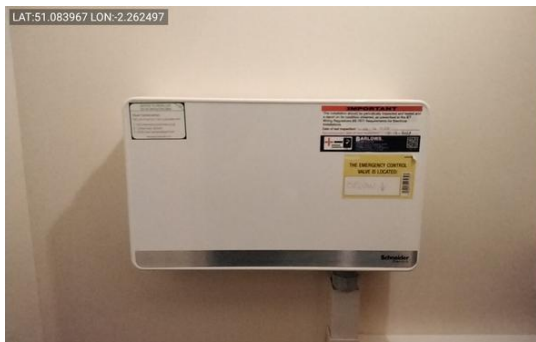
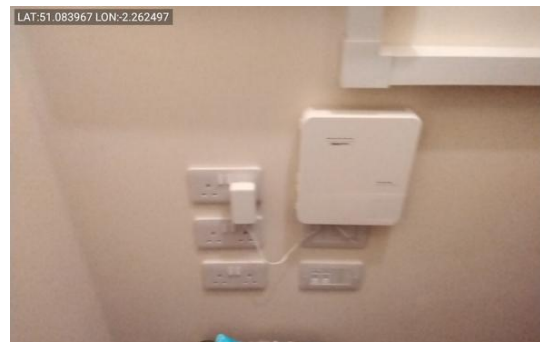
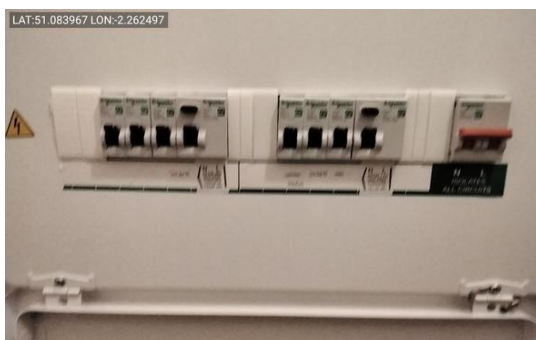
In hallway store cupboard.

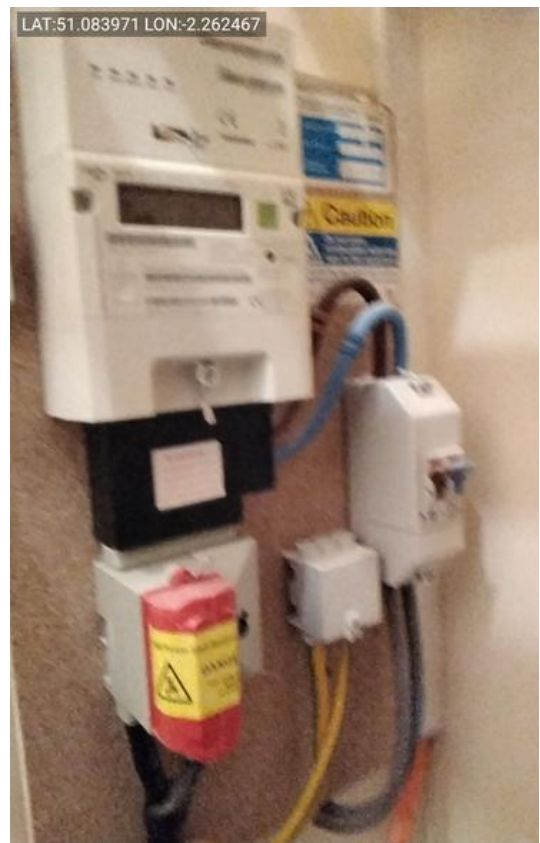
Photo 46

Smart

£4.75 cr, on supply.

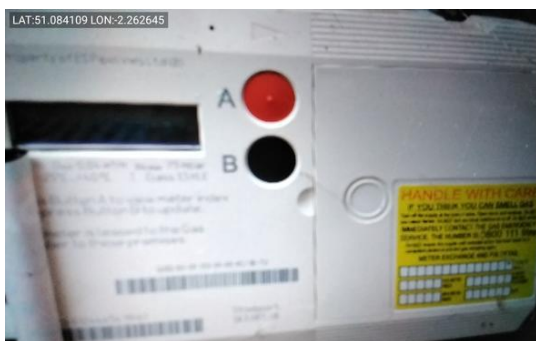
Photo 47

External in floor mounted gas box, marked no 8.

None shown. Message saying
'Pre-Comm. ON'.

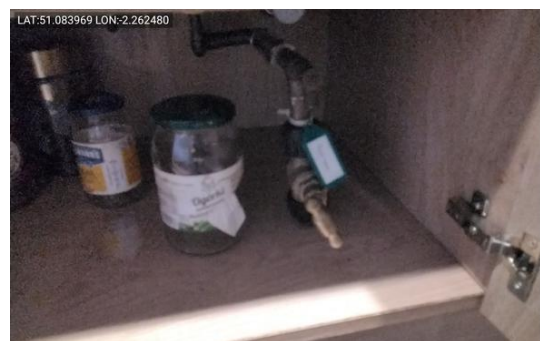
Photo 48

Under kitchen sink.
