Guinness Property - Empty Homes - Handover Form

8 Roman House, Walcot Gate, Walcot, Bath, BA1 5UE

Works Order Number

5528353/1

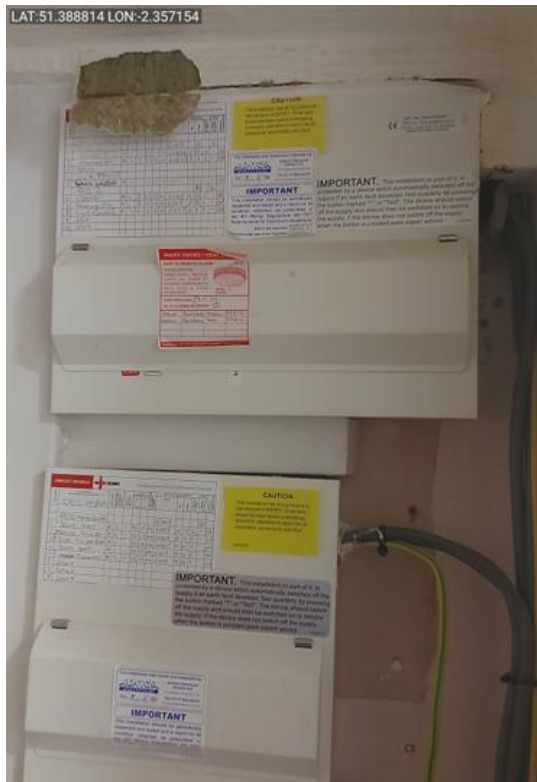
Photo 1

Location of Consumer Unit

Electric cupboard outside flat

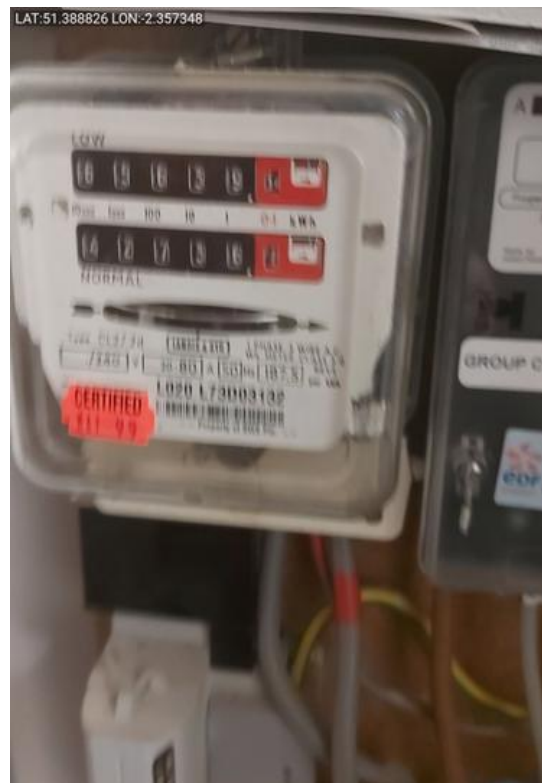
Photo 4

Serial Number

L020 L73D03132

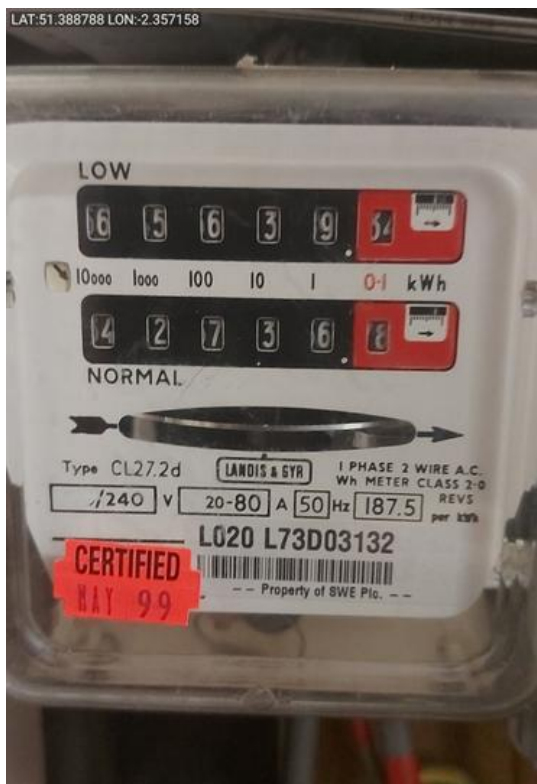
Photo 5

Before Readings

65639

42736
