**An Asbestos Management Survey (MA & PA) at
Flat 8 Roman House, Walcot Gate, Bath, Somerset
BA1 5UE**

| Survey Conducted: | 25 September 2023 | |
| Our Reference: | J335292 | |

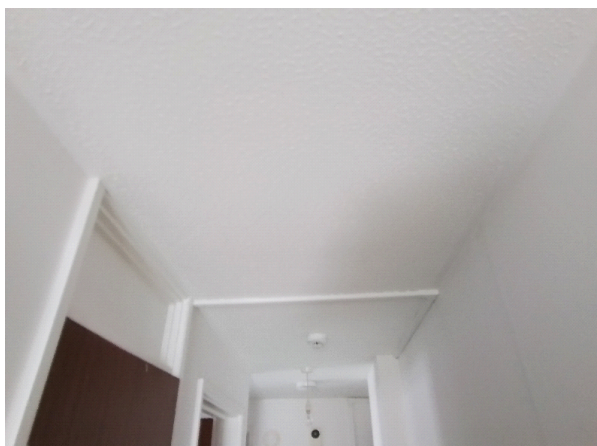
| Room Name: | (001) Hall | | | | |

| Component: | Textured coating to plasterboard ceiling | | | | |

| Material Assessment | | |
|---|---|---|
| No Asbestos Detected | | |

| Conclusions and Actions | |
|--|---|
| General Notes: Textured coating to plasterboard ceiling. Plaster to brick walls. Carpet to concrete floor. Wooden front door. Insulation board header panel above door to cupboard. Modern storage heater on wall. | |

| Conclusions and Actions | |
|--|---|
| Recommendation: | No further action required |

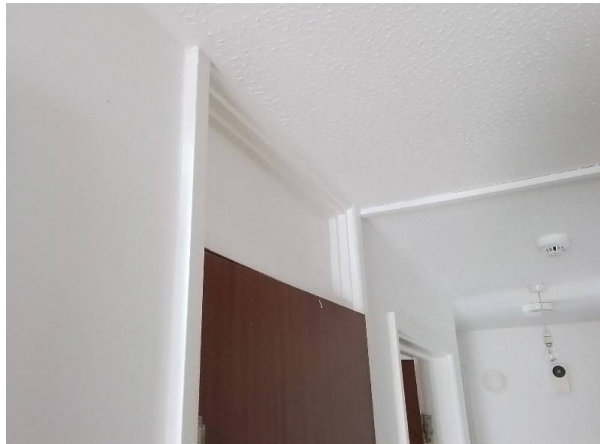
| Room Name: | (001) Hall | | | | |

| Component: | Insulation board header panel above cupboard door | | | | |

| Material Assessment | | |
|---|---|---|
| No Asbestos Detected | | |

| Conclusions and Actions | |
|--|---|
| Recommendation: | No further action required |

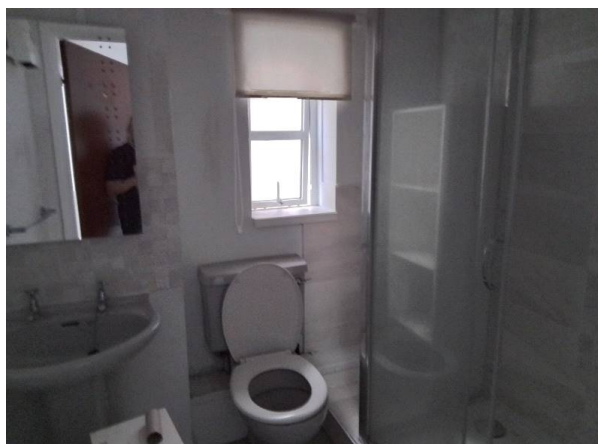
| Component: | No asbestos containing materials found | | | | |

| Conclusions and Actions | |
|--|---|
| General Notes: Plasterboard ceiling. Plaster to brick walls. Modern linoleum to floor - no access under modern linoleum (excessive damage). Plasterboard boxing adjacent to and wooden boxing under toilet - no access within boxing (excessive damage). Ceramic cistern. uPVC window and sill. Modern heater on wall. | |

| Conclusions and Actions | |
|--|---|
| Recommendation: | No further action required |

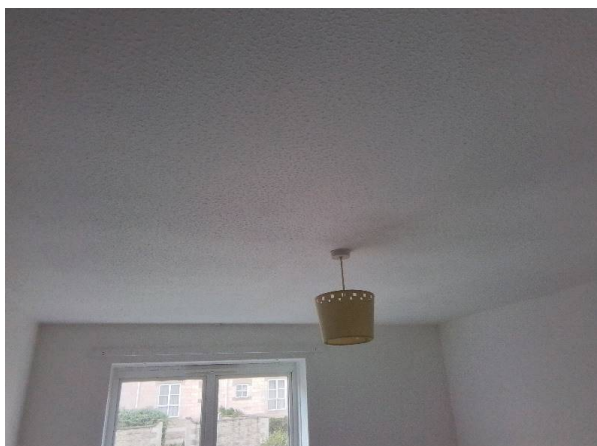
| Component: | Textured coating to plasterboard ceiling | | | | |

| Conclusions and Actions | |
|---|---|
| Recommendation: | No further action required |

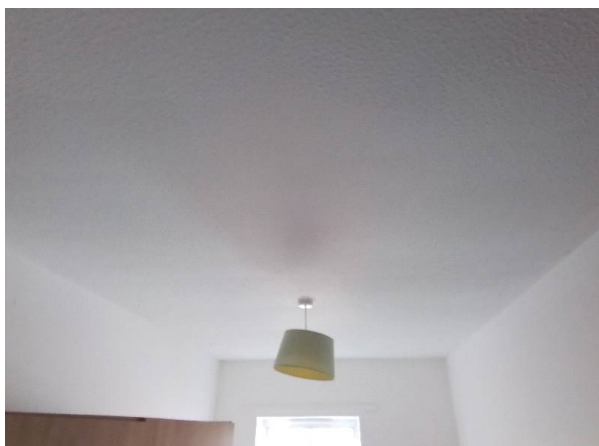
| Component: | Textured coating to plasterboard ceiling | | | | |

| Conclusions and Actions | |
|---|---|
| Recommendation: | No further action required |

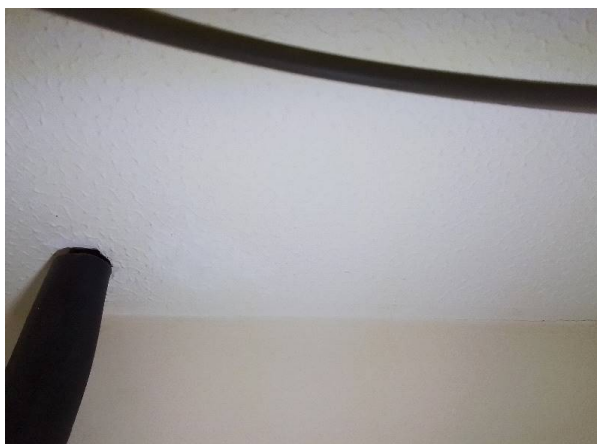
| Component: | Textured coating to plasterboard ceiling | | | | |

| Conclusions and Actions | |
|--|---|
| Recommendation: | No further action required |

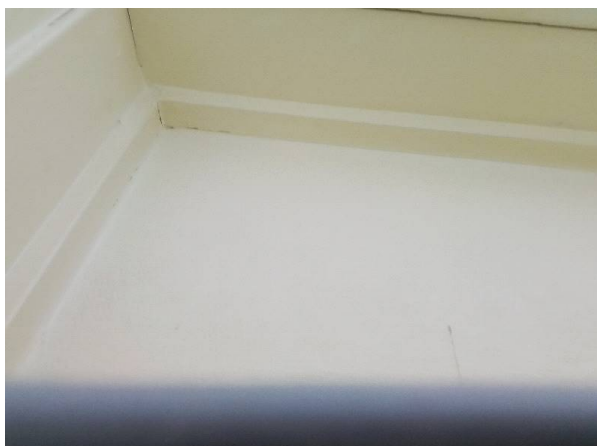
| Component: | Insulation board header panel above door to hall | | | | |

| Conclusions and Actions | |
|--|---|
| Recommendation: | No further action required |

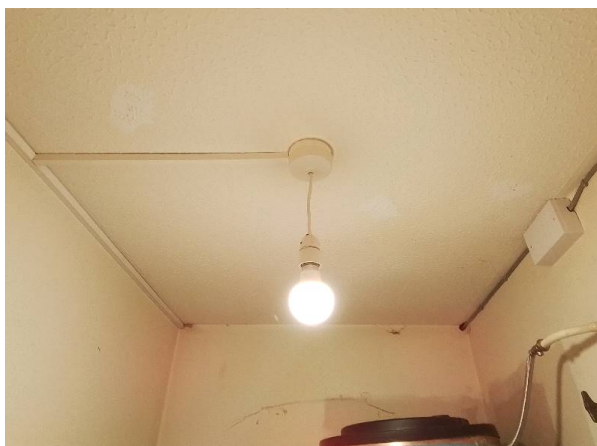
| Component: | Textured coating to plasterboard ceiling | | | | |

| Conclusions and Actions | |
|---|---|
| Recommendation: | No further action required |

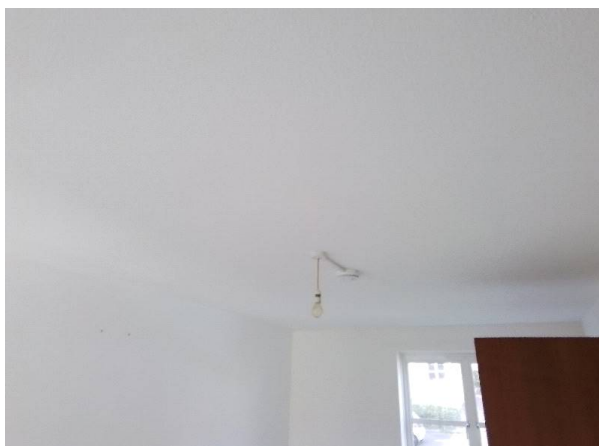
| Component: | Textured coating to plasterboard ceiling | | | | |

| Conclusions and Actions | |
|---|---|
| Recommendation: | No further action required |

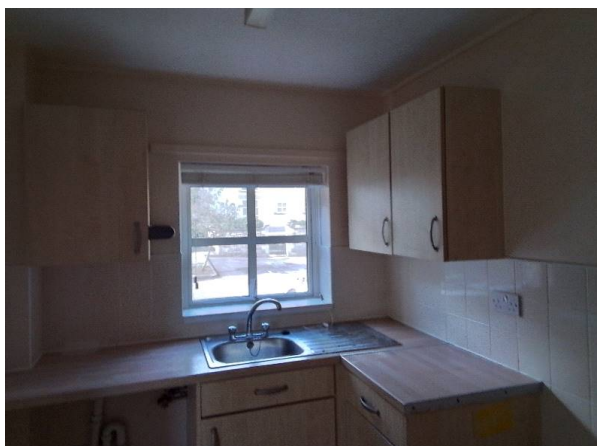
| Component: | No asbestos containing materials found | | | | |

| Conclusions and Actions | |
|--|---|
| General Notes: Plasterboard ceiling. Plaster to brick walls. Two layers of modern linoleum to floor - no access under modern linoleum (excessive damage). Plasterboard boxing adjacent to cabinet - no access within boxing (excessive damage). Modern sink pad. uPVC window and sill. | |

| Conclusions and Actions | |
|--|---|
| Recommendation: | No further action required |

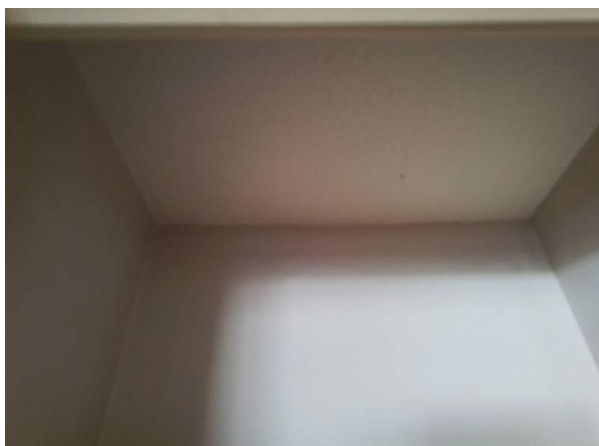
| Component: | Textured coating to plasterboard ceiling | | | | |

| Conclusions and Actions | |
|---|---|
| General Notes: Textured coating to plasterboard ceiling. Plaster to brick walls. Modern linoleum to floor - no access under modern linoleum (excessive damage). | |

| Conclusions and Actions | |
|---|---|
| Recommendation: | No further action required |
