**An Asbestos Management Survey with part Refurbishment/Demolition (MA and PA) to  
the areas affected by kitchen replacement**

**at  
71 Ridge Green Close  
Bath  
BA2 2EG**

<b>Survey Carried Out On:</b>	<b>28 August 2018</b>	 
<b>Commissioned By:</b>	<b>Daniel Edwards Guinness Partnership The Guinness Partnership 30 Brock Street Regents Place London NW1 3FG</b>	
<b>Date:</b>	<b>3 September 2018</b>	
<b>Our Reference:</b>	<b>J117158</b>	
<b>Surveyed By:</b>	<b>Fiona Williamson</b>

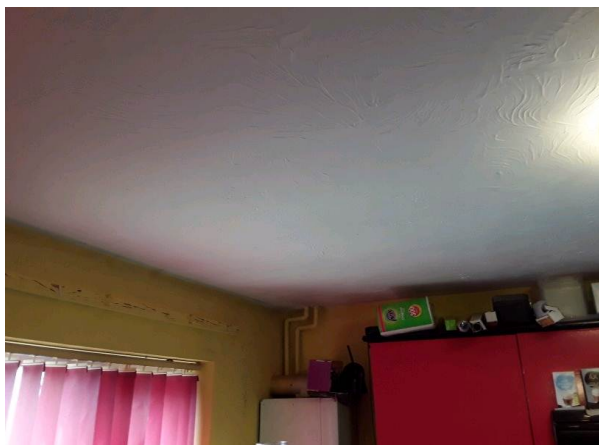
<b>Building:</b> Building	<b>Floor Level:</b> Ground	<b>Room Name:</b> (001) Kitchen
<b>Component:</b> Textured Coating (Asbestos Reinforced Composite)

Sample Reference	Asbestos Type	Material	Surface Treatment Score	
AZ002635 (Sample 1)	No Asbestos Detected			
Extent of damage	Material Assessment**	Accessibility	Extent/amount	Location
Occupant Activity	No. of Occupants	Frequency of Use	Average Time Area is in Use	
Type of Maintenance		Frequency of Maintenance	Priority Assessment	
Recommendations				
Who	What		When	
-	No further action required		-	
Further Recommendations: None				
<b>General Notes:</b> Textured coating to plasterboard ceiling Plaster to brick and plasterboard walls Modern linoleum to hardboard floor Plasterboard boxing to cabinets - no access within boxing (excessive damage) Wood panels to void area under cabinets - no access to void area under cabinets (excessive damage) uPVC window Ceramic tile sill Modern boiler Metal flue to boiler Modern sink pad Modern extract fan

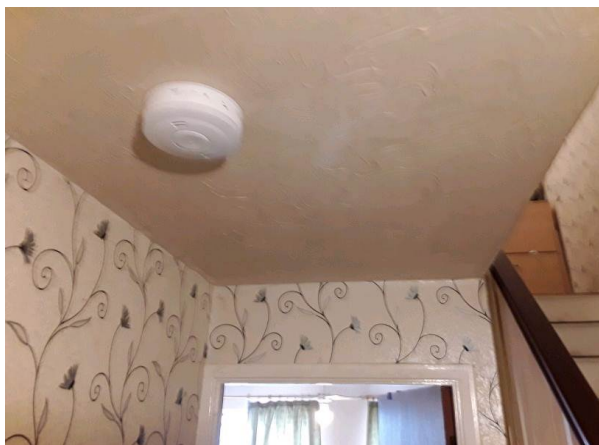
<b>Building:</b> Building	<b>Floor Level:</b> Ground	<b>Room Name:</b> (002) Hall
<b>Component:</b> Textured Coating (Asbestos Reinforced Composite)

Sample Reference	Asbestos Type	Material	Surface Treatment Score	
As AZ002635 (Ref Sample 1)	No asbestos detected in visually consistent material			
Extent of damage	Material Assessment**	Accessibility	Extent/amount	Location
Occupant Activity	No. of Occupants	Frequency of Use	Average Time Area is in Use	
Type of Maintenance		Frequency of Maintenance	Priority Assessment	
Recommendations				
Who	What		When	
-	No further action required		-	
Further Recommendations: None				
General Notes: Textured coating to plasterboard ceiling Plaster to brick and plasterboard walls Modern flooring to hardboard floor Wood stairs Modern radiator

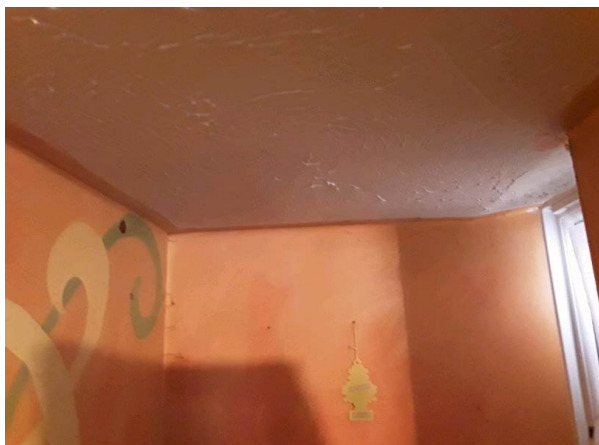
<b>Building:</b> Building	<b>Floor Level:</b> Ground	<b>Room Name:</b> (003) WC
<b>Component:</b> Textured Coating (Asbestos Reinforced Composite)

Sample Reference	Asbestos Type		Material	Surface Treatment Score	
As AZ002635 (Ref Sample 1)	No asbestos detected in visually consistent material				
Extent of damage	Material Assessment**		Accessibility	Extent/amount	Location
Occupant Activity	No. of Occupants		Frequency of Use	Average Time Area is in Use	
Type of Maintenance		Frequency of Maintenance		Priority Assessment	
Recommendations					
Who	What			When	
-	No further action required			-	
Further Recommendations: None					
<b>General Notes:</b> Textured coating to plasterboard ceiling Plaster to brick and plasterboard walls Modern floor tiles to hardboard floor Modern electrics uPVC window Ceramic tile sill

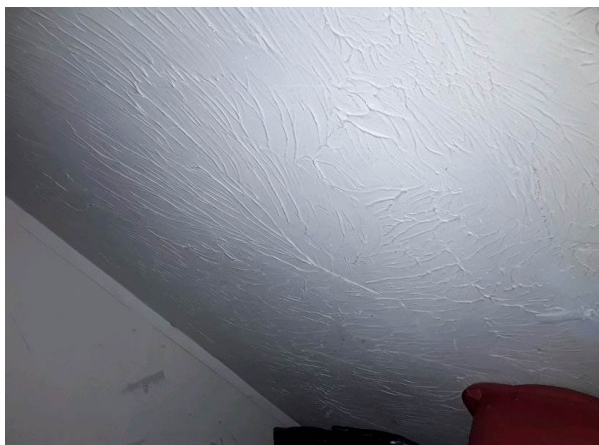
<b>Building:</b> Building	<b>Floor Level:</b> Ground	<b>Room Name:</b> (004) Cupboard
<b>Component:</b> Textured Coating (Asbestos Reinforced Composite)

Sample Reference	Asbestos Type	Material	Surface Treatment Score	
AZ002636 (Sample 2)	No Asbestos Detected			
Extent of damage	Material Assessment**	Accessibility	Extent/amount	Location
Occupant Activity	No. of Occupants	Frequency of Use	Average Time Area is in Use	
Type of Maintenance		Frequency of Maintenance	Priority Assessment	
Recommendations				
Who	What		When	
-	No further action required		-	
Further Recommendations: None				
General Notes: Textured coating to plasterboard ceiling Plaster to brick and plasterboard walls Hardboard floor

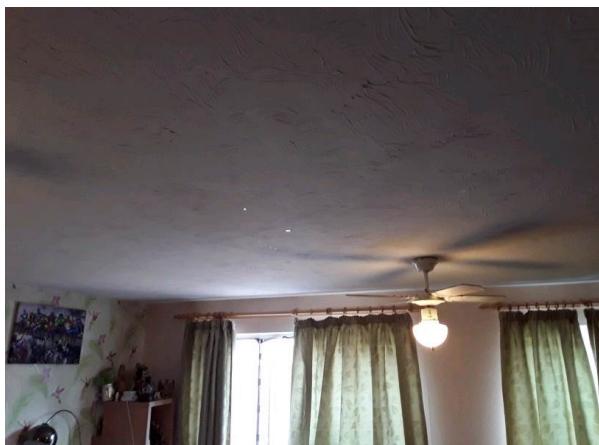
<b>Building:</b> Building	<b>Floor Level:</b> Ground	<b>Room Name:</b> (005) Lounge
<b>Component:</b> Textured Coating (Asbestos Reinforced Composite)

Sample Reference	Asbestos Type		Material	Surface Treatment Score	
As AZ002636 (Ref Sample 2)	No asbestos detected in visually consistent material				
Extent of damage	Material Assessment**		Accessibility	Extent/amount	Location
Occupant Activity	No. of Occupants		Frequency of Use	Average Time Area is in Use	
Type of Maintenance		Frequency of Maintenance		Priority Assessment	
Recommendations					
Who	What			When	
-	No further action required			-	
Further Recommendations: None					
<b>General Notes:</b> Textured coating to plasterboard ceiling Plaster to brick and plasterboard walls Modern flooring to hardboard floor uPVC Windows and door Wood sill Modern radiator

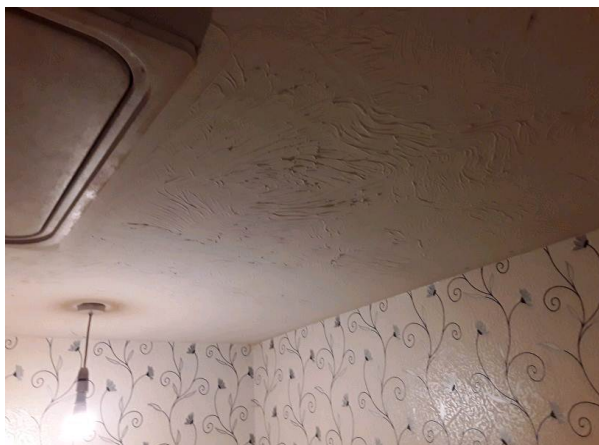
<b>Building:</b> Building	<b>Floor Level:</b> First	<b>Room Name:</b> (006) Landing
<b>Component:</b> Textured Coating (Asbestos Reinforced Composite)

Sample Reference	Asbestos Type	Material	Surface Treatment Score	
AZ002637 (Sample 3)	No Asbestos Detected			
Extent of damage	Material Assessment**	Accessibility	Extent/amount	Location
Occupant Activity	No. of Occupants	Frequency of Use	Average Time Area is in Use	
Type of Maintenance		Frequency of Maintenance	Priority Assessment	
Recommendations				
Who	What		When	
-	No further action required		-	
Further Recommendations: None				
General Notes: Textured coating to plasterboard ceiling Plaster to brick and plasterboard walls Modern flooring to hardboard floor Plastic loft hatch

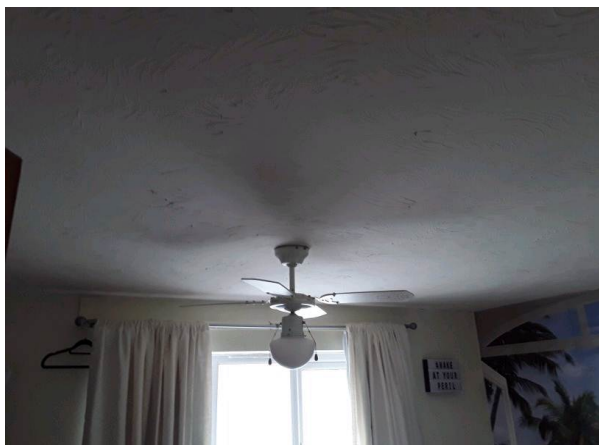
<b>Building:</b> Building	<b>Floor Level:</b> First	<b>Room Name:</b> (007) Bedroom
<b>Component:</b> Textured Coating (Asbestos Reinforced Composite)

Sample Reference	Asbestos Type	Material	Surface Treatment Score	
As AZ002637 (Ref Sample 3)	No asbestos detected in visually consistent material			
Extent of damage	Material Assessment**	Accessibility	Extent/amount	Location
Occupant Activity	No. of Occupants	Frequency of Use	Average Time Area is in Use	
Type of Maintenance		Frequency of Maintenance	Priority Assessment	
Recommendations				
Who	What		When	
-	No further action required		-	
Further Recommendations: None				
General Notes: Textured coating to plasterboard ceiling Plaster to brick and plasterboard walls Modern flooring to hardboard floor uPVC window Wood sill Modern radiator

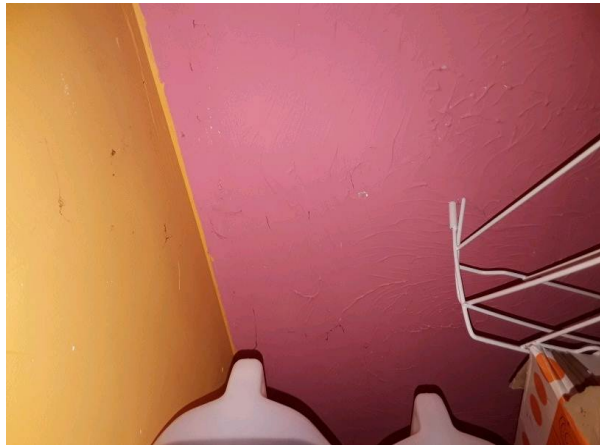
<b>Building:</b> Building	<b>Floor Level:</b> First	<b>Room Name:</b> (008) Cupboard
<b>Component:</b> Textured Coating (Asbestos Reinforced Composite)

Sample Reference	Asbestos Type	Material	Surface Treatment Score	
As AZ002637 (Ref Sample 3)	No asbestos detected in visually consistent material			
Extent of damage	Material Assessment**	Accessibility	Extent/amount	Location
Occupant Activity	No. of Occupants	Frequency of Use	Average Time Area is in Use	
Type of Maintenance		Frequency of Maintenance	Priority Assessment	
Recommendations				
Who	What		When	
-	No further action required		-	
Further Recommendations: None				
General Notes: Textured coating to plasterboard ceiling Plaster to brick and plasterboard walls floor Wood boxing over floor - no access within boxing (excessive damage)

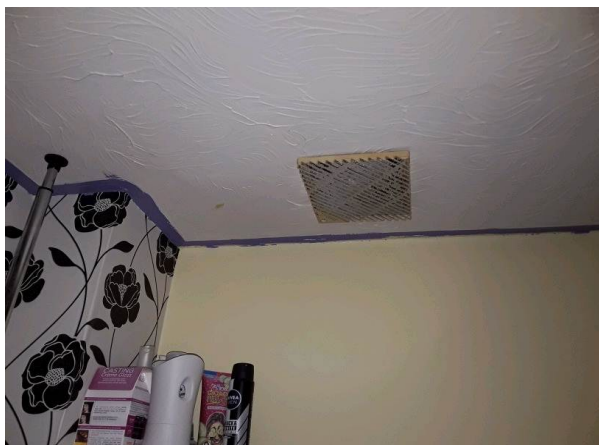
<b>Building:</b> Building	<b>Floor Level:</b> First	<b>Room Name:</b> (009) Bathroom
<b>Component:</b> Textured Coating (Asbestos Reinforced Composite)

Sample Reference	Asbestos Type	Material	Surface Treatment Score	
As AZ002637 (Ref Sample 3)	No asbestos detected in visually consistent material			
Extent of damage	Material Assessment**	Accessibility	Extent/amount	Location
Occupant Activity	No. of Occupants	Frequency of Use	Average Time Area is in Use	
Type of Maintenance		Frequency of Maintenance	Priority Assessment	
Recommendations				
Who	What		When	
-	No further action required		-	
Further Recommendations: None				
General Notes: Textured coating to plasterboard ceiling Plaster to brick and plasterboard walls floor Modern linoleum to hardboard floor Plasterboard boxing adjacent to bath - no access within boxing (excessive damage) Plastic bath panel - no access behind bath panel (excessive damage) Modern radiator

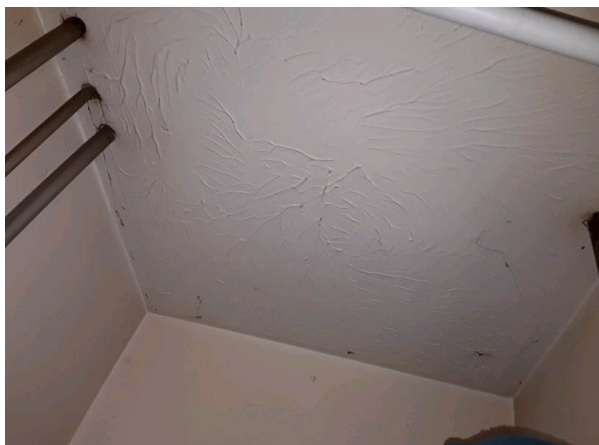
<b>Building:</b> Building	<b>Floor Level:</b> First	<b>Room Name:</b> (010) Cupboard
<b>Component:</b> Textured Coating (Asbestos Reinforced Composite)

Sample Reference	Asbestos Type	Material	Surface Treatment Score	
As AZ002637 (Ref Sample 3)	No asbestos detected in visually consistent material			
Extent of damage	Material Assessment**	Accessibility	Extent/amount	Location
Occupant Activity	No. of Occupants	Frequency of Use	Average Time Area is in Use	
Type of Maintenance		Frequency of Maintenance	Priority Assessment	
Recommendations				
Who	What		When	
-	No further action required		-	
Further Recommendations: None				
General Notes: Textured coating to plasterboard ceiling Plaster to brick and plasterboard walls Hardboard floor Modern immersion heater Metal pipes

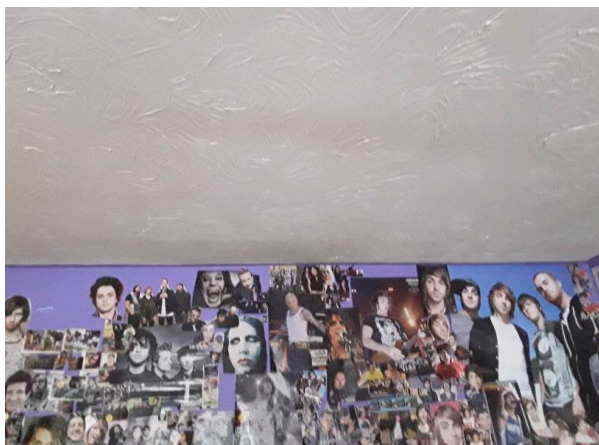
<b>Building:</b> Building	<b>Floor Level:</b> First	<b>Room Name:</b> (011) Bedroom
<b>Component:</b> Textured Coating (Asbestos Reinforced Composite)

Sample Reference	Asbestos Type	Material	Surface Treatment Score	
AZ002638 (Sample 4)	No Asbestos Detected			
Extent of damage	Material Assessment**	Accessibility	Extent/amount	Location
Occupant Activity	No. of Occupants	Frequency of Use	Average Time Area is in Use	
Type of Maintenance		Frequency of Maintenance	Priority Assessment	
Recommendations				
Who	What		When	
-	No further action required		-	
Further Recommendations: None				
General Notes: Textured coating to plasterboard ceiling Plaster to brick and plasterboard walls Hardboard floor uPVC window Wood sill Modern radiator

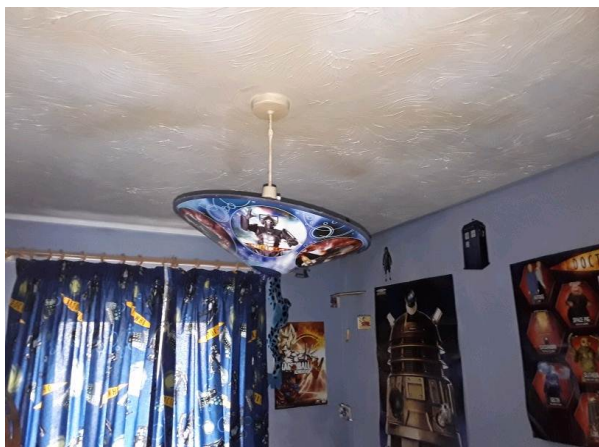
<b>Building:</b> Building	<b>Floor Level:</b> First	<b>Room Name:</b> (012) Bedroom
<b>Component:</b> Textured Coating (Asbestos Reinforced Composite)

Sample Reference	Asbestos Type	Material	Surface Treatment Score	
As AZ002638 (Ref Sample 4)	No asbestos detected in visually consistent material			
Extent of damage	Material Assessment**	Accessibility	Extent/amount	Location
Occupant Activity	No. of Occupants	Frequency of Use	Average Time Area is in Use	
Type of Maintenance		Frequency of Maintenance	Priority Assessment	
Recommendations				
Who	What		When	
-	No further action required		-	
Further Recommendations: None				
General Notes: Textured coating to plasterboard ceiling Plaster to brick and plasterboard walls Hardboard floor uPVC window Wood sill Modern radiator

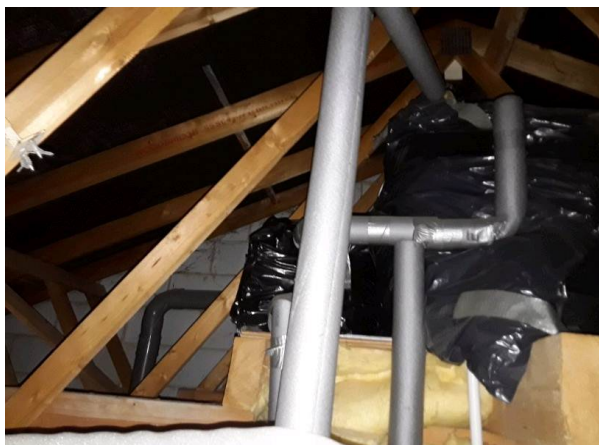
<b>Building:</b> Building	<b>Floor Level:</b> Roof Void	<b>Room Name:</b> (013) Loft
<b>Component:</b> No Asbestos Product Type

Sample Reference	Asbestos Type		Material	Surface Treatment Score	
	No suspect materials				
Extent of damage	Material Assessment**		Accessibility	Extent/amount	Location
Occupant Activity	No. of Occupants		Frequency of Use	Average Time Area is in Use	
Type of Maintenance		Frequency of Maintenance		Priority Assessment	
Recommendations					
Who	What			When	
-	No further action required			-	
Further Recommendations: None					
General Notes: Modern roof felt Breeze block walls Plasterboard floor panels MMMF insulation Plastic water tank Bagged MMMF insulation to water tank Foam insulation to metal pipes Plastic loft hatch panel

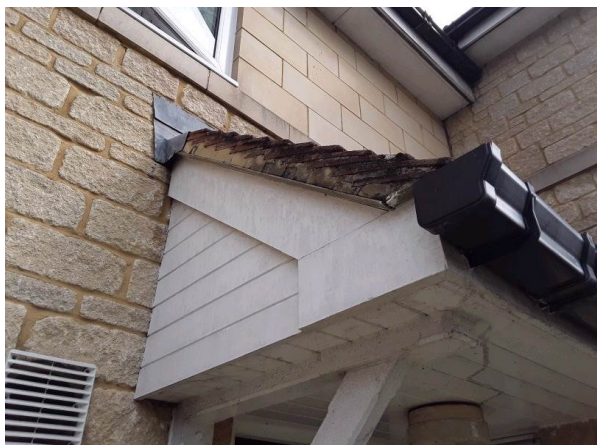
<b>Building:</b> Building	<b>Floor Level:</b> External	<b>Room Name:</b> (014) External
<b>Component:</b> Asbestos Cement (Asbestos Reinforced Composite)

Location	Result (asbestos type)	Action	Sample Ref
Building External (014) External Asbestos Cement (Asbestos Reinforced Composite)	Chrysotile	Manage and Inspect	AZ002639 (Sample 5)

Sample Reference	Asbestos Type	Material	Surface Treatment Score	
AZ002639 (Sample 5)	Chrysotile (1)	Cement (1)	1	
Extent of damage	Material Assessment**	Accessibility	Extent/amount	Location
Low Damage (1)	Very Low (4)	1	6.0m² (1)	0
Occupant Activity	No. of Occupants	Frequency of Use	Average Time Area is in Use	
1 (Low disturbance)	0 (None)	0 (Infrequent)	0 (<1 hour)	
Type of Maintenance		Frequency of Maintenance	Priority Assessment	
1 (Low disturbance)		1 (<1 per year)	3	
Recommendations				
Who	What		When	
Competent person	Manage and Inspect		Now and periodically	
Further Recommendations: Cement undercloak to roof and entrance canopy				
General Notes: Modern roof tiles Cement undercloak to roof and entrance canopy Plastic guttering and drainpipes Wood soffit Wood ceiling panels to entrance canopy Modern damp proof course uPVC Windows Wood front door uPVC rear door
