An Asbestos Management with part Refurbishment Survey (MA & PA) at
24 Claridge Close
Aldbourne
Marlborough
Wiltshire
SN8 2SL

| Survey Conducted: | 12 September 2023 | |
| Our Reference: | J331628 | |
| Scope of Works: | Refurbishment survey to the living room prior to refurbishment, with a management survey to the remainder of the property. | |

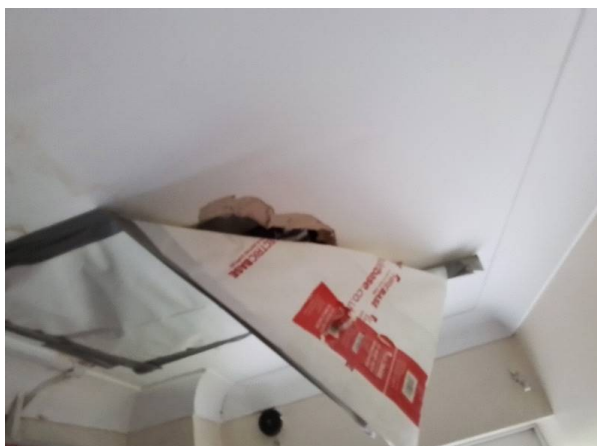
| Component: | Plasterboard ceiling panel | | | | |
| Extent: | 10m ² | | | | |

| Conclusions and Actions | |
|---|---|
| Recommendation: | No further action required |

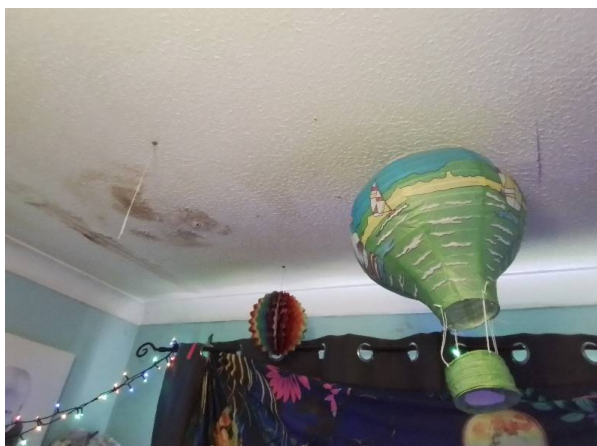
| Component: | Textured coating to plasterboard ceiling | | | | |
| Extent: | 8m ² | | | | |

| Conclusions and Actions | |
|---|---|
| Recommendation: | No further action required |

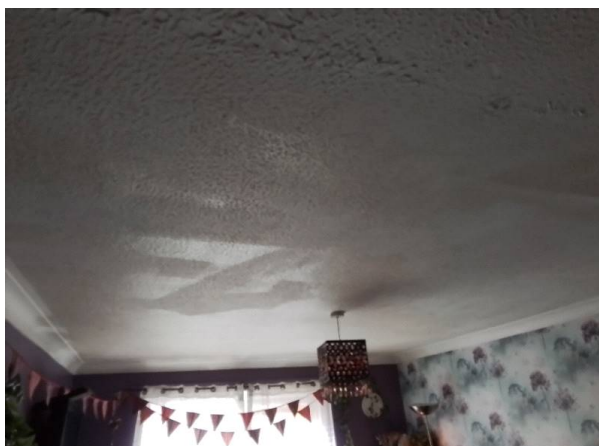
| Component: | Textured coating to plasterboard ceiling | | | | |
| Extent: | 18m ² | | | | |

| Conclusions and Actions | |
|---|---|
| Recommendation: | No further action required |

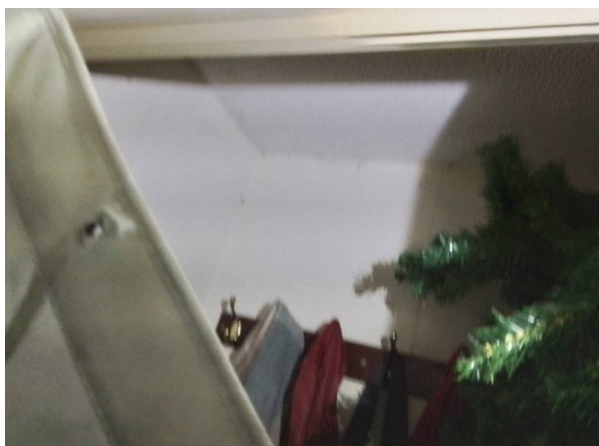
| Component: | Textured coating to plasterboard ceiling | | | | |
| Extent: | 1m ² | | | | |

| Conclusions and Actions | |
|--|---|
| Recommendation: | No further action required |

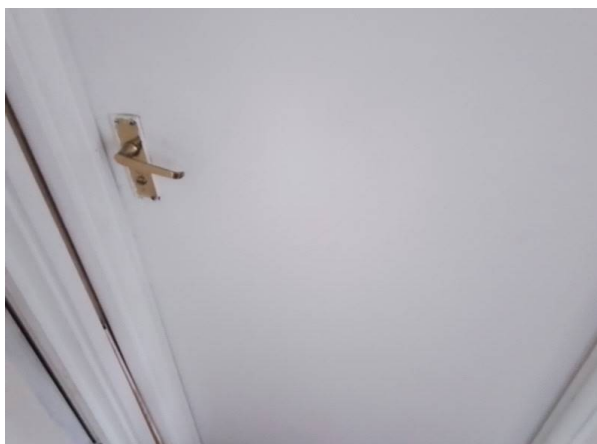
| Component: | No Access | | | | |

| Conclusions and Actions | |
|---|---|
| Recommendation: | Further Inspection Required. |

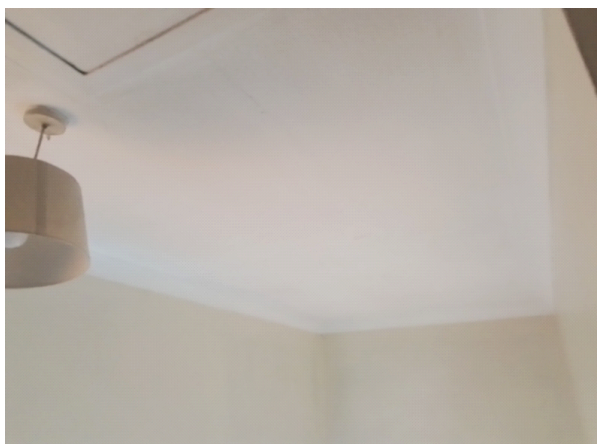
| Component: | Textured coating to plasterboard ceiling | | | | |
| Extent: | 10m ² | | | | |

| Conclusions and Actions | |
|---|---|
| Recommendation: | No further action required |

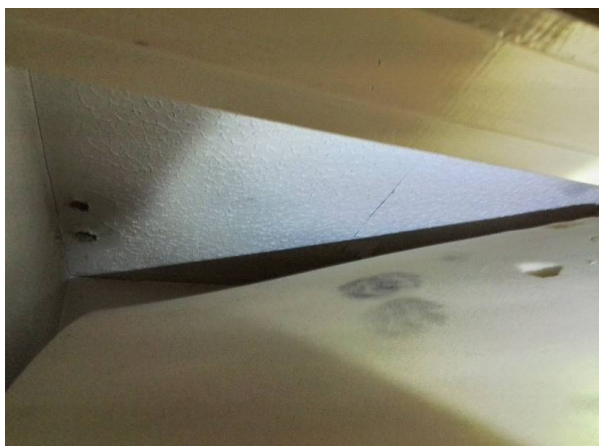
| Component: | Textured coating to plasterboard ceiling | | | | |
| Extent: | 2m ² | | | | |

| Conclusions and Actions | |
|---|---|
| Recommendation: | No further action required |

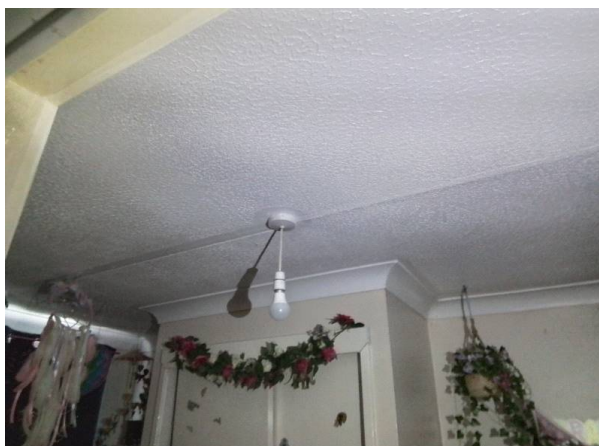
| Component: | Textured coating to plasterboard ceiling | | | | |
| Extent: | 10m ² | | | | |

| Conclusions and Actions | |
|--|---|
| Recommendation: | No further action required |

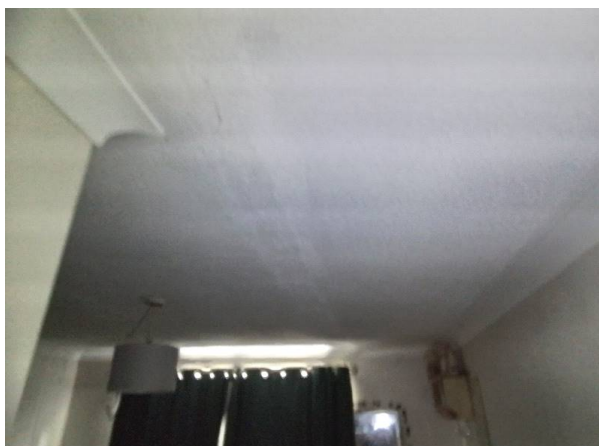
| Component: | Textured coating to plasterboard ceiling | | | | |
| Extent: | 12m ² | | | | |

| Conclusions and Actions | |
|--|---|
| Recommendation: | No further action required |

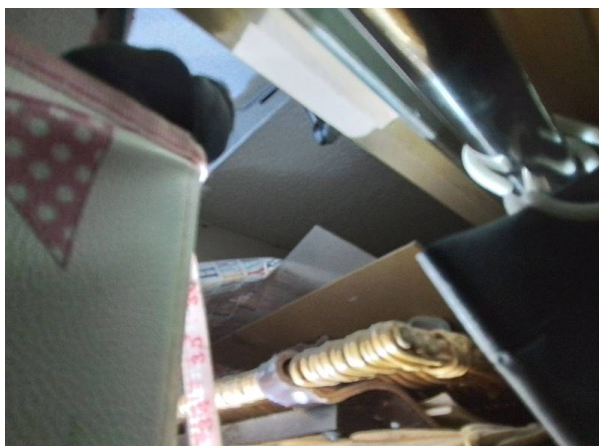
| Component: | Textured coating to plasterboard ceiling | | | | |
| Extent: | 2m ² | | | | |

| Conclusions and Actions | |
|--|---|
| Recommendation: | No further action required |

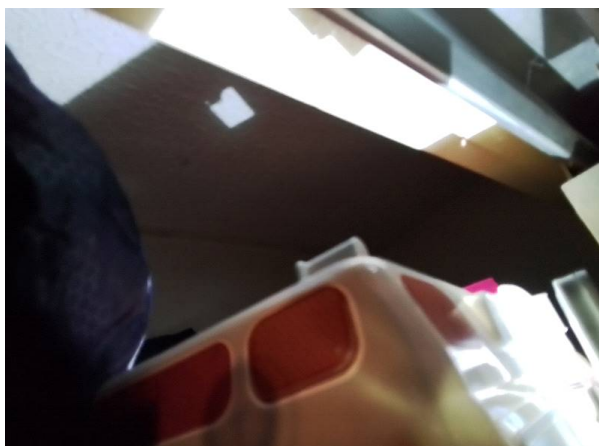
| Component: | Textured coating to plasterboard ceiling | | | | |
| Extent: | 1.5m ² | | | | |

| Conclusions and Actions | |
|--|---|
| Recommendation: | No further action required |

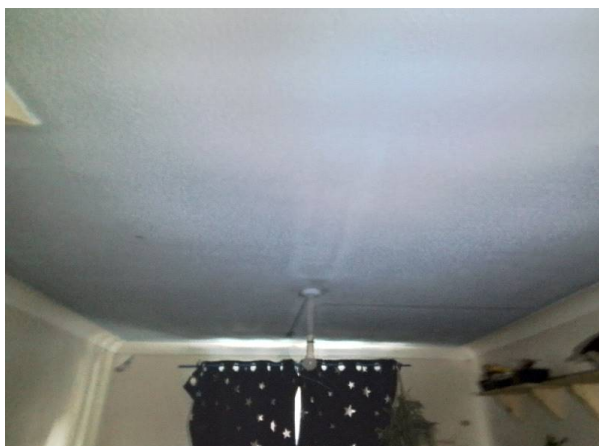
| Component: | Textured coating to plasterboard ceiling | | | | |
| Extent: | 10m ² | | | | |

| Conclusions and Actions | |
|--|---|
| Recommendation: | No further action required |

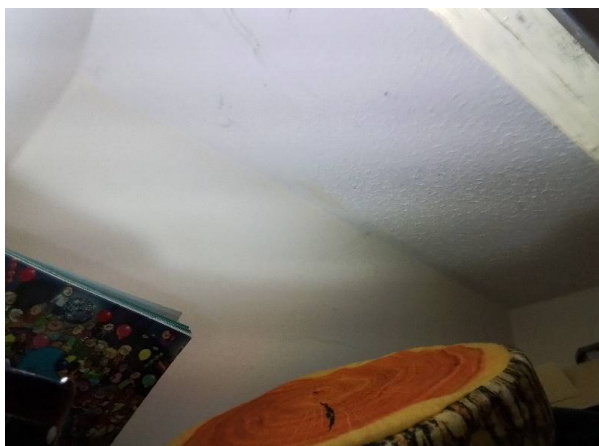
| Component: | Textured coating to plasterboard ceiling | | | | |
| Extent: | 1.5m ² | | | | |

| Conclusions and Actions | |
|--|---|
| Recommendation: | No further action required |

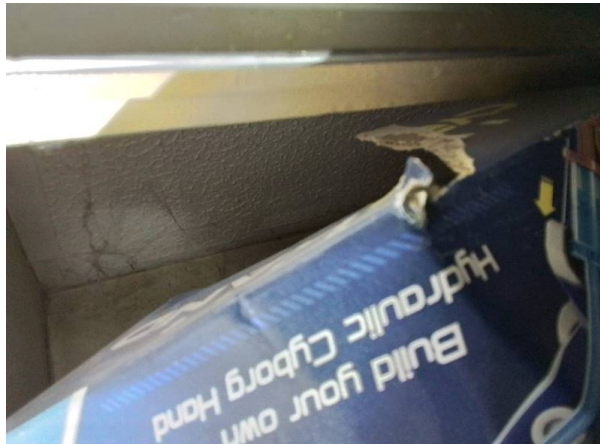
| Component: | Textured coating to plasterboard ceiling | | | | |
| Extent: | 1m ² | | | | |

| Conclusions and Actions | |
|--|---|
| Recommendation: | No further action required |

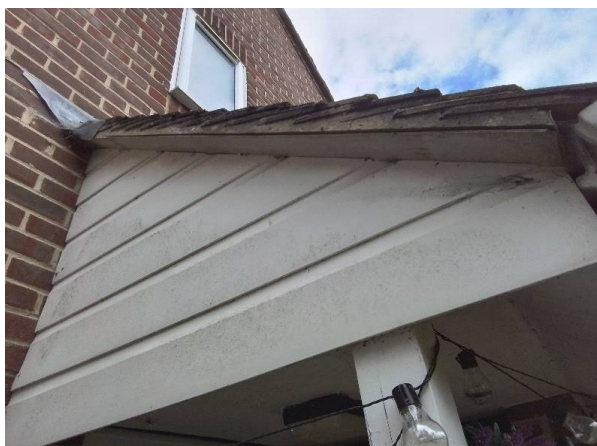
| Component: | Cement board undercloak to roof and entrance canopy | | | | |
| Extent: | 18lm | | | | |

| Material Assessment | | |
|---|---|---|
| Cement (1) | Low Damage (1) | 1 |

| Conclusions and Actions | |
|--|---|
| Recommendation: | Manage and Inspect |

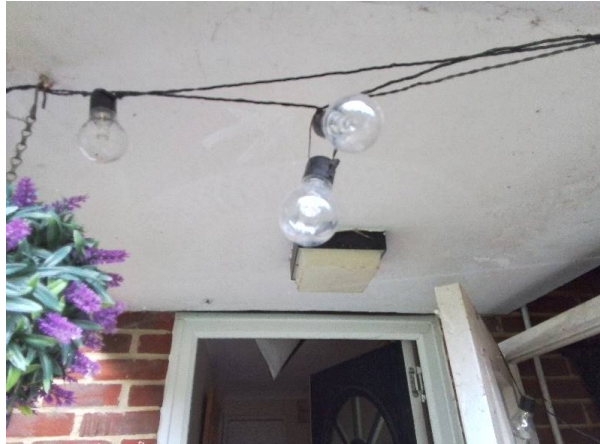
| Component: | Insulation board ceiling panel to entrance canopy | | | | |
| Extent: | 2m ² | | | | |

| Conclusions and Actions | |
|--|---|
| Recommendation: | No further action required |
