# **RBS - Short Inspection Form V1**

22 Apr 2025 / Flat 15 Blackhorse Court Blackhorse Road, Kingswood, Bristol, BS15 8EA / Julian Mallia - RBS North

RBS Inspection requested by d2d to check condition of windows, according to suppliers they are unable to source replacement mechanisms in UK

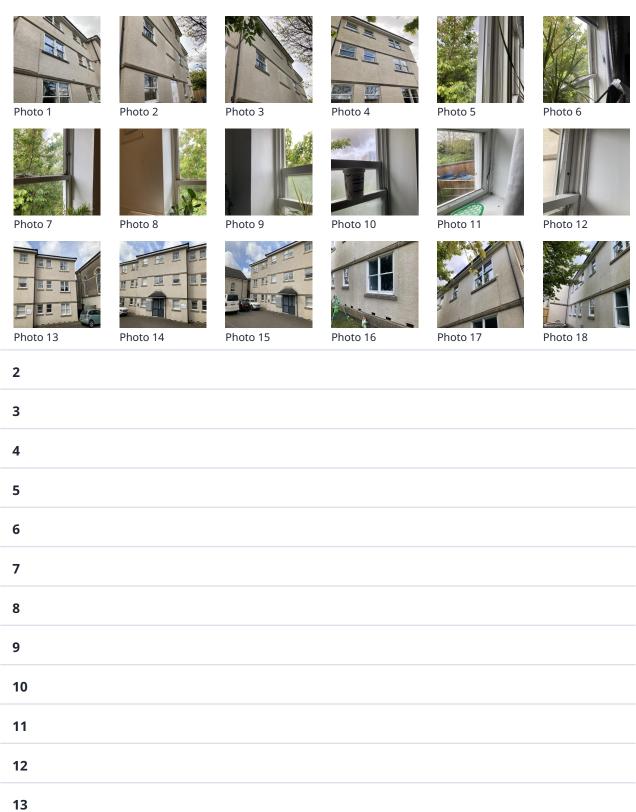
1

There are five pairs of sliding sash windows in flat 15 and the cords are broken on 3 of the 5 windows. Our in house team have researched these windows to try to source the correct parts to allow the windows to be repaired and it appears that they would need to be sourced from the USA and approximate costs for obtaining the correct parts for the 3 windows would be around £700 plus any fitting costs etc. The design means that springs could not be used instead and the diameter and make up of the cord is critical to be able to pass through openings and pullies that form the mechanism.

The tenant advised that on one occasion when a cord broke the window slipped and they thought they were going to end up with a broken finger when it was trapped between the two sashes.

Consideration needs to be given to bringing the block forward in the programme. If this is not feasible then it will be necessary to replace a minimum of 3 windows as an ACR.
