## REFURBISHMENT SURVEY TO THE ROOF TILES ONLY

Flats 1-12,14,15 Blackhorse Court Blackhorse Road Kingswood Bristol

BS15 8EA

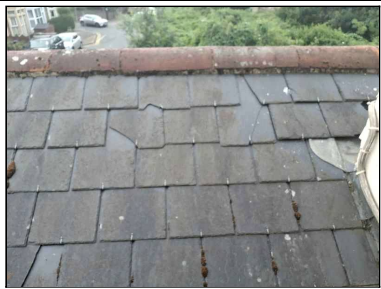
| 23 Jul 2025 | Anthony Osborne | Refurbishment/Demolition Survey | External | No Asbestos Detected |

| Recommendation | No further action required | | | | | | |

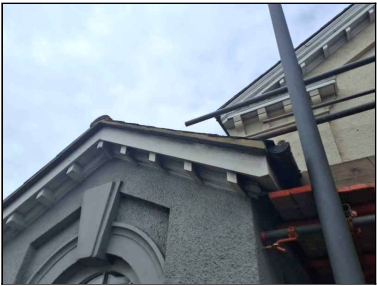
| 23 Jul 2025 | Anthony Osborne | Refurbishment/Demolition Survey | External | No Asbestos Detected |

| Recommendation | No further action required | | | | | | |

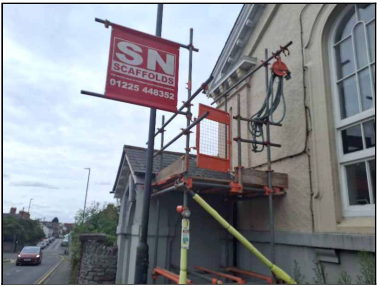
| 23 Jul 2025 | Anthony Osborne | Refurbishment/Demolition Survey | External | N/A |

| Recommendation | No further action required | | | | | | |
