CONTROLLED ASBESTOS REFURBISHMENT SURVEY

Client	Swindon Borough Council
Site	24 Meadowcroft, Upper Stratton, Swindon, Wilts , SN2 7JE
Date started	13 Jan 2022
Date completed	13 Jan 2022
Date report issued	14 Jan 2022
Survey reference	J677851
Lead surveyor	Alison McIntyre
Assistant surveyor	N/A
UPRN	0946002400

ASBESTOS SURVEY OF 24 MEADOWCROFT, UPPER STRATTON, SWINDON, WILTS

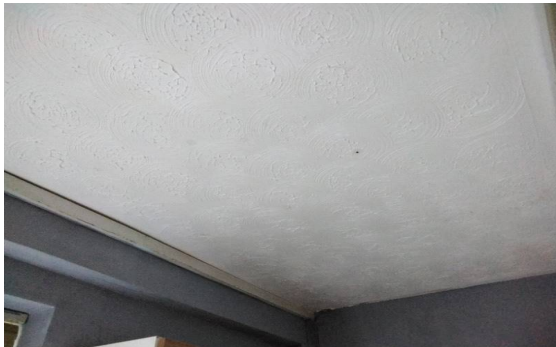
Item Reference	J677851 #1
	Sample reference number	BB011939
	Client name	Swindon Borough Council
	Site address	24 Meadowcroft, Upper Stratton, Swindon, Wilts , SN2 7JE
	Date surveyed	13/01/22
	Date analysed	January 14 2022
	Building	24 Meadowcroft
	Floor level	Ground Floor
	Room	Kitchen
	Position	Ceiling
	Item description	Textured coating
	Condition / damage	
	Surface treatment	
	Product type	
Asbestos Type	No Asbestos Detected	
Extent		
Recommended Action	None required	Accessibility
Comments:		Material assessment score
		Risk code

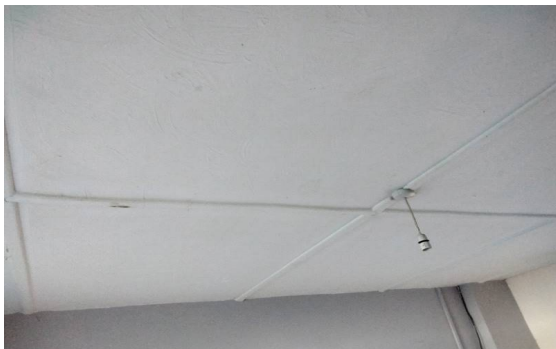
Item Reference	J677851 #2
	Sample reference number	BB011940
	Client name	Swindon Borough Council
	Site address	24 Meadowcroft, Upper Stratton, Swindon, Wilts , SN2 7JE
	Date surveyed	13/01/22
	Date analysed	January 14 2022
	Building	24 Meadowcroft
	Floor level	Ground Floor
	Room	Dining room
	Position	Ceiling
	Item description	Textured coating
	Condition / damage	
	Surface treatment	
	Product type	
Asbestos Type	No Asbestos Detected	
Extent		
Recommended Action	None required	Accessibility
Comments:		Material assessment score
		Risk code

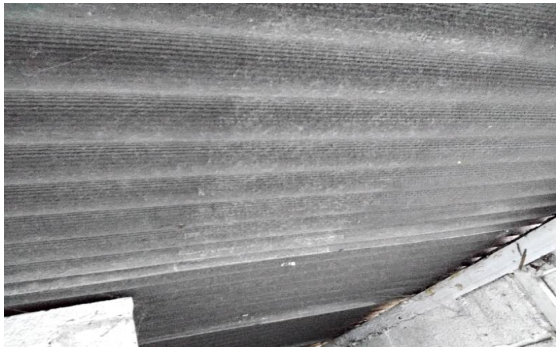
Item Reference	J677851 #3
	Sample reference number	BB011941
	Client name	Swindon Borough Council
	Site address	24 Meadowcroft, Upper Stratton, Swindon, Wilts , SN2 7JE
	Date surveyed	13/01/22
	Date analysed	January 14 2022
	Building	24 Meadowcroft
	Floor level	External
	Room	Outhouse
	Position	Roof sheets
	Item description	Cement
	Condition / damage	
	Surface treatment	
	Product type	
	Asbestos Type	No Asbestos Detected
Extent		
Recommended Action	None required	Accessibility
Comments:		Material assessment score
		Risk code

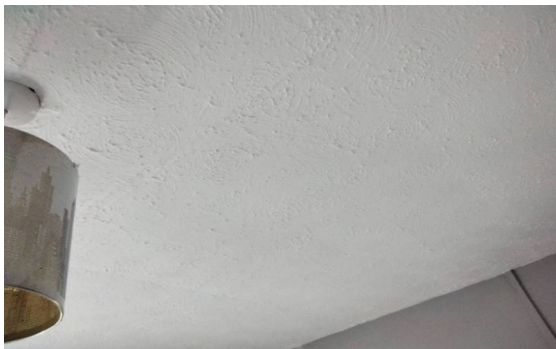
Item Reference	J677851 #4
	Sample reference number	BB011942
	Client name	Swindon Borough Council
	Site address	24 Meadowcroft, Upper Stratton, Swindon, Wilts , SN2 7JE
	Date surveyed	13/01/22
	Date analysed	January 14 2022
	Building	24 Meadowcroft
	Floor level	Ground Floor
	Room	Lounge
	Position	Ceiling
	Item description	Textured coating
	Condition / damage	
	Surface treatment	
	Product type	
	Asbestos Type	No Asbestos Detected
Extent		
Recommended Action	None required	Accessibility
Comments:		Material assessment score
		Risk code

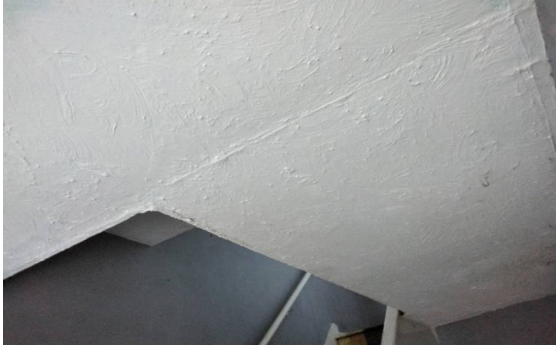
Item Reference	J677851 #5
	Sample reference number	BB011943
	Client name	Swindon Borough Council
	Site address	24 Meadowcroft, Upper Stratton, Swindon, Wilts , SN2 7JE
	Date surveyed	13/01/22
	Date analysed	January 14 2022
	Building	24 Meadowcroft
	Floor level	Ground Floor
	Room	Hall and cupboards
	Position	Ceiling
	Item description	Textured coating
	Condition / damage	
	Surface treatment	
	Product type	
Asbestos Type	No Asbestos Detected	
Extent		
Recommended Action	None required	Accessibility
Comments:		Material assessment score
		Risk code

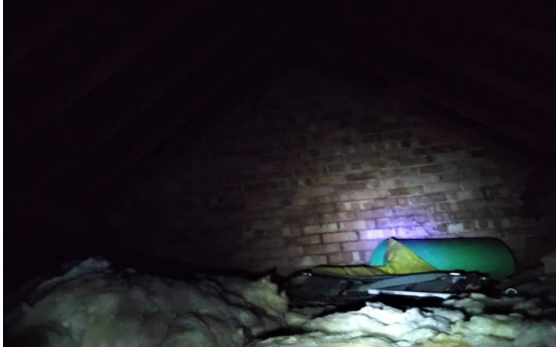
Item Reference	J677851 #6
	Sample reference number	
	Client name	Swindon Borough Council
	Site address	24 Meadowcroft, Upper Stratton, Swindon, Wilts , SN2 7JE
	Date surveyed	13/01/22
	Date analysed	
	Building	24 Meadowcroft
	Floor level	1st Floor
	Room	Loft
	Position	
	Item description	General view
	Condition / damage	
	Surface treatment	
	Product type	
Asbestos Type		
Extent		
Recommended Action		Accessibility
Comments:		Material assessment score
		Risk code

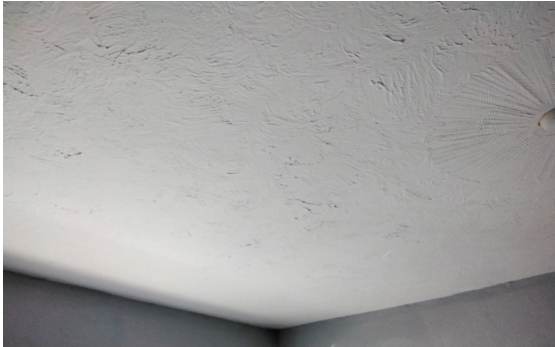
Item Reference	J677851 #7
	Sample reference number	BB011944
	Client name	Swindon Borough Council
	Site address	24 Meadowcroft, Upper Stratton, Swindon, Wilts , SN2 7JE
	Date surveyed	13/01/22
	Date analysed	January 14 2022
	Building	24 Meadowcroft
	Floor level	1st Floor
	Room	Bedroom 2 and cupboard
	Position	Ceiling
	Item description	Textured coating
	Condition / damage	
	Surface treatment	
	Product type	
Asbestos Type	No Asbestos Detected	
Extent		
Recommended Action	None required	Accessibility
Comments:		Material assessment score
		Risk code

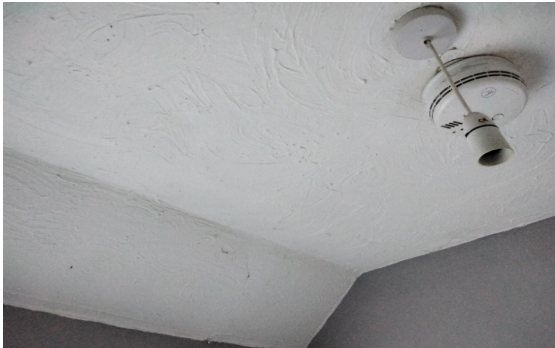
Item Reference	J677851 #8
	Sample reference number	BB011945
	Client name	Swindon Borough Council
	Site address	24 Meadowcroft, Upper Stratton, Swindon, Wilts , SN2 7JE
	Date surveyed	13/01/22
	Date analysed	January 14 2022
	Building	24 Meadowcroft
	Floor level	1st Floor
	Room	Landing
	Position	Ceiling
	Item description	Textured coating
	Condition / damage	
	Surface treatment	
	Product type	
Asbestos Type	No Asbestos Detected	
Extent		
Recommended Action	None required	Accessibility
Comments:		Material assessment score
		Risk code

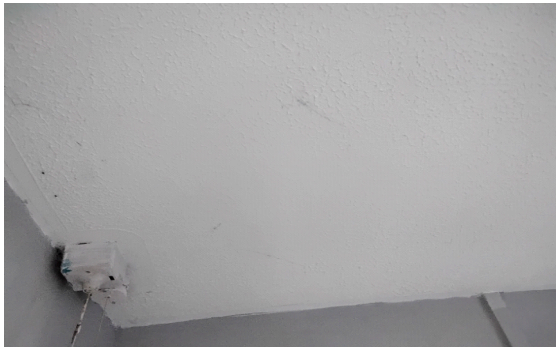
Item Reference	J677851 #9
	Sample reference number	BB011946
	Client name	Swindon Borough Council
	Site address	24 Meadowcroft, Upper Stratton, Swindon, Wilts , SN2 7JE
	Date surveyed	13/01/22
	Date analysed	January 14 2022
	Building	24 Meadowcroft
	Floor level	1st Floor
	Room	Bathroom
	Position	Ceiling
	Item description	Textured coating
	Condition / damage	
	Surface treatment	
	Product type	
Asbestos Type	No Asbestos Detected	
Extent		
Recommended Action	None required	Accessibility
Comments:		Material assessment score
		Risk code

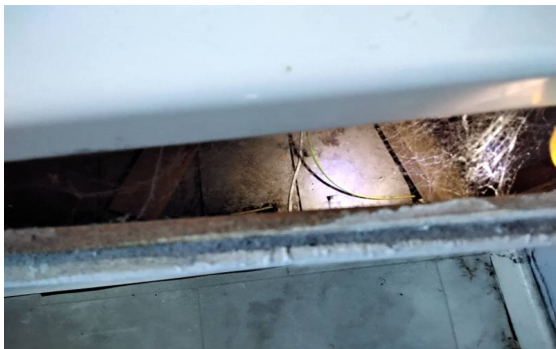
Item Reference	J677851 #10
	Sample reference number	
	Client name	Swindon Borough Council
	Site address	24 Meadowcroft, Upper Stratton, Swindon, Wilts , SN2 7JE
	Date surveyed	13/01/22
	Date analysed	
	Building	24 Meadowcroft
	Floor level	1st Floor
	Room	Bathroom
	Position	General view
	Item description	Bath void
	Condition / damage	
	Surface treatment	
	Product type	
Asbestos Type		
Extent		
Recommended Action		Accessibility
Comments:		Material assessment score
		Risk code

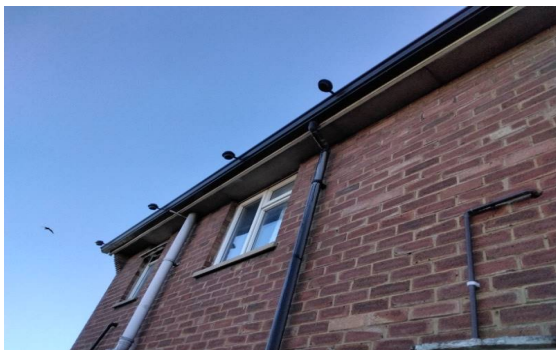
Item Reference	J677851 #11
	Sample reference number	BB011947
	Client name	Swindon Borough Council
	Site address	24 Meadowcroft, Upper Stratton, Swindon, Wilts , SN2 7JE
	Date surveyed	13/01/22
	Date analysed	January 14 2022
	Building	24 Meadowcroft
	Floor level	External
	Room	Externals
	Position	Soffit

Item description	Cement
	Condition / damage	(2) Medium Damage
	Surface treatment	(1) Enclosed sprays and lagging, Sealed AIB, asbestos cement, textured coating, gasket
	Product type	Asbestos Cement
Asbestos Type	Chrysotile	
Extent	20lm	
Accessibility	Low	
Recommended Action	Monitor and manage	
Comments: Has the appearance of cement and the sample point was degraded and delaminated making it soft. Please refer to the HSE guidance to determine if this product requires a licensed contractor - Decision Flow Chart- Introduction to Asbestos Essentials, HSE		
Material assessment score	5	
Risk code	Risk code E

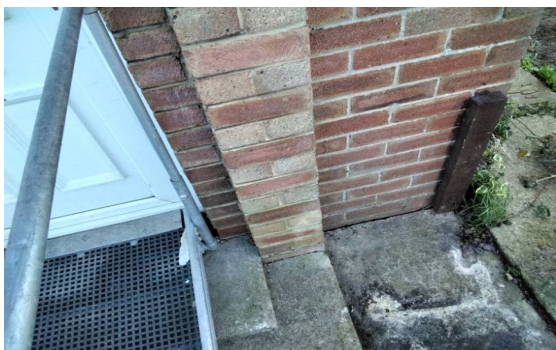
Item Reference	J677851 #12
	Sample reference number	BB011948
	Client name	Swindon Borough Council
	Site address	24 Meadowcroft, Upper Stratton, Swindon, Wilts , SN2 7JE
	Date surveyed	13/01/22
	Date analysed	January 14 2022
	Building	24 Meadowcroft
	Floor level	External
	Room	Externals
	Position	Damp proof course
	Item description	Bitumen
	Condition / damage	
	Surface treatment	
	Product type	
Asbestos Type	No Asbestos Detected	
Extent		
Accessibility		
Recommended Action	None required	
Comments:		
Material assessment score		
Risk code
