## Asbestos Refurbishment Survey

**0408002700**  
**27 BUCKLAND CLOSE**  
**PARK NORTH**  
**SWINDON**  
**WILTS**  
**SN3 2RP**

**Swindon Borough Council**

Project Number:	Survey Date:	Issue Date:
N-58424	10 September 2024	15 September 2024

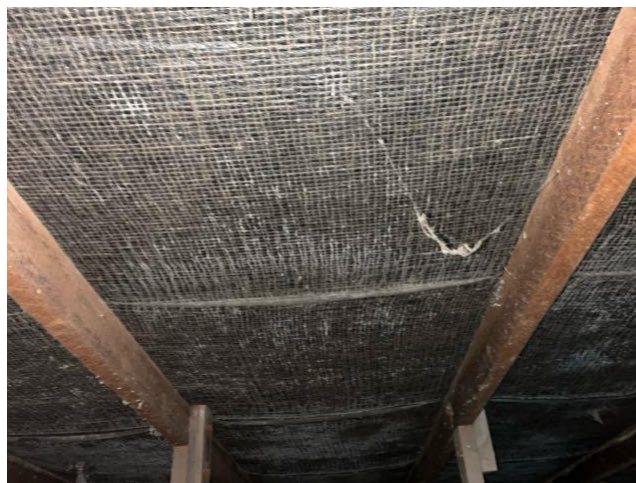
<b>Building</b>	27 BUCKLAND CLOSE
<b>Floor</b>	LOFT
<b>Room</b>	001 - Roof
<b>Description</b>	Felt lining to pitched roof
<b>Sample Reference</b>	S001
<b>Quantity</b>	60 m <sup>2</sup>

Analysis Result	
No Asbestos Detected	0
Product Type	
Felt	1

Condition	
Low Damage	1
Surface Treatment	
Composite (Self Sealed)	0

No asbestos was detected within the sample collected and as such no further action is required.

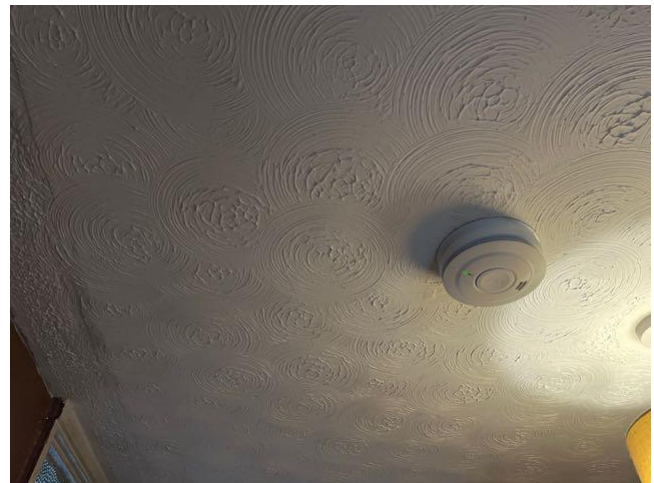
<b>Building</b>	27 BUCKLAND CLOSE
<b>Floor</b>	F01
<b>Room</b>	002 - Landing
<b>Description</b>	Textured coating to plasterboard ceiling
<b>Sample Reference</b>	S002
<b>Quantity</b>	5 m <sup>2</sup>

Analysis Result	
No Asbestos Detected	0
Product Type	
Textured Coating	1

Condition	
Low Damage	1
Surface Treatment	
Composite (Self Sealed)	0

No asbestos was detected within the sample collected and as such no further action is required.

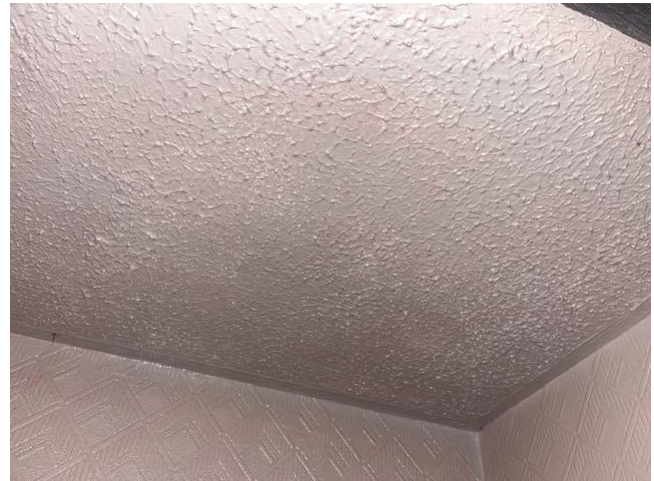
<b>Building</b>	27 BUCKLAND CLOSE
<b>Floor</b>	F01
<b>Room</b>	002 - Landing
<b>Description</b>	Textured coating to plasterboard ceiling
<b>Sample Reference</b>	Ref S004
<b>Quantity</b>	1 m <sup>2</sup>

Analysis Result	
Chrysotile	1
Product Type	
Textured Coating	1

Condition	
Low Damage	1
Surface Treatment	
Composite (Self Sealed)	0

Occupancy Activity	Location	Accessibility
1	2	1
Extent of Material	No of Occupants	Frequency of Use
1	1	3
Average Time	Maintenance Activity	Freq of Maintenance
0	1	1
<b>Material Risk Score:</b>	<b>Priority Risk Score:</b>	
3	4	
<b>Total Risk Score:</b>	<b>Risk Description:</b>	
<b>7</b>	<b>Very Low Risk</b>

Sample referenced to a sample previously collected during the survey

Whilst the asbestos containing material continues to remain undisturbed, no immediate action is required. However a system of ongoing management should be implemented which includes routine condition inspections. Although not a legal requirement, labelling the material as asbestos should be considered to reduce the risk of accidental disturbance. If however the asbestos containing material is likely to be disturbed during the refurbishment works then it should be removed and disposed of in full accordance with current and relevant legislation prior to the refurbishment works being undertaken.

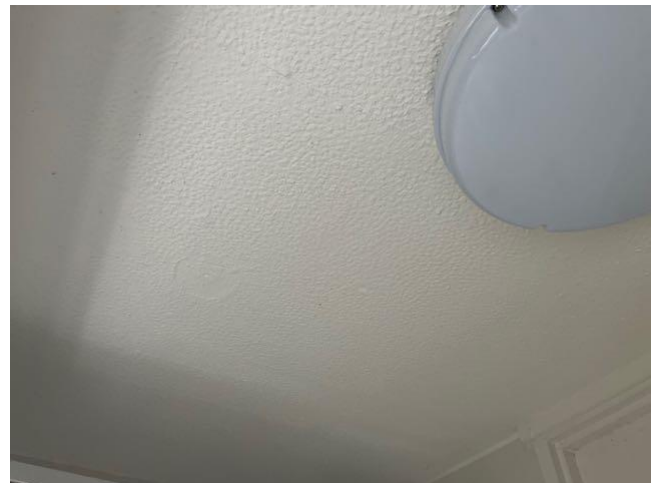
<b>Building</b>	27 BUCKLAND CLOSE
<b>Floor</b>	F01
<b>Room</b>	003 - Bathroom
<b>Description</b>	Textured coating to plasterboard ceiling
<b>Sample Reference</b>	S003
<b>Quantity</b>	4 m <sup>2</sup>

Analysis Result	
No Asbestos Detected	0
Product Type	
Textured Coating	1

Condition	
Low Damage	1
Surface Treatment	
Composite (Self Sealed)	0

No asbestos was detected within the sample collected and as such no further action is required.

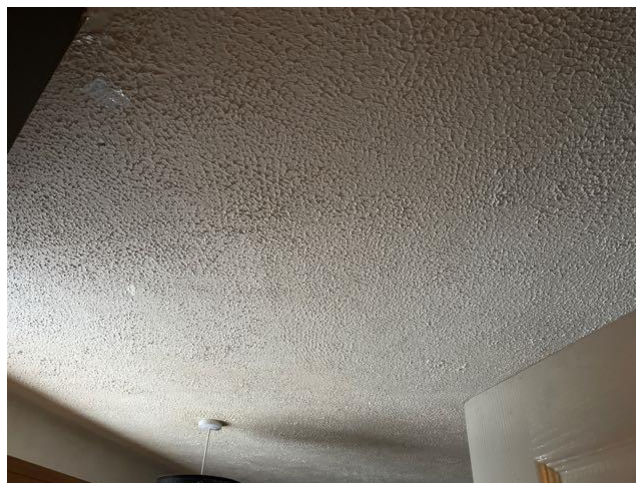
<b>Building</b>	27 BUCKLAND CLOSE
<b>Floor</b>	F01
<b>Room</b>	004 - Bedroom
<b>Description</b>	Textured coating to plasterboard ceiling
<b>Sample Reference</b>	S004
<b>Quantity</b>	11 m <sup>2</sup>

Analysis Result	
Chrysotile	1
Product Type	
Textured Coating	1

Condition	
Low Damage	1
Surface Treatment	
Composite (Self Sealed)	0

Occupancy Activity	Location	Accessibility
1	2	1
Extent of Material	No of Occupants	Frequency of Use
2	1	3
Average Time	Maintenance Activity	Freq of Maintenance
3	1	1
<b>Material Risk Score:</b>	<b>Priority Risk Score:</b>	
3	6	
<b>Total Risk Score:</b>	<b>Risk Description:</b>	
<b>9</b>	<b>Low Risk</b>

Whilst the asbestos containing material continues to remain undisturbed, no immediate action is required. However a system of ongoing management should be implemented which includes routine condition inspections. Although not a legal requirement, labelling the material as asbestos should be considered to reduce the risk of accidental disturbance. If however the asbestos containing material is likely to be disturbed during the refurbishment works then it should be removed and disposed of in full accordance with current and relevant legislation prior to the refurbishment works being undertaken.

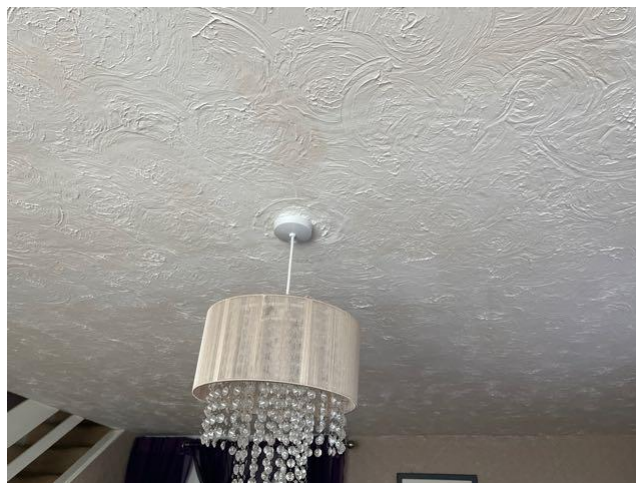
<b>Building</b>	27 BUCKLAND CLOSE
<b>Floor</b>	F00
<b>Room</b>	008 - Lounge
<b>Description</b>	Textured coating to plasterboard ceiling
<b>Sample Reference</b>	S005
<b>Quantity</b>	18 m <sup>2</sup>

Analysis Result	
No Asbestos Detected	0
Product Type	
Textured Coating	1

Condition	
Medium Damage	2
Surface Treatment	
Composite (Self Sealed)	0

Small area of cracking and damaged to textured coating.

No asbestos was detected within the sample collected and as such no further action is required.

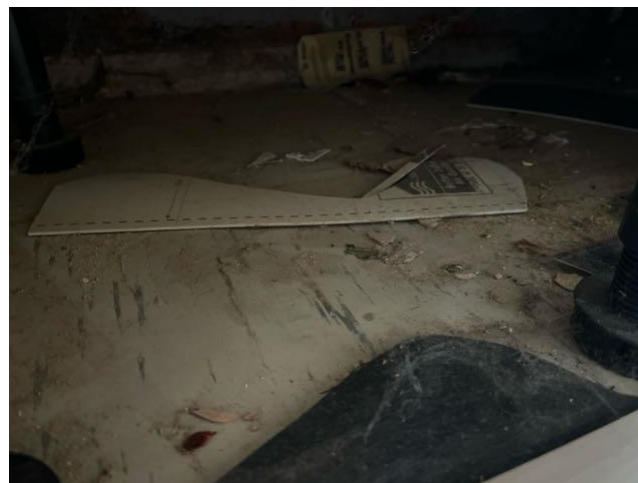
<b>Building</b>	27 BUCKLAND CLOSE
<b>Floor</b>	F00
<b>Room</b>	009 - Kitchen
<b>Description</b>	Thermoplastic tiles below modern linoleum
<b>Sample Reference</b>	S006
<b>Quantity</b>	10 m <sup>2</sup>

Analysis Result	
No Asbestos Detected	0
Product Type	
Thermoplastic Tiles	1

Condition	
Low Damage	1
Surface Treatment	
Composite (Self Sealed)	0

Found behind kickboards.

No asbestos was detected within the sample collected and as such no further action is required.

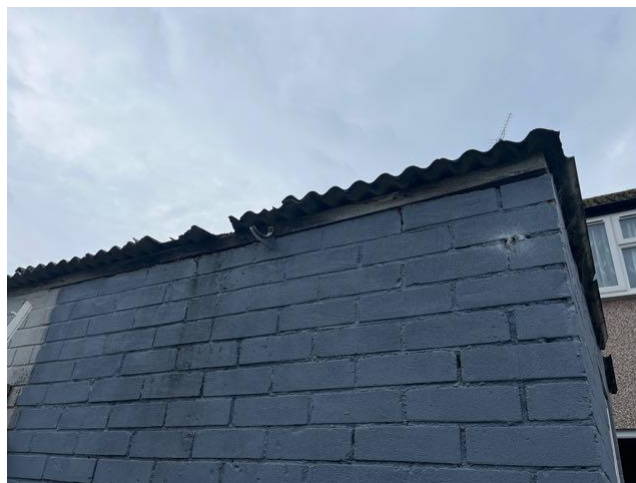
<b>Building</b>	27 BUCKLAND CLOSE
<b>Floor</b>	External
<b>Room</b>	99 - External
<b>Description</b>	Cement sheet roof to outbuilding
<b>Sample Reference</b>	S007
<b>Quantity</b>	8 m <sup>2</sup>

Analysis Result	
Chrysotile	1
Product Type	
Cement	1

Condition	
Medium Damage	2
Surface Treatment	
Unsealed Cement	1

Occupancy Activity	Location	Accessibility
1	0	1
Extent of Material	No of Occupants	Frequency of Use
1	1	3
Average Time	Maintenance Activity	Freq of Maintenance
3	0	2
<b>Material Risk Score:</b>		<b>Priority Risk Score:</b>
5		5
<b>Total Risk Score:</b>		<b>Risk Description:</b>
<b>10</b>		<b>Low Risk</b>

Lots of areas of damage to the edges of the roofing.

The asbestos containing material should be encapsulated with a suitable sealant. Once encapsulated, a system of ongoing management should be implemented which includes routine condition inspections. Although not a legal requirement, labelling the material as asbestos should be considered to reduce the risk of accidental disturbance. If however the asbestos containing material is likely to be disturbed during the refurbishment works then it should be removed and disposed of in full accordance with current and relevant legislation prior to the refurbishment works being undertaken.

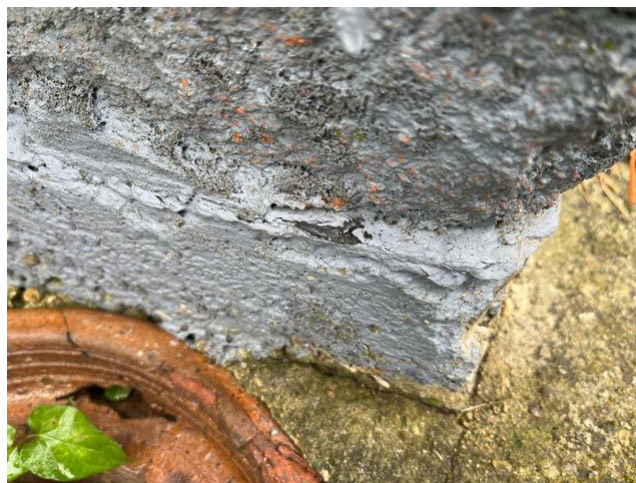
<b>Building</b>	27 BUCKLAND CLOSE
<b>Floor</b>	External
<b>Room</b>	99 - External
<b>Description</b>	Bitumen damp proof course to low level walls of outbuilding
<b>Sample Reference</b>	S008
<b>Quantity</b>	4 Lin M

Analysis Result	
Chrysotile	1
Product Type	
Bitumen	1

Condition	
Low Damage	1
Surface Treatment	
Composite (Self Sealed)	0

Occupancy Activity	Location	Accessibility
1	0	1
Extent of Material	No of Occupants	Frequency of Use
1	1	3
Average Time	Maintenance Activity	Freq of Maintenance
3	0	2
<b>Material Risk Score:</b>		<b>Priority Risk Score:</b>
3		5
<b>Total Risk Score:</b>		<b>Risk Description:</b>
<b>8</b>		<b>Very Low Risk</b>

Whilst the asbestos containing material continues to remain undisturbed, no immediate action is required. However a system of ongoing management should be implemented which includes routine condition inspections. Although not a legal requirement, labelling the material as asbestos should be considered to reduce the risk of accidental disturbance.

If however the asbestos containing material is likely to be disturbed during the refurbishment works then it should be removed and disposed of in full accordance with current and relevant legislation prior to the refurbishment works being undertaken.

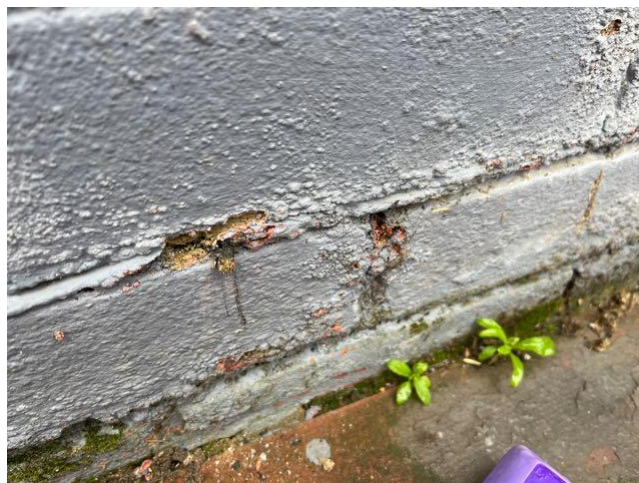
<b>Building</b>	27 BUCKLAND CLOSE
<b>Floor</b>	External
<b>Room</b>	99 - External
<b>Description</b>	Bitumen damp proof course to low level walls
<b>Sample Reference</b>	S009
<b>Quantity</b>	10 Lin M

Analysis Result	
Chrysotile	1
Product Type	
Bitumen	1

Condition	
Low Damage	1
Surface Treatment	
Composite (Self Sealed)	0

Occupancy Activity	Location	Accessibility
1	0	1
Extent of Material	No of Occupants	Frequency of Use
2	1	3
Average Time	Maintenance Activity	Freq of Maintenance
3	0	2
<b>Material Risk Score:</b>		<b>Priority Risk Score:</b>
3		5
<b>Total Risk Score:</b>		<b>Risk Description:</b>
<b>8</b>		<b>Very Low Risk</b>

Whilst the asbestos containing material continues to remain undisturbed, no immediate action is required. However a system of ongoing management should be implemented which includes routine condition inspections. Although not a legal requirement, labelling the material as asbestos should be considered to reduce the risk of accidental disturbance.

If however the asbestos containing material is likely to be disturbed during the refurbishment works then it should be removed and disposed of in full accordance with current and relevant legislation prior to the refurbishment works being undertaken.
